# HIGHGATE CEMETERY

## INSPECTION AND REPORT ON THE CONDITION OF BUILDINGS AND STRUCTURES

### VOLUME 2 PARTS 5 to 12: THE FUNERARY BUILDINGS

JANUARY- MARCH 2022  
REVISION A: DECEMBER 2022

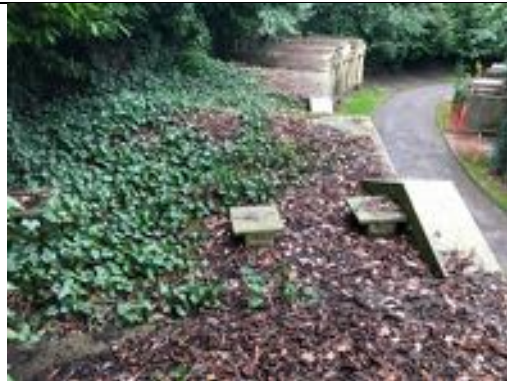
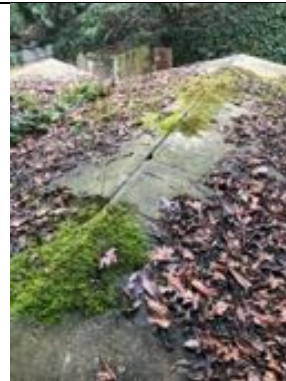
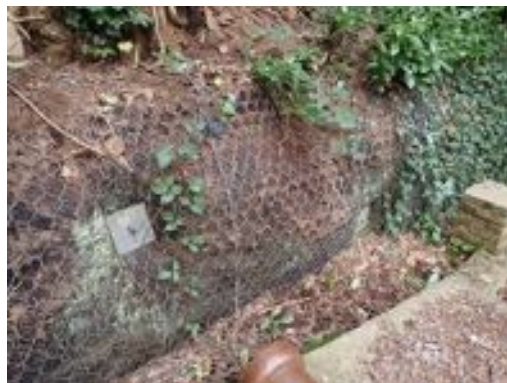
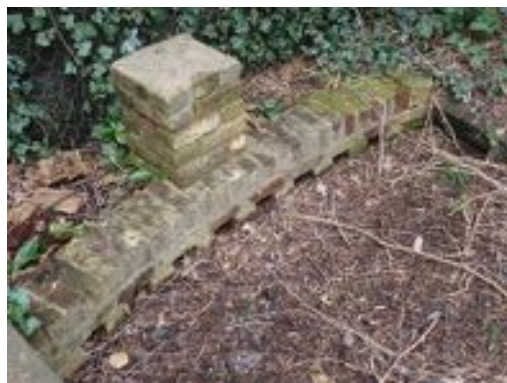
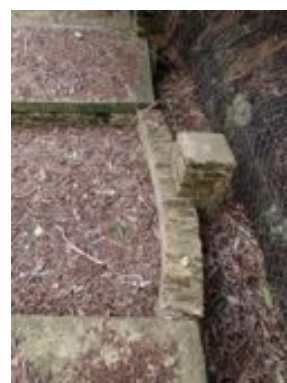
Small brick 'chimney' vents to some chambers are sound. Pitched roofs to pedimented vault buildings are in thick stone slabs, neatly jointed together. The abutment to and over the scalloped retaining wall at the back is unresolved and crude, with mortar fillets to weather brick offsets, but not defective. There is potential for water penetration through stonework joints if the pointing fails. To one vault (13) the stonework has been rendered over, and the render (unsurprisingly) has numerous defects.

It is not clear how the water that collects between the vault roofs is carried away, and it can be considered certain that any channel is choked so this needs to be cleared and reviewed.

Flat roofs to Nos 12 and 14 are also constructed with stone slabs. Of these one falls to the back, with drainage holes through the brick parapet and one to the front where is simply discharges over the edge.

<b>5.2</b>	<b>EXTERIORS</b>	
5.2.1	ROOFS	
	<p>Vegetation from the bank behind, with probably 12 years unimpeded build-up of leaf mould, has completely choked any drainage from the roofs to the land drainage behind, which leaves little opportunity for inspection. This needs to be cleared, and the drainage (a French drain) reviewed.</p> <p>All of the roofs need to be cleaned off more regularly in order that the drainage that is there has a chance of working. When clear of plants and debris, the roofs can be reinspected and repairs scheduled. Major defects are not anticipated.</p>

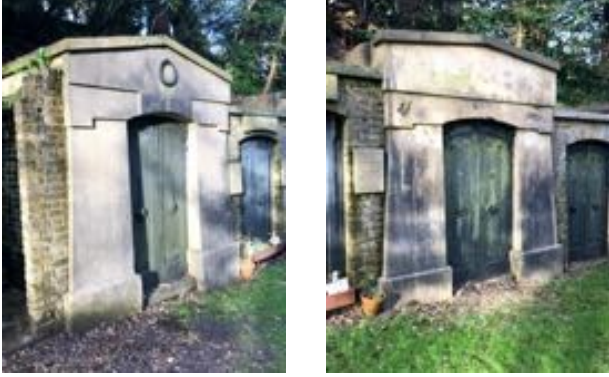
5.2.4	<b>DOORS AND GATES</b>	
	<p>Iron doors and gates were repaired in 2010 and now need light repairs and painting, following an overall programme of opening up and reactivating them.</p> <p>The steel frames to Nos. 11,12 &amp; 13 need earlier attention as they are corroding quickly.</p>

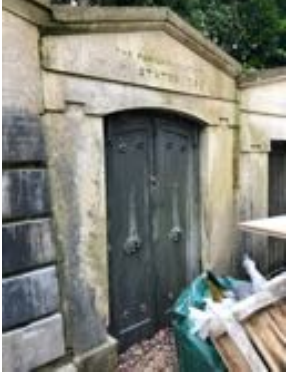
5.3.3	CUTTING CATACOMBS: No.3 ALLEN VAULT	
	Visible through gate. Roof evidently leaks at slab joints. Ivy trailing through the vent. Some light cleaning and repairs needed.

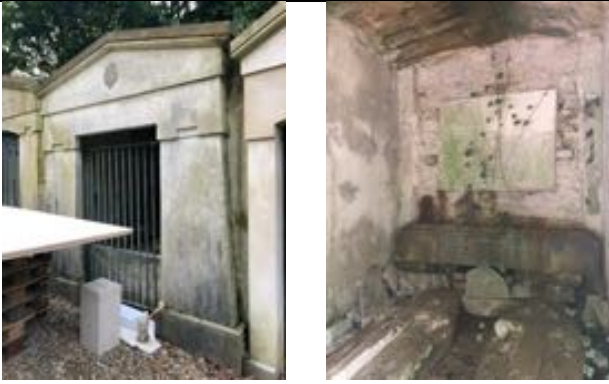
5.3.4	CUTTING CATACOMBS: No.4 HANGES VAULT	
5.3.4.1	General:	
	Recently extensively reconstructed. New front stonework (approx. 10 years old) and interior still being fitted out. All in very good order.	
5.3.4.2	Ceiling and walls:	
	Interior all rendered, smooth and painted.

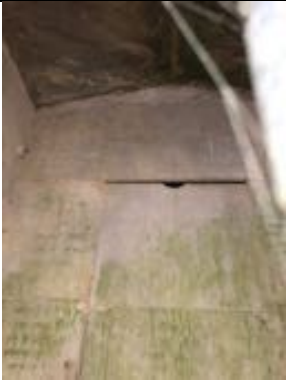
5.3.6	CUTTING CATACOMBS: No. 6 VAULT	
	Similar to Vault No.5, so part only of the interior is visible. Badly cracked marble facing to the sealed vaults has been neatly repaired. Rendered walls and ceiling, all sound. Floor tiles dirty and a bit damp.

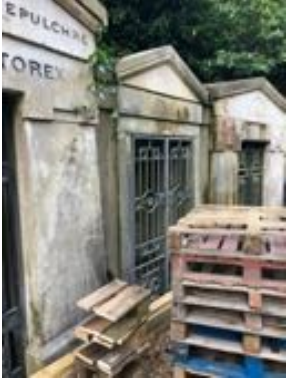
5.3.7	CUTTING CATACOMBS: No. 7 HAWES VAULT	
	Half wall near the front. Roof supported on steel frame appears sound, and that and the upper part of the walls are quite dry. Marble half wall quite sound, old cracks have been repaired.

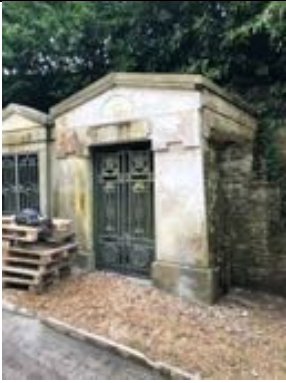
5.3.8	CUTTING CATACOMBS: No. 8 GAP	
	Gap. Plant growth in back wall should be controlled. Offsets in buttresses would benefit from some weathering.

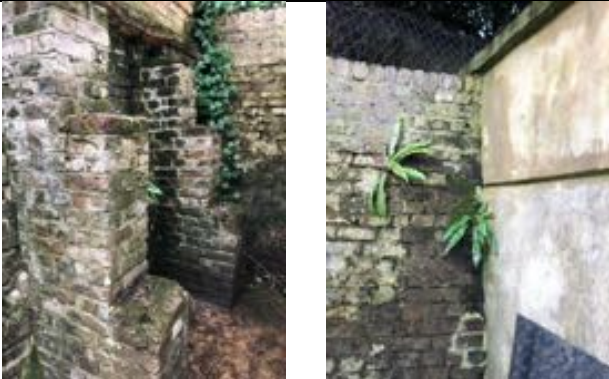
5.3.9	CUTTING CATACOMBS: No. 9 VAULT	
	Roof supported with steel structure visible over $\frac{3}{4}$ tall wall. Looks sound and fairly dry as do the tops of the walls. Marble wall similar to Vault No.7.

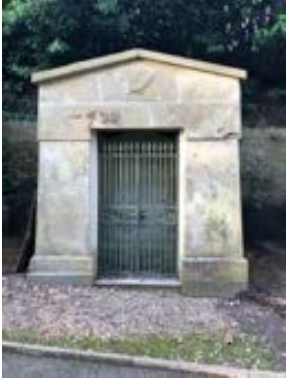
5.3.10	CUTTING CATACOMBS: No. 10 GAP	
	Gap. Very wet but no plant growth. The water from this section should be better managed.

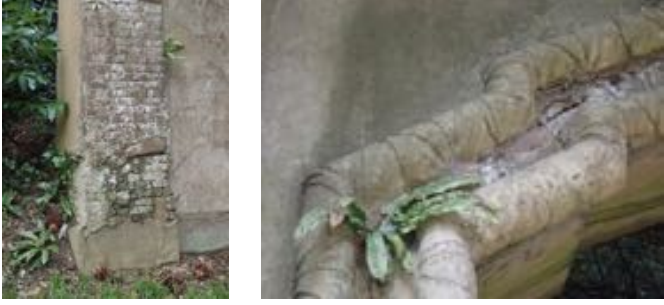
<p>The structure is however very wet, and there are now once again plants taking root in crevices and cracks.</p>

<p>Continuing the established conservation policy here will demand a renewed engagement with vegetation management and topical repair. At present the render and pointing defects are not extensive, but new plant growth new cracks and other defects are escalation. A random tap-test revealed areas of render that ring hollow and there are some places where it is delaminating from the surface, both of which have the potential for rapid deterioration. Exposed areas of brickwork have pointing new quite eroded, and a full inspection will inform the extent to which this needs to be repointed to maintain structural stability, particularly of the obelisks.</p>

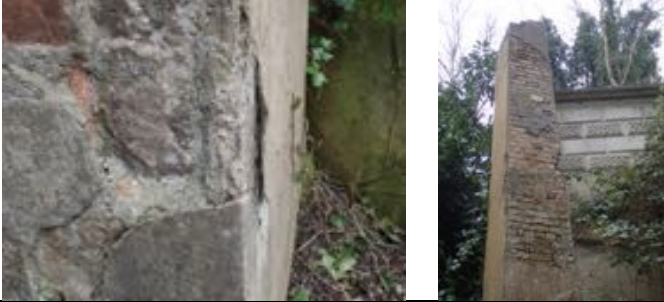
<p>The trailing ivy is picturesque, but full review of the wall heads and the back face of structures will only be possible after full (if temporary) clearance. The most critical area is probably that at the base of the Cory-Wright mausoleum, now infested with brambles.</p> <p>Wall heads may also require further work to minimise direct water ingress, as the state of the fibreglass trays installed in 1990 cannot be determined at the moment.</p>

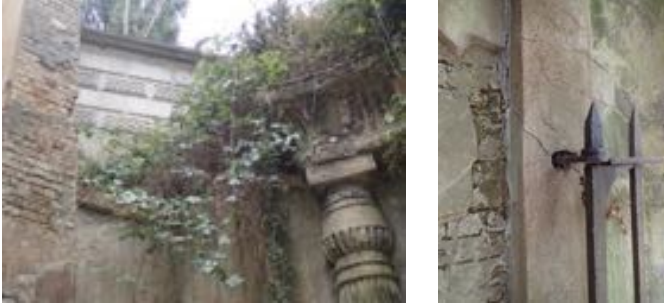
<p>The iron gates, like the rest of the ironwork in this part of the Cemetery, was treated in the last cycle of repairs with 'Fertan' corrosion inhibitor. The present renewed corrosion is superficial, but decorations are very degraded. There is cracking of brickwork and render associated with corroding embedded iron fittings such as hinges.</p>

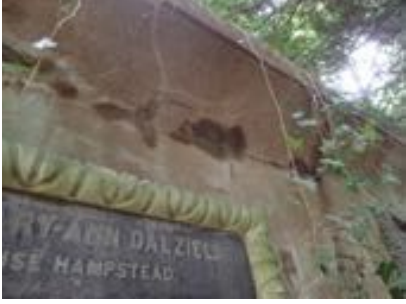
<p>Other conserved render to the facades is continuing to gently decay, but very slowly and only a few areas were found to ring hollow to a random tap-test.</p> <p>One area badly affected by salt mobilisation between EA13 and EA15 is extensively 'hollow'. An area of exposed brick to EA9 is very wet at the bottom, and earlier repairs are rather crude, but it is not actually defective or unstable. At EA6- EA8 there are areas of render near the ground that are actually detaching and these and similar patches will require conservation if they are not to be lost.</p>

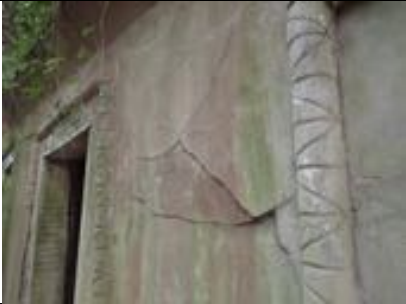
<p>The worst degradation is to the vault entrance reveals and soffits where moisture above drains out through the structure and where the steel door frames abut. Several door soffits are affected, the worst at EA15 where render is detaching in lumps now.</p>

<p>Future repairs should concentrate on water management, with a review of details, drainage and the weatherings to wall heads and cornices. Render repairs will be concentrated on the entrances, to be undertaken in tandem with treatment of the steel door frames.</p>

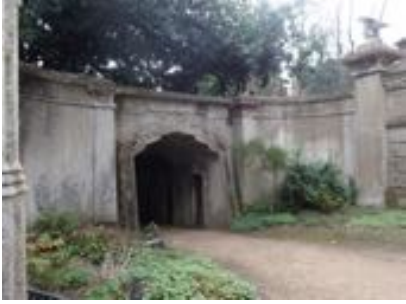
<p>The Avenue side of the vault has a hairline crack following the concealed arch-ring, and very small lateral cracks at the spring of the arch both sides, visible more by the water staining that they allow through than the cracks themselves. Subject to engineer's corroboration this is not of concern but should be monitored from year to year in case the defects are or become progressive.</p>

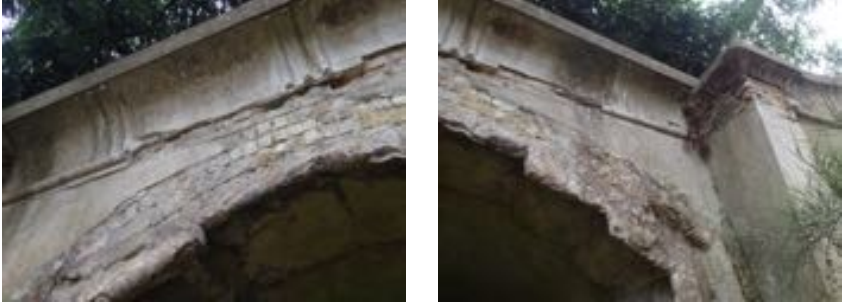
<p>On the outer side of the portal the wall head forms a substantial parapet to the footpath above. There are some cracks in coping joints but only minor repairs are essential. This parapet, at approx. 900mm high, does not meet current regulations for the context but it is substantial and safe in the context of the Cemetery. The protection of the dangerous drop to the other side (into the Avenue cutting) is only a low iron railing and a split lath fence, and this needs to be reviewed.</p>

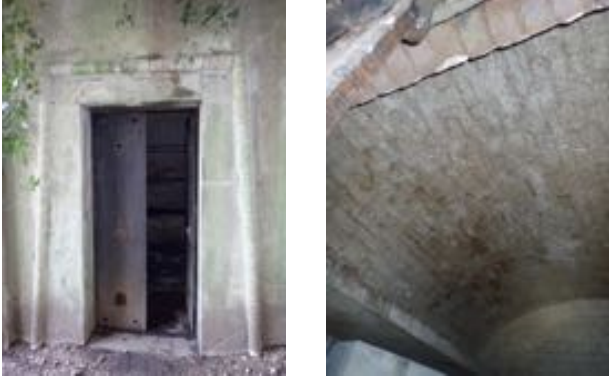
<p>6.3.1</p>	<p>EA1 HARRIS VAULT</p>

<b>GENERAL</b>	
	Damp but not running with water. Plinth and 3 shelves all around. 4 coffins, all broken.	
	<b>CEILING</b>	
	Brick vault. No defects.

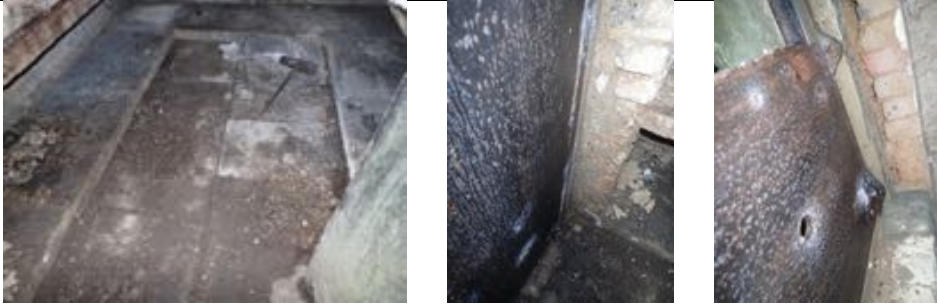
<b>FLOOR</b>	
	Stone slabs. Dirty but sound.	
	<b>DOOR</b>	
	In fair condition. No serious corrosion to frame but very vulnerable.

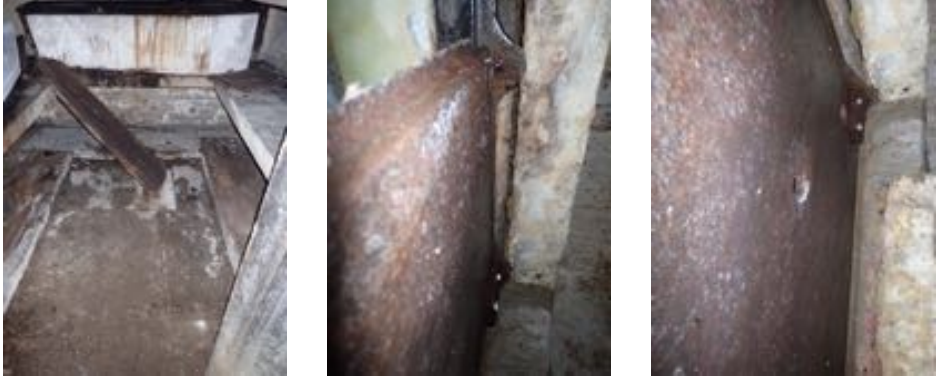
FLOOR	
	Stone slabs. Dirty but sound.	
	DOOR	
	In fair condition. No serious corrosion to frame but very vulnerable to it.

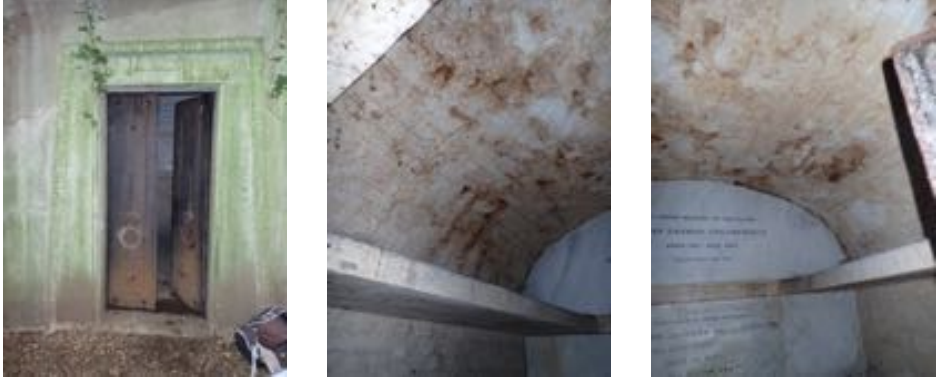
6.3.3	EA7 CHILLINGWORTH VAULT

GENERAL	
	Generally as EA1. Top shelf around 3 sides. 1 shelf below at the back only. Both back shelves sealed with marble inscription slabs.	
	CEILING	
	No defects.

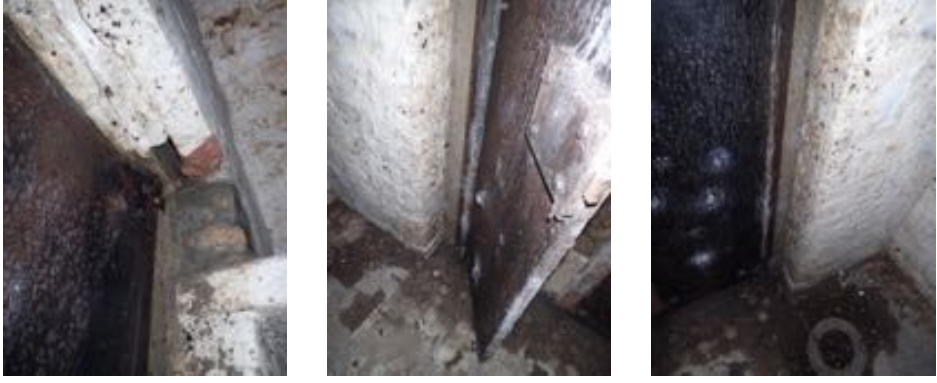
<b>FLOOR</b>	
	150mm black and white tiles. Dirty but sound.	
	<b>DOOR</b>	
	Some corrosion but not fundamentally unsound. 1 lettering ring from the door detached and loose inside.	
6.3.4	<b>EA8 STONEHAM VAULT</b>

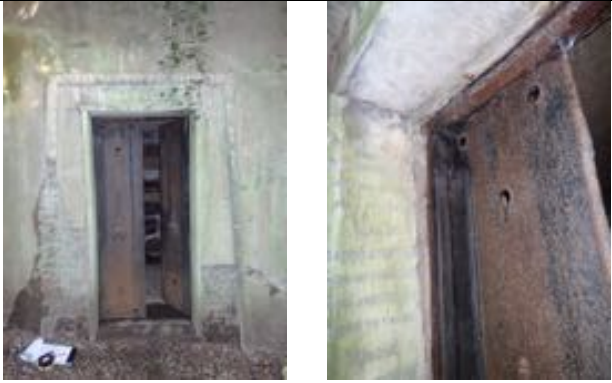
<b>GENERAL</b>	
	Generally as EA1. 3 shelves all around. 7 adult coffins and 1 child coffin, all very decayed.	
	<b>CEILING</b>	
	No defects. A very few fibrous roots.

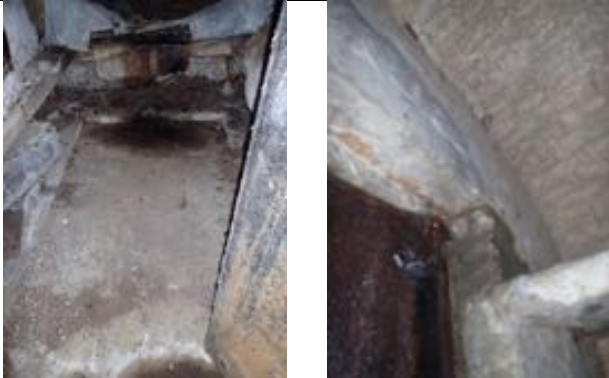
<p><b>WALLS</b></p> <p>Not fully visible but no defects seen. Door lining outside has displaced up to 75mm away from the door frame at the top. Inside face of the wall not displaced. Collar joint issues at door frame.</p>

<p><b>FLOOR</b></p> <p>Damps stone slabs. Wet at the door.</p>	
	<p><b>DOOR</b></p> <p>Bolt detaching and some corrosion. Medium overhaul needed.</p>

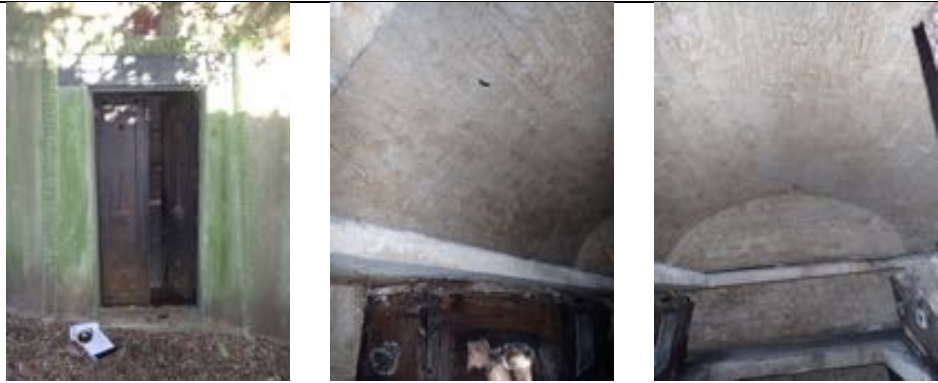
6.3.5	EA10 DALZIEL VAULT 2

<p><b>GENERAL</b></p> <p>Generally as EA1. Plinth and 3 shelves all around. 4 adult coffins.</p>	
	<p><b>CEILING</b></p> <p>No defects. Very few fibrous roots.</p>

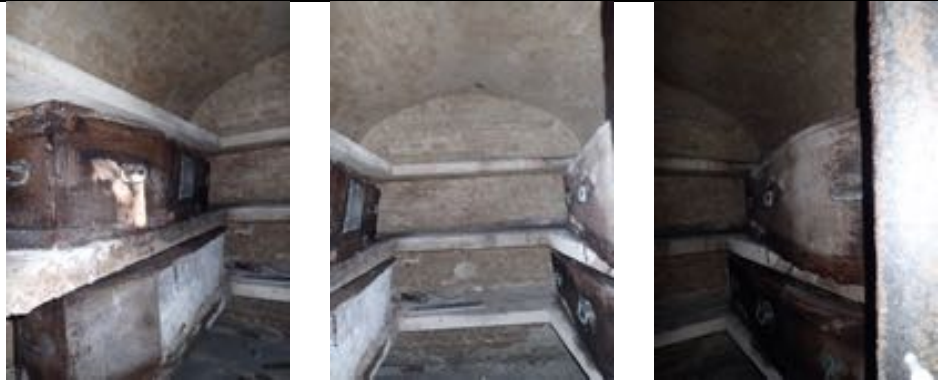
WALLS	
	No structural defects. Collar joint issues at door frame.

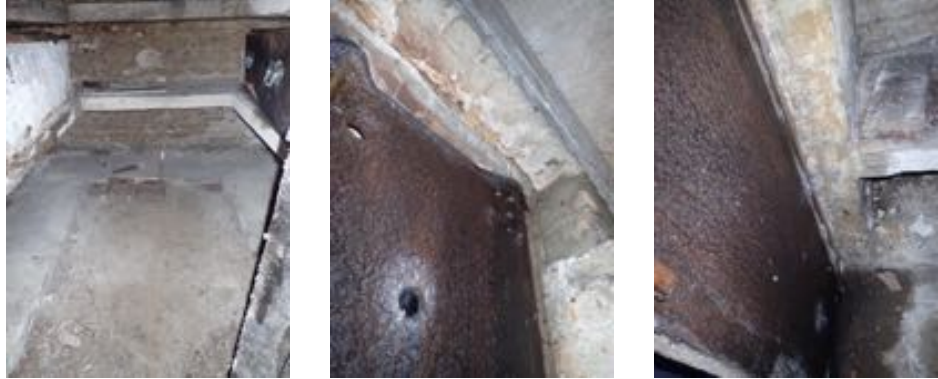
FLOOR	
	Stone slabs. Sound enough.	
	DOOR	
	Some light corrosion. Light overhaul needed.

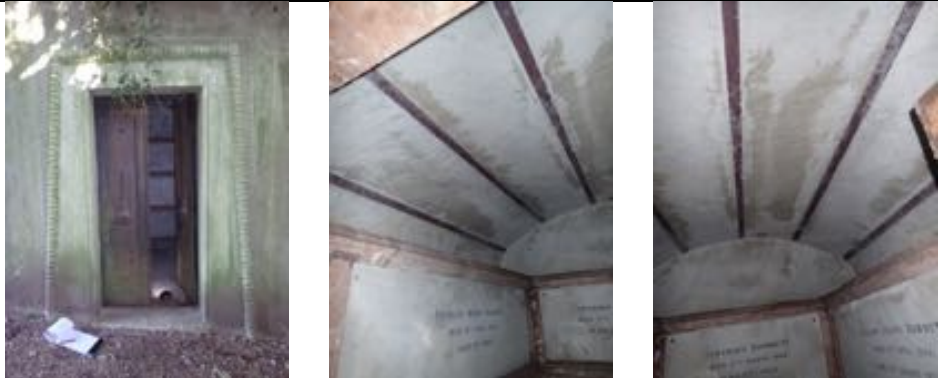
6.3.6	EA12 DUMMETT VAULT

GENERAL	
	Generally as EA1 but with elaborate finishes in red and white marble. 3 shelves all around with 4 coffins sealed with marble inscription slabs.	
	CEILING	
	Faceted lining of 6 white marble slabs separated by iron T-bars. Marble is sound, although lightly stained by moisture ingress from above. Bars have light corrosion, and the potential for these to cause structural issues with the marble lining should be carefully considered in conserving them.

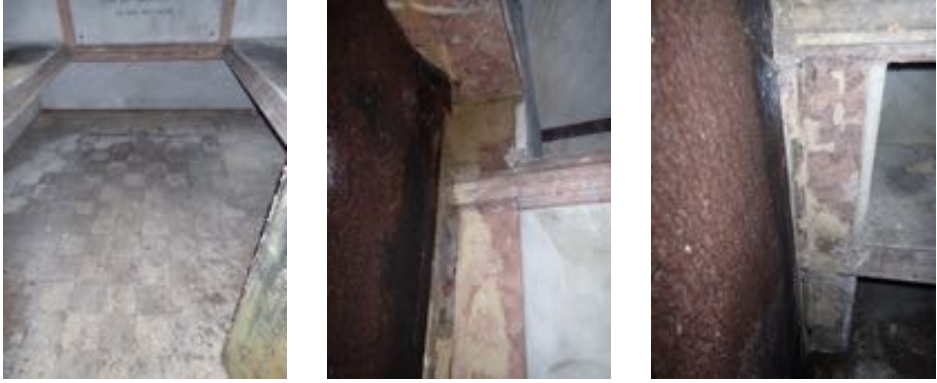
<b>WALLS</b>	
	<p>Similarly lined in large marble slabs. Shelves in stone with red marble mouldings on front edges. Mouldings are detaching in places, and shelves have delamination to the underside. Red marble lining to door opening is cracked and broken. Repairs required.</p>

<b>FLOOR</b>	
	150mm black and white tiles. Dirty but sound.	
	<b>DOOR</b>	
	Bolt to free leaf missing. Some corrosion. Medium overhaul needed.	
<b>6.3.7</b>	<b>EA15 BEADNELL VAULT</b>

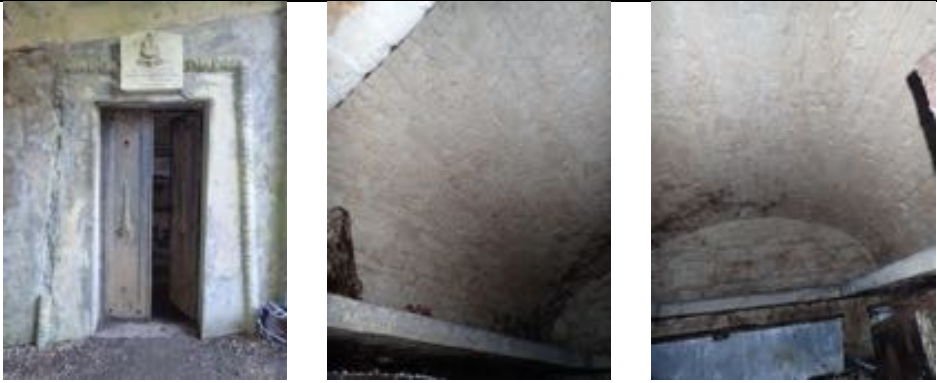
<b>GENERAL</b>	
	Generally as EA1. Plinth and 3 shelves all around. 5 adult and 3 child coffins.	
	<b>CEILING</b>	
	No defects. A lot of fibrous roots.

WALLS	
	No visible defects, view limited by the coffins. Many roots. Missing collar joint on both sides of the door arch.

FLOOR	
	Stone slabs, some uneven. Open joints. Very wet at the door.	
	DOOR	
	Very stiff. Bolt to free leaf is detaching and frame corroding. Medium overhaul required.

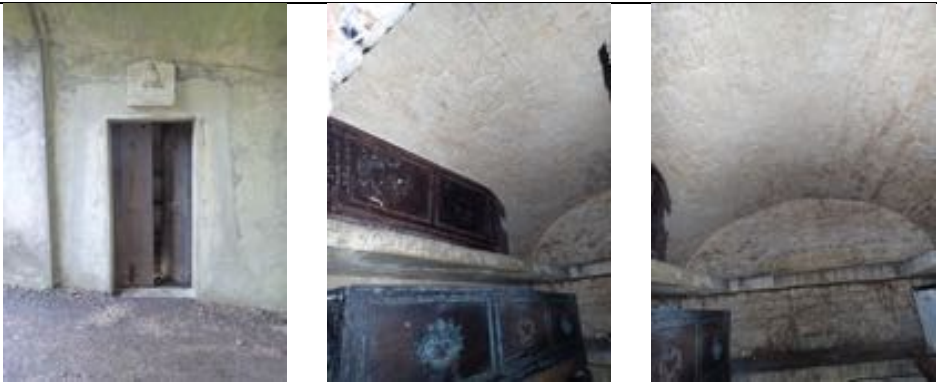
6.3.8	EA16 VIGERS VAULT

GENERAL	
	Generally as EA1. Plinth and 3 shelves all around. 6 coffins.	
	CEILING	
	No defects, sound.

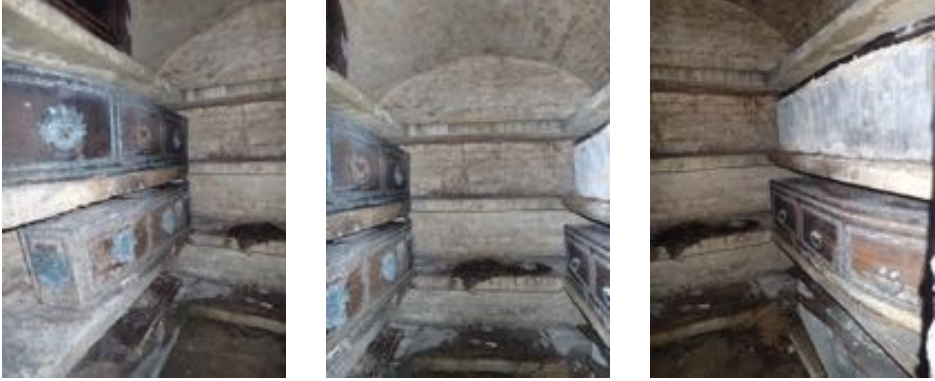
<p><b>WALLS</b></p>	
	<p>No defects, some fibrous roots.</p>

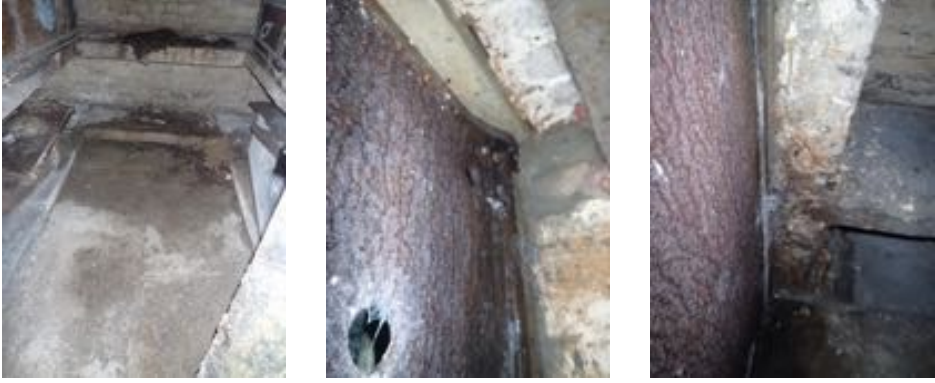
<p><b>FLOOR</b></p>	
	<p>Stone slabs. Open joints but not uneven. Wet at the door and back half of the vault.</p>	
	<p><b>DOOR</b></p>	
	<p>Light corrosion. Light overhaul required.</p>	
<p><b>6.4</b></p>	<p><b>SUMMARY AND COMMENTARY</b></p>	
	<p>The structures should be reviewed when vegetation has been comprehensively cleared prior to a programme of works, and following a general programme here and elsewhere of reopening non-functional doors allowing full access to all of the spaces.</p> <p>From the present limited inspections and access possible it is reasonable to assess that the general structural condition of the Egyptian Avenue and the vaults opening from it is reasonably good and will require only localised and minor repair.</p> <p>The philosophy and implementation of repairs in 1990 has stood the test of time well, and the ongoing care of the building should involve continued similarly specified cyclical repairs to the render and decorations of the exterior, paying particular attention (in the context of the Capital Project) to drainage, the weathering and protection of wall heads and ledges and the conservation and protection of doors and frames with other external ironwork.</p> <p>In common with the Circle of Lebanon there will be a need for a unified approach to the vault doors and gates, irrespective of their varying</p>

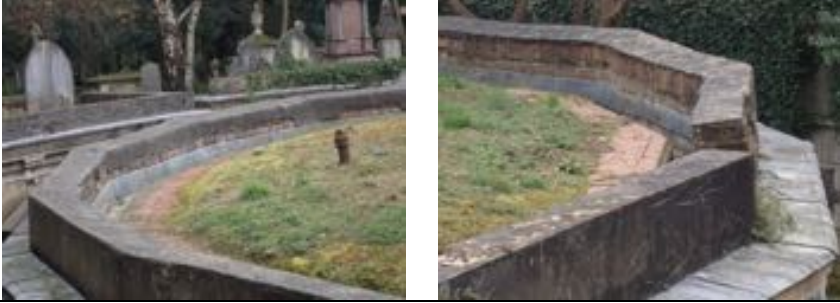
7.1.1.1	<p><b>ROOF AND PARAPETS</b></p> <p>This was inspected only from the roof level of the outer circle, so detailed inspection was limited. The lead-lined drainage channel appears to be clear and spound, and this should be verified by close inspection next time it is swept clean. The brick wall forming the inner kerb of the channel appears to be sound from this slightly remote inspection.</p> <p>The render to the parapet has failed in many places, and the cement render is detaching. As this forms an essential part of the waterproofing of the structure this should be fully repaired to a carefully considered specification, not conserved 'as found'.</p>

<p>The cornice below the parapet, with rendered finish and ribbed decoration, is generally sound, although conserved as found and in places the brick substrate is visible. The lead capping is intact and needs some careful re-dressing where the edge has been disrupted. There is extensive vegetation growing in the joint at the abutment of the lead, and this needs to be killed, removed and the cracking made good.</p> <p>Picturesque it may be, but this vegetation is unwelcome in the context of the building fabric.</p> <p>There is one cast iron vent pipe protruding from the grass roof (serving IC14?). The top is broken and unsightly, but could easily be cut neatly above grass level without other disruption.</p>

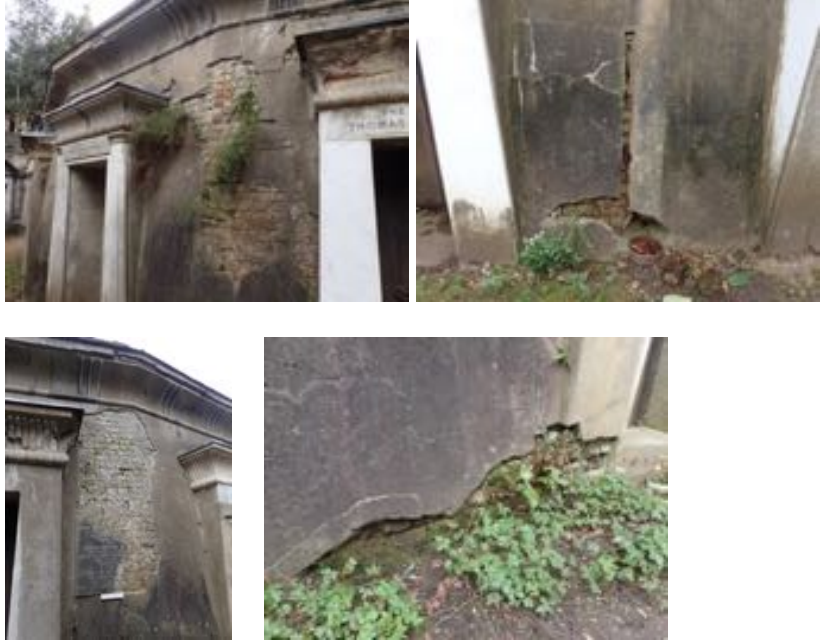
Such render defects as there are are concentrated at the base of the walls, and there are some sections where render is now detaching. These will need repair if the surface is not to be lost.

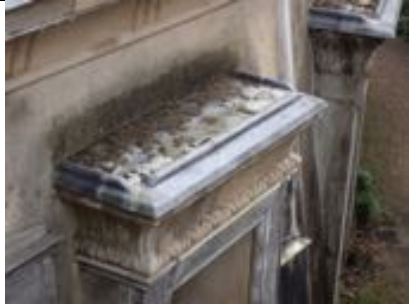
The doorcases are generally in good order other than the abutment of the steel door frames (see below) and they have neat and sound lead capping which will discharge the rainwater effectively if they are cleared of vegetation debris.

As in the Egyptian Avenue the iron doors in their newer steel frames present the most concerns, and here it is compounded by their having a steel cill embedded in the stone paving. The steelwork is heavily corroded in places, particularly the top and bottom corners. It is likely that they will have to be removed for further conservaiton, and the condition of the steel itself will only be revealed when the corrosion has been removed. Some replacement should be planned for.

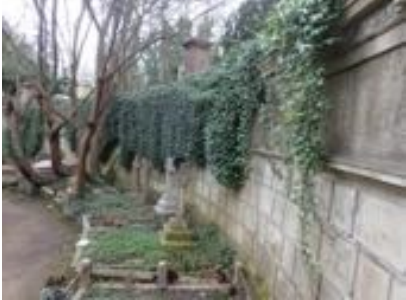
7.2.1.1	<p><b>RETAINING WALL (1)</b></p> <p>A heavily rusticated retaining wall approx. 4m high has an elaborate cornice with vestigial triglyphs at the top. The rustication stops at a secondary cornice rather more than halfway up. The wall is constructed in brick, with finishes including all of the decorations formed in render.</p>

<p>With the exception of a few rustication panels where the render has broken away (exposing the brick) the lower part of the wall is in remarkably good condition, free from structural cracks and defects. This includes the secondary cornice.</p> <p>The upper part of the wall in smooth render has hairline cracks, largely horizontal, which have been repaired in the past and have not moved since. Some of this part of the wall is concealed by trailing ivy, but all the visible parts are consistently sound except for the extreme corners, where diagonal cracks have similarly been repaired and remain fairly stable.</p> <p>The top cornice is sound where it can be seen, and there is a neat lead capping (added in 1990 we suppose). There are a few blemishes where the brickwork is visible and some fine cracks notably at the end returns.</p>

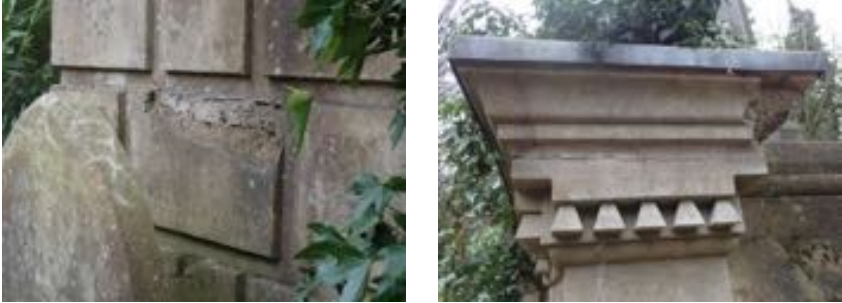
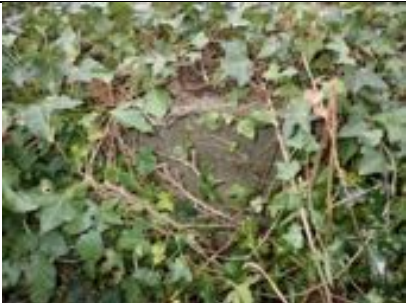
<p>The wall head forms a low parapet to the upper level, unprotected other than by the row of graves between it and the path. The wall head is completely obscured by ivy but a random check revealed cracking and defects to the render which should be addressed by thorough cyclical repairs to ensure that water ingress is minimised.</p>

<p>Subject to review when the ivy has been cleared the other repairs needed at the moment to this wall are localised and very minor.</p>	
<p>7.2.1.2</p>	<p><b>STEPS 1</b>  Stone steps with rendered brick kerb each side.  There are some open joints in the steps, but only the top step has any significant displacement, and that could be easily rectified. Some previous indent repairs are sound and two steps have broken edges that might warrant repair in the future.  The kerbs have long-standing cracks in the render, some repaired, but none that indicate any fundamental underlying defect.</p> <p>There are no handrails, and this might be considered in a review of access considerations.</p>

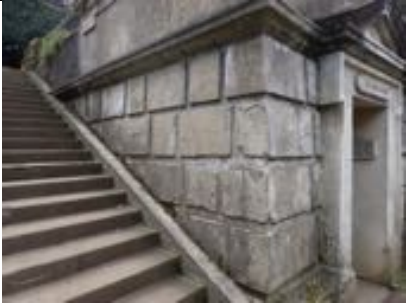
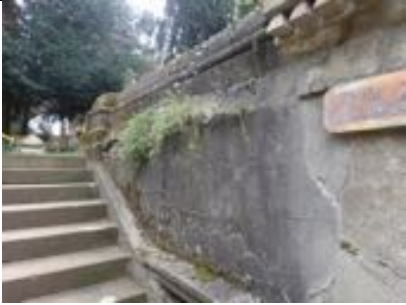
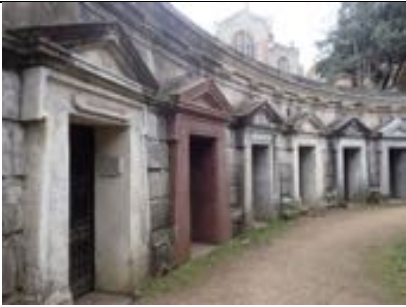
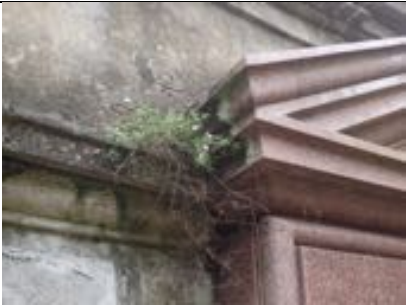
<p>7.2.1.3</p>	<p><b>VAULT FACADES OC1-OC7</b>  The vault facades added in 1870 continue the rusticated treatment and details of the retaining wall, with neo-Egyptian doorway matching those to the Inner Circle, mainly in render but with some renewed in granite. The end return wall to the steps (1) has lost much of its render finish coat, but the backing coats are sound and the degraded effect in keeping with the overall aesthetic. Crazeing to the smooth render at the top of the steps is progressive and more problematic, and this will need repair within 5 years.</p>

<p>The vault facades are less damaged than those to the Inner Circle, and as there the previous conservation works have served well. Vegetation taking a secure hold should be removed and holes stopped up. Minor render defects can be addressed by ongoing cyclical repairs.</p>

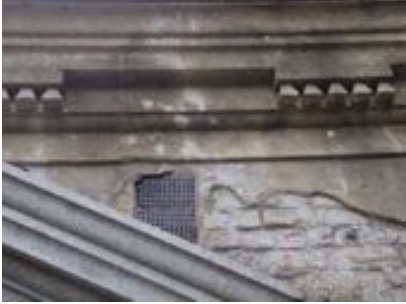
<p>The iron doors with steel frames have the same issues as noted for the Inner Circle, but without water ingress from above they are much less corroded and need only light repairs.</p>

<p>The vaults are ventilated by cast iron vents at high level. The originals are decorative and are sound enough. Where broken they could be replicated. Later additions are less attractive and less sound, and these are worthy of better resolution in the course of repair.</p>

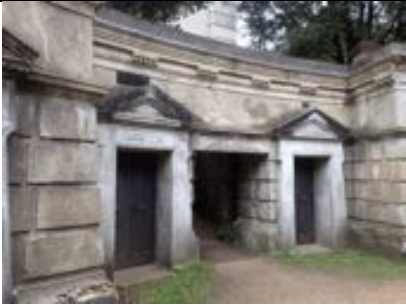
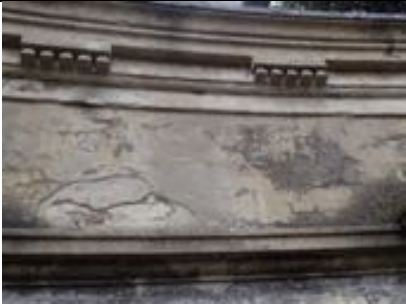
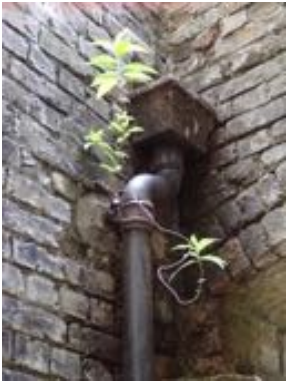
<p>7.2.1.4</p>	<p><b>VAULT EXTERIORS OC8-9, WITH BEER MAUSOLEUM ENTRANCE</b>  Generally these are as OC1-OC7 above.  Extensive cracking to the upper part of the façade render has not failed since previous repairs</p> <p>The brick retaining walls to the Beer mausoleum forecourt are free of structural defects, but the pointing has eroded... not to a degree that threatens stability but it will eventually get to that. Some minor vegetation for removal.</p> <p>The cast iron rain water pipes show every sign of discharging down the wall as a result of being blocked, regularly if not at this moment. They need overhaul and painting.</p>

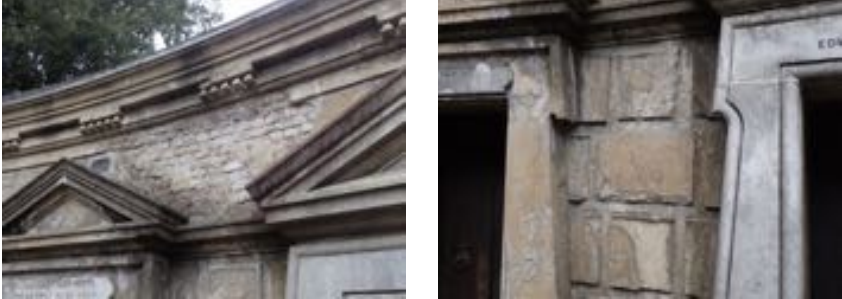
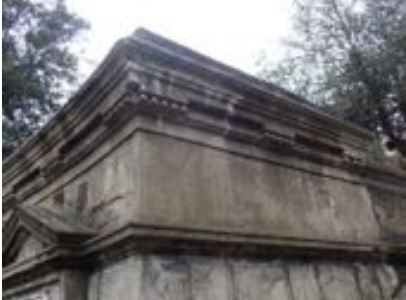
7.2.1.5	<p>VAULT FACADES OC10-OC16</p> <p>Generally as OC1-7, but there are more stone door cases, and the rendering is generally more degraded. However, as elsewhere the previous conservation works remain generally sound and the progressive defects are minor</p>

<p>Diagonal cracking in the upper corner to steps (2) clearly allows water through it as there are heavy calcium deposits, but it does not appear to be progressive.</p> <p>Repairs will be needed, but should be relatively minor.</p>

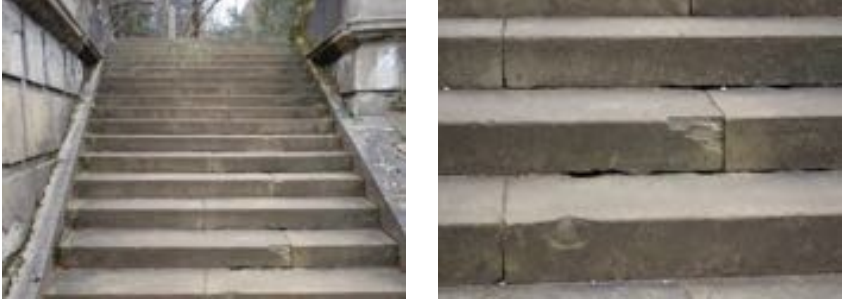
7.1.2.6	<p>STEPS (2)</p> <p>Stone steps with rendered brick kerbs each side.</p> <p>There is no displacement or distortion, but there are extensive holes between the stone units, both in the treads and risers. Some (at the back of the treads) are open to a considerable void so simple repointing will not be viable. Nothing makes these steps structurally defective or compromises their use.</p> <p>There are no handrails, and this might be considered in a review of access considerations.</p>

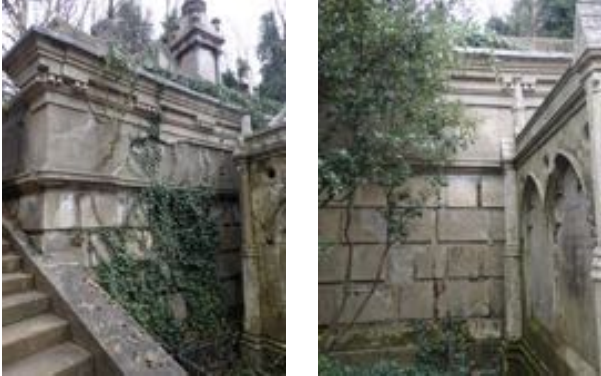
7.1.2.7	<p><b>RETAINING WALL (2)</b>  The rendered brick retaining wall between Steps 2 and the Egyptian Avenue is detailed exactly as retaining wall (1) above, see 7.2.1.1.</p>

<p>Structurally it has not fared as well as Retaining Wall (1), historically there has been some major displacement of the wall head, up to 50mm, including the cornice. The render has also degraded more than for Retaining Wall (1).</p> <p>Notwithstanding, the repairs that addressed these defects in c 1990 appear to be performing well and the render remains for the most part in need of nothing more than cyclical repairs to maintain the status quo.</p>

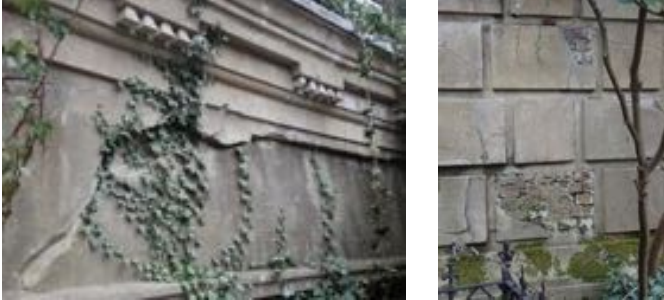
<p>The cornice has the same neat and sound lead weathering detail as the rest.</p> <p>The parapet render is in need of more urgent and invasive repair, in common with the rest of the Outer Circle</p>

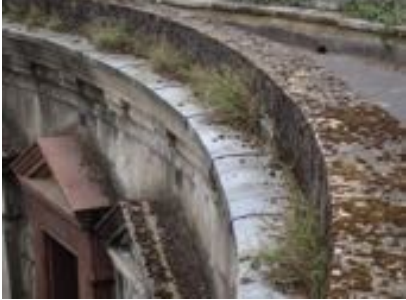
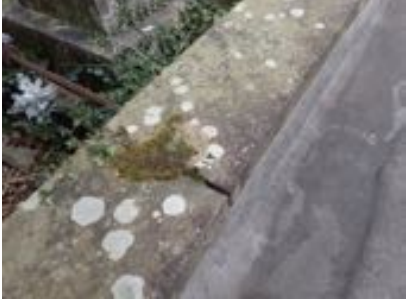
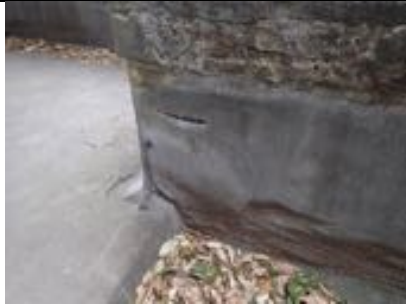
<p>The roof of solid masonry has a mastic asphalt surface integral with abutment upstands all round. The roof drains to the rear, where there are outlets to the adjacent ground in several places, and to rain water pipes in the Beer Mausoleum entrance at the centre. The rear edge has a low kerb without a flashing and stone copings, the front edge a higher rendered parapet with a lead flashing.</p> <p>The render to the front parapet is in poor condition, with extensive cracking and defects that require attention. There is a lot of light vegetation in the external face, above the cornice. As noted elsewhere these parapets are not considered candidates for conservation 'as found' and care must be taken to specify the repairs and exclude water ingress.</p> <p>The rear parapet has minor defects with open joints between coping stones.</p> <p>The asphalt upstands have localised failure of adhesion to the vertical substrate, and have consequentially slumped, with cracks as a result.</p>

The roofing defects should be addressed by repair rather than complete renewal, but there will be a need for some review of details and specification.

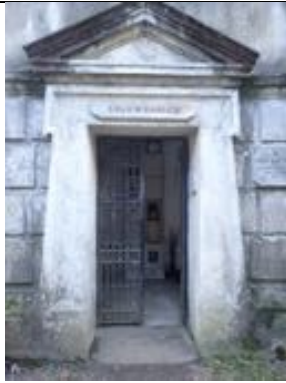
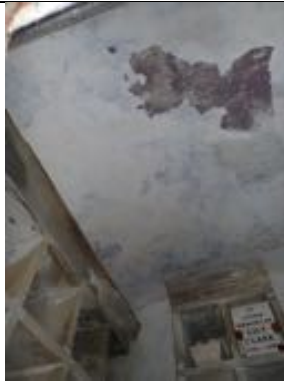
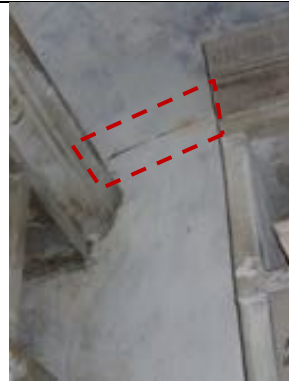
**7.2.2.1 OC1 COLUMBARIUM**

Plastered vault and walls with 'pigeon holes' on 3 sides. Open iron gates.

Render damp but sound to visual inspection. Hairline crack at wall junction on left hand side of the back wall.

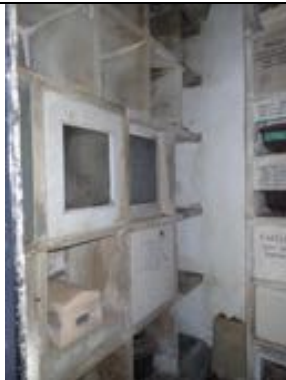
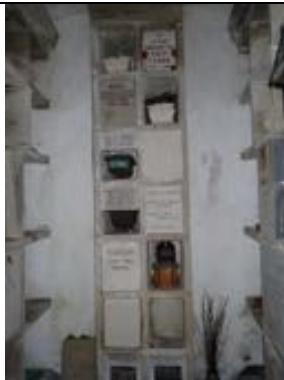
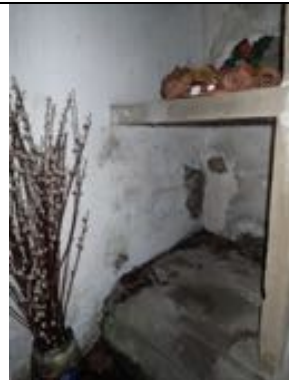
<b>WALLS</b>	
	Visible parts all rendered and affected by damp, but render has blown only to the back wall at low level. Stone shelves generally sound. Some infilled with inscription slabs.

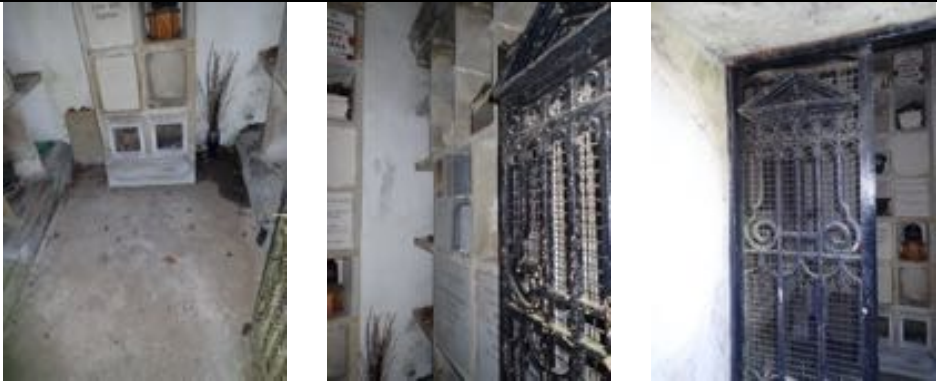
<b>FLOOR</b>	
	Cement screed, a bit rough but not unsound. Wet at the back on right hand side.	
	<b>GATES</b>	
	Light corrosion and failing decorations. Medium overhaul needed.

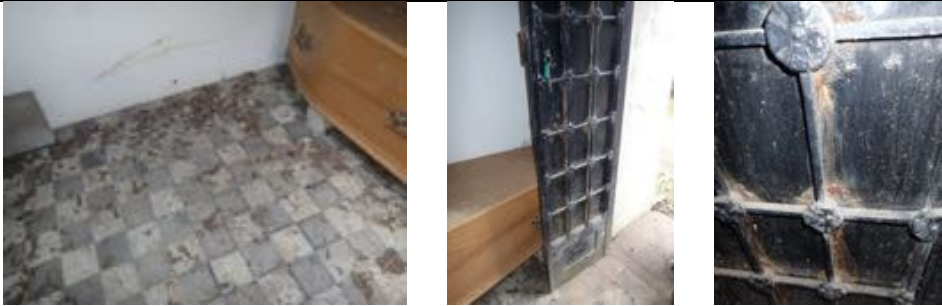
7.2.2.2	<b>OC4: BATTEN/RADCLYFFE HALL VAULT</b>

<b>WALLS</b>	
	<p>Plastered. No cracks. Damp in places, especially around shelf junctions and over the door.</p> <p>Whitewashed stone shelves (some could be concrete) have minor defects and some have lost edge faces. To be defrassed and made good.</p> <p>Marble shelf with white brackets in good order.</p>

<b>FLOOR</b>	
	Black and white marble tiles, in good order.	
	<b>GATES</b>	
	<p>Open iron lattice with steel plate infill. Light corrosion to framing, worse to infill plates. Medium overhaul needed.</p> <p>Cast iron frame of the gates is corroded at head but appears to be only superficial.</p>

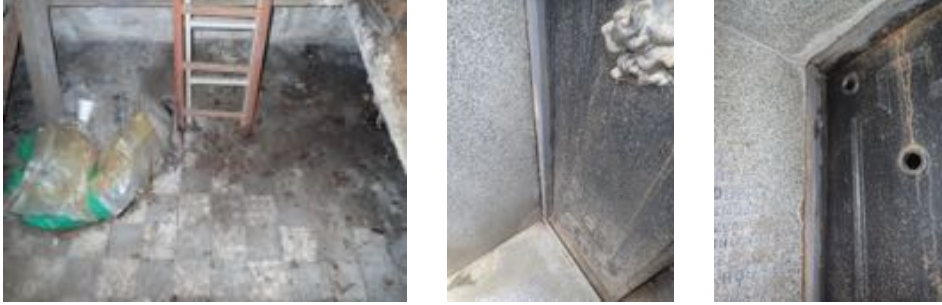
7.2.2.3	<b>OC6: ROBERTS VAULT</b>

<b>WALLS</b>	
	Rendered. Generally in good condition but very uneven/repared above the shelf on left hand side. Crack to upper part of both front corners and diagonal crack down from the front right hand corner at the top. Small horizontal crack halfway up left hand wall. Extensive making good around the door frame required.

<b>FLOOR</b>	
	Black and white marble tiles, in good order. Damp at back corners.	
	<b>DOOR</b>	
	All in good order but open collar joint outside.

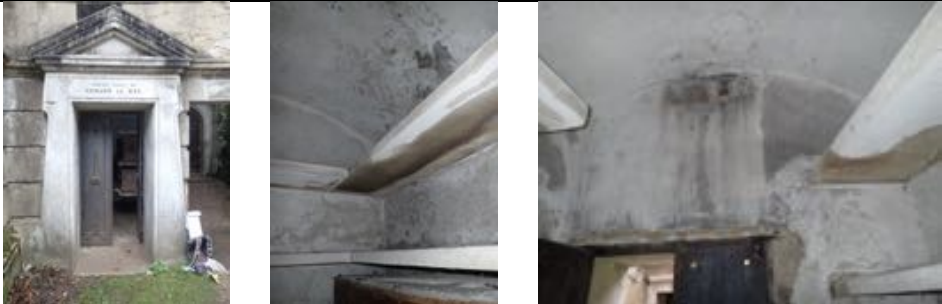
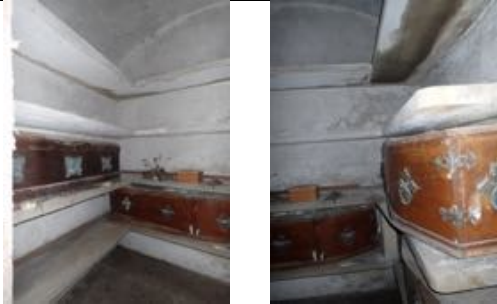
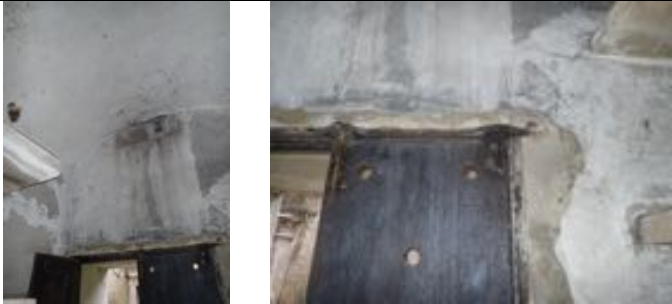
7.2.2.4	<b>OC8: LE BAS VAULT</b>

<b>GENERAL</b>	
	Irregular Plan. Segmental vault. All rendered. 4 shelves to 3 sides. 4 adult coffins.	
	<b>CEILING</b>	
	Rendered vault. Spot water ingress affecting appearance but no render detachment.

<b>WALLS</b>	
	All rendered. Some micro cracking to right hand wall. Old making good around the door.

<b>FLOOR</b>	
	Black and white marble tiles with elaborate pattern. Dirty but sound.	
	<b>DOOR</b>	
	All sound except the frame (securely fixed) is not in alignment with external lining to the opening.

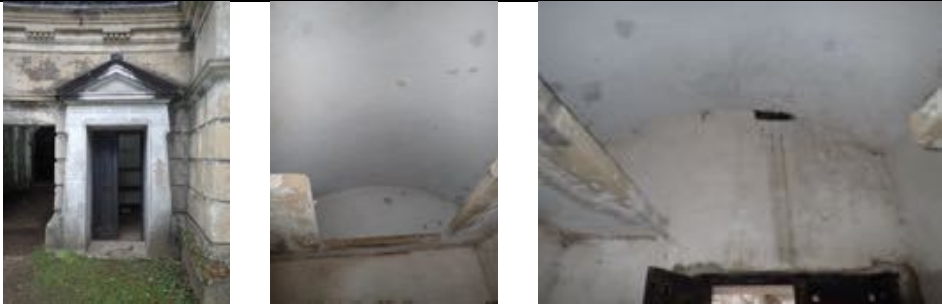
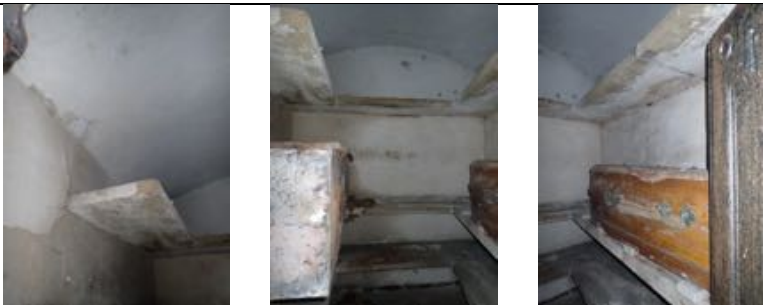
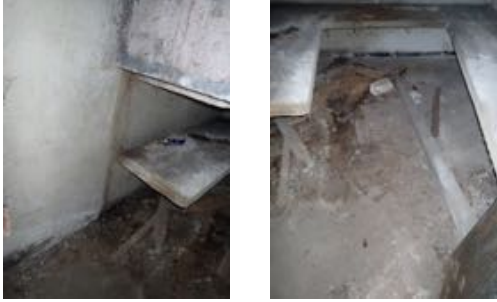
7.2.2.5	<b>OC9: HUGHES VAULT</b>

<b>GENERAL</b>	
	Irregular Plan. Segmental vault. All rendered. 3 shelves to 3 sides. 2 coffins, 1 of them bigger and overhanging the shelf it rests on.	
	<b>CEILING</b>	
	Rendered vault. No structural defects. Isolated damp spotting.

<b>WALLS</b>	
	All rendered. Some old repairs and irregularities but broadly sound. Old making good around the door. Some delamination on stone shelves but nothing major.

<b>FLOOR</b>	
	Large format (250mm) diagonal black and white marble tiles. Dirty but sound.	
	<b>DOOR</b>	
	In good condition.
