# HIGHGATE CEMETERY

## INSPECTION AND REPORT ON THE CONDITION OF BUILDINGS AND STRUCTURES

### VOLUME 2 PARTS 5 to 12: THE FUNERARY BUILDINGS

JANUARY- MARCH 2022  
REVISION A: DECEMBER 2022

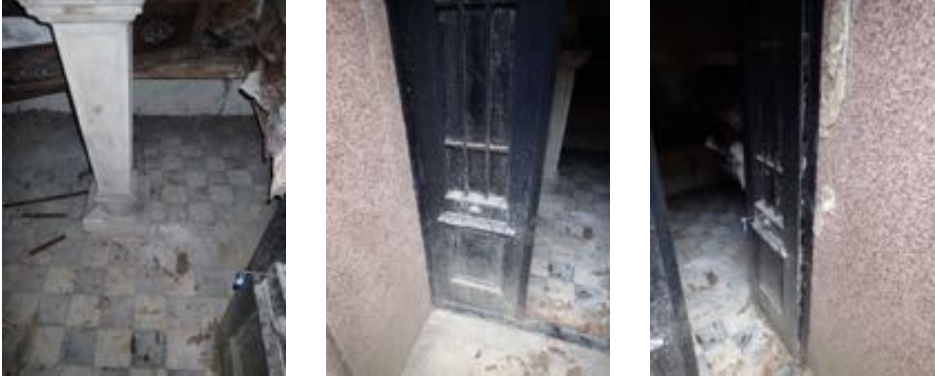
7.2.2.6	OC10: PAZZI VAULT

<b>WALLS</b>	
	Only parts visible. Render is quite sound but there are a lot of fibrous roots. Substantial vertical crack in left hand wall from the top front corner

<p>down (5mm wide, decreasing towards bottom). Structural Engineer's advice needed. Stone shelves, nothing to comments.</p>

<p><b>FLOOR</b></p>	
	<p>150mm black and white tiles. Pillar and bust stained but in good condition.</p>	
	<p><b>GATES</b></p>	
	<p>Cast iron gates with open lattice, plated behind. In good condition, requiring light overhaul.</p>	
<p><b>7.3</b></p>	<p><b>SUMMARY AND COMMENTARY</b></p>	
	<p>The external fabric of the Circle of Lebanon is in need of cyclical repairs to maintain the status quo, with concentration on the parts that are critical to the management of rain water... roofs, parapets, cornices etc. The removal of picturesque vegetation will be less extensive here than in the Egyptian Avenue, but it will nonetheless be essential to full review when the documents are prepared for the repair works.</p> <p>In common with the Egyptian Avenue there will be a need for a unified approach to the vault doors and gates, irrespective of their varying condition. To some the works will be significant, to others relatively superficial. The finish/colour will have to be carefully considered.</p> <p>The internal fabric to the Inner Circle will need further assessment, including by structural engineer, following a programme of works to enable entry to more, if not all, of the vaults. The one vault inspected presents some structural concerns which can only be properly assessed in a wider context.</p> <p>The larger sample of 6/16 vaults in the Outer Circle allows <i>some</i> general conclusions to be drawn, but full access and a review will be needed before works are specified. Structural defects noted in the Outer Circle vaults appear to be minor, and of a varied nature with no generic defects emerging as a pattern. They will need to be addressed by localised repairs individually specified with structural engineer's advice.</p> <p>If accessibility matters are to be addressed by the Capital Project there will be decisions to be made regarding steps, handrails and edge protection.</p>

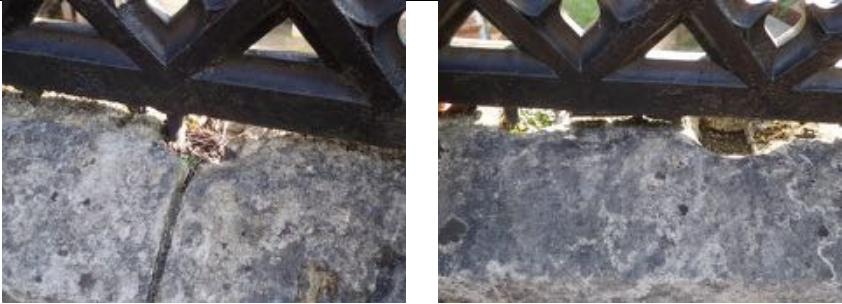
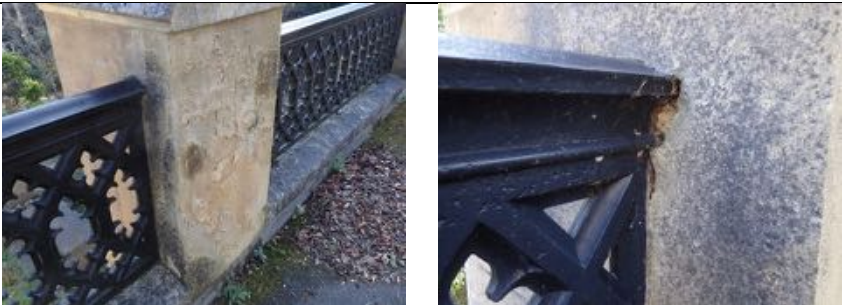
<p>Piers are rendered and have stone caps, gabled and flat. There is some render erosion but nothing requiring major or particularly urgent intervention. Such defects as there are are either superficial or very localised to the points where there are embedded iron fixings for the balustrade. The stone caps are sound, with small and localised breakages that do not really affect either appearance or performance.</p>

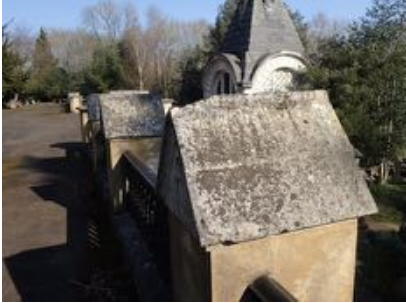
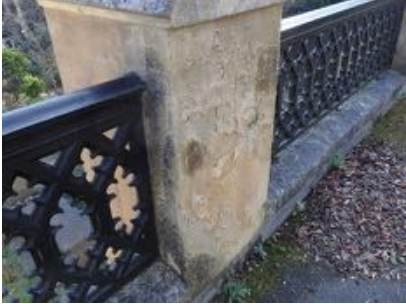
<p>The iron balustrade panels are in good order. Light corrosion at the ends has affected adjacent render but not the integrity of the ironwork. It should be better protected against corrosion before repairs to the render.</p>

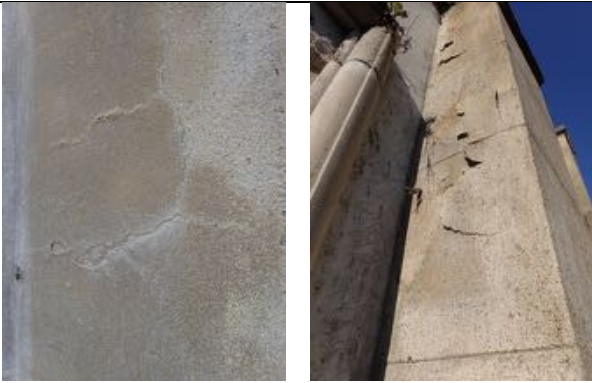
<p>Defects to the surrounds of openings are largely due to corroding ironwork, and they DO need attention. Render door surrounds are cracked, and the stone doorcases have broken stones, notably to WV1 and WV2 where corroding iron door frames have triggered the worst cases. Repairs including rust treatment and isolation are needed. Similarly the steps to vaults WV1, WV2, EV1, EV2 all have open joints which need to be repaired to prevent escalating defects.</p>

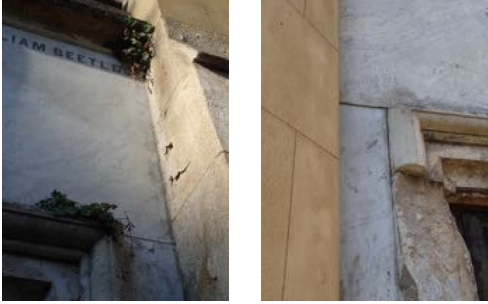
<p>8.1.2.2</p>	<p>WEST WING (W4-W14)</p>	
	<p>Render is generally sound, with some small cracks and delamination to the arched opening at W8. Even where there are hairline cracks there appears to be no debonding of the render, and there are no cracks indicating structural movement. A big woody bush growing in one of the vents should be killed and removed. Bird proofing mesh has been crudely fitted and is coming away, so that it now just traps debris.</p> <p>The decorative state of the ironwork is poor, but there is little actual corrosion.</p>

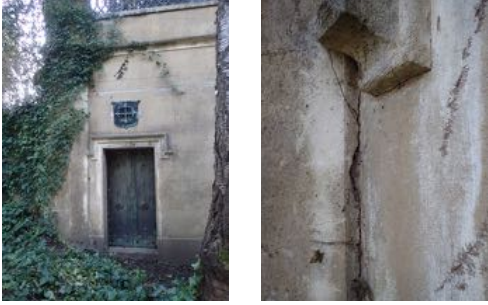
<p>The pier and the retaining wall to the slope beyond are heavily infested with ivy which needs to be cleared for proper inspection and repairs. There are render defects visible through the leaves, but managed decay may be appropriate here if no major defects are revealed.</p> <p>The two iron vault doors are corroded and in need of overhaul, rust treatment and decoration.</p>

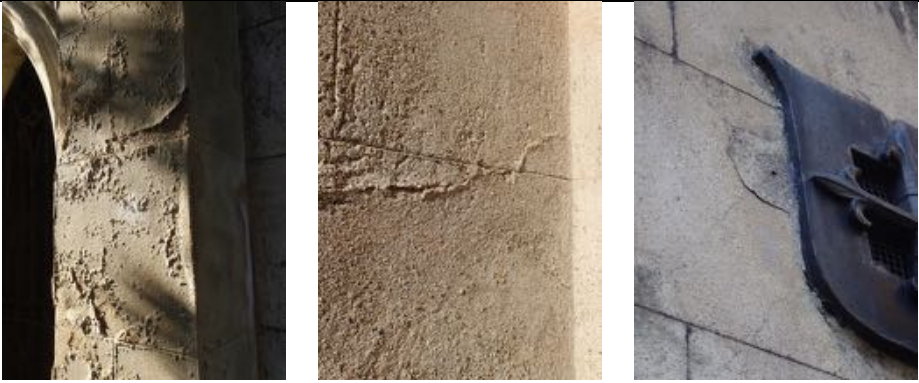
8.1.2.4	<p><b>EAST WING (E4-E14)</b>  Most of the comments on the west wing apply equally here, but the render condition is more variable, with more cracks and surface loss. Even so the backing coats remain secure, and a policy of managed care could be appropriate rather than renewal.</p> <p>There are a few defects relating to corroding iron fixings to the vent plates, and these do need repair.</p>

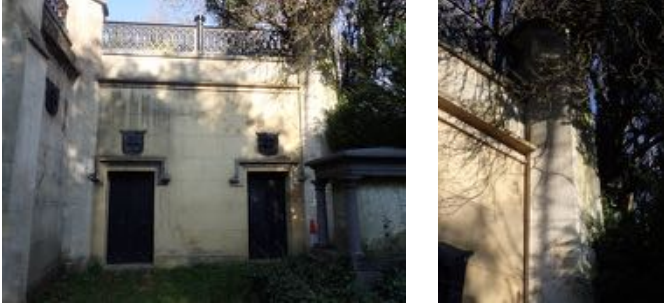
<p>The extended retaining wall to the slope beyond is badly affected by damp where it is below the upper ground level. Here the render has delaminated and detached. This is doing no structural harm in itself but doesn't look very good, and as above may be a candidate for actively managed decay.</p>

There is a big crack half wall along the retaining section that should be referred to the engineer and monitored.

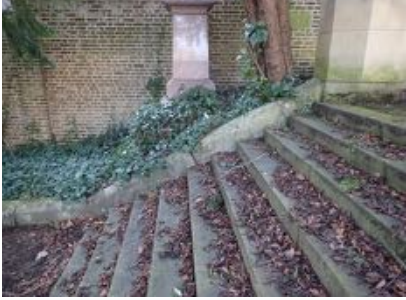
8.1.4	<p><b>WEST STEPS</b>  Upper flight of York Stone steps has stone kerb on outer side and a high rendered brick parapet wall on inside.  Parapet is all as noted for the terrace above, and there is a small holly bush rooting in one crevice. The kerb is partly displaced and has big open joints  The steps themselves are dirty but sound, with some smaller open joints.</p>

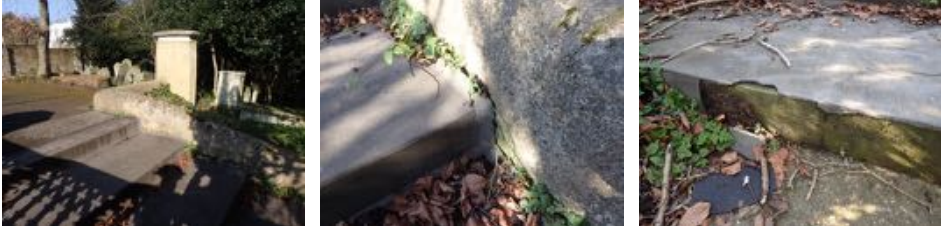
8.1.5	<p><b>EAST STEPS</b>  The upper flight of the east steps was also rebuilt in York Stone, but subsequently coated over with asphalt to waterproof them. This has pulled away at the abutment each side, and to the lower steps it has failed in the middle of the steps as well.  If the steps need to be waterproofed the membrane should be introduced lower, below the stonework, and it should be integrated with the parapet/kerb details. The lower part is of wide steps in concrete, much degraded.</p>

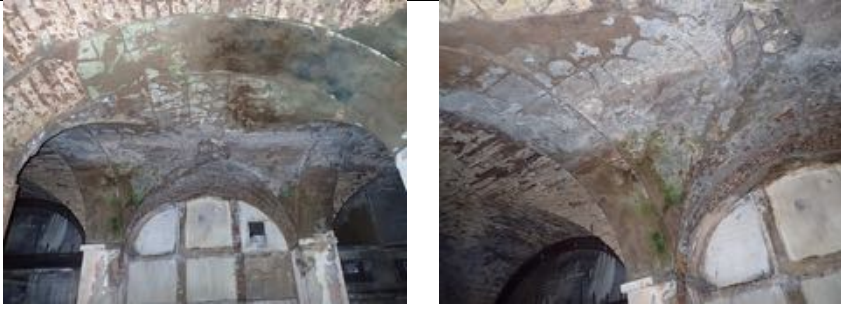
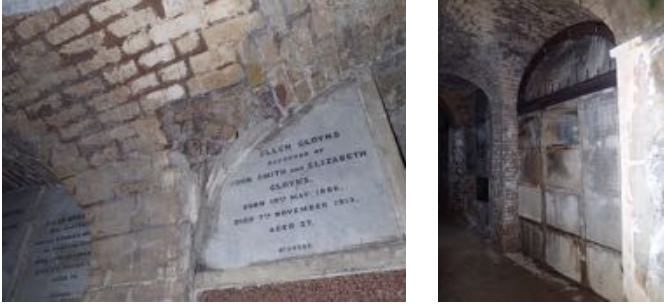
<p>8.2.1</p>	<p><b>CENTRAL SECTION BAYS W3 TO E3</b></p> <p>No cracks or structural defects in the vaults or walls. The render finish to the central bay is much degraded but the approx. 50% remaining appears to be well adhered. One damaged vault-spring in E2 needs to be referred to the engineer for a repair specification.</p> <p>The back half of the structure is understandably much wetter than the front part, but this does not appear to have affected structural integrity.</p> <p>Not much can be seen of the external and retaining walls behind the burial compartments, but nothing visible indicates a problem</p>

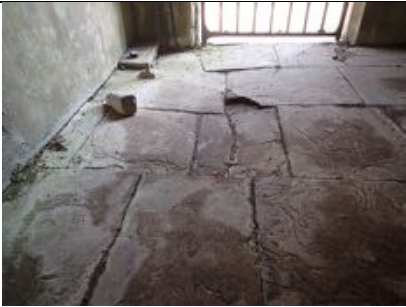
<p>The majority of burial spaces here have closing slabs and these are largely secure, or if displaced show no sign of collapsing or falling. An iron frame at the top of the back section of bay W1 has corroded and has allowed the inscription slab to displace.</p> <p>The floor slabs are old and worn but not defective in the context of the place, other than a few slabs near the door which have subsided and should be relevelled.</p>

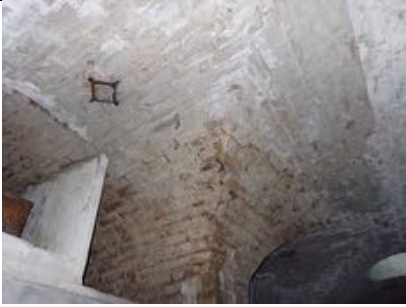
<p>8.2.2</p>	<p><b>EAST SECTION BAYS E4 TO E14</b></p> <p>Generally the construction is as the central part. Only bay E8 is plastered and paved. Similarly condition is consistent with the central section. There is a damaged vault-spring at E6 and a lesser version of the same at E9. In E7 water migration has led to voiding of the brickwork joints in the vault.</p> <p>A crack along the lines of joints in the vault to E11 should be referred to the engineer. In summary the vault brickwork will need some repairs, but it will be localised and relatively minor.</p>

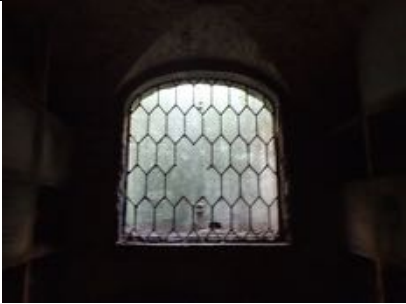
<p>The decorative cast iron grille to the east end vent shaft is broken in the middle, but in functional terms it is now protected by the bars above.</p>

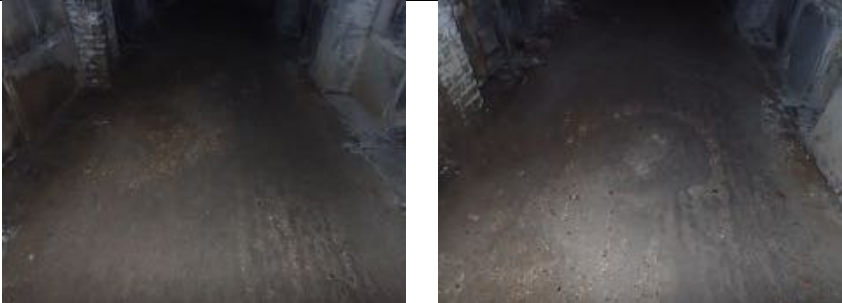
<p>There are places where the floor has eroded in patterns that appear to reflect water dripping from the vault above. This illustrates vividly the need to address the roof and mitigate water penetration.</p>

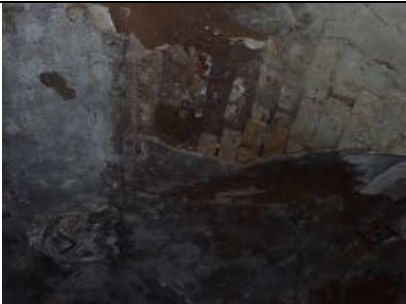
<p>8.2.3</p>	<p><b>WEST SECTION BAYS W4 TO W14</b>  All as the east section, but the plaster in bay W8 is showing signs of detaching. This needs to be either consolidated or removed under controlled conditions.</p>

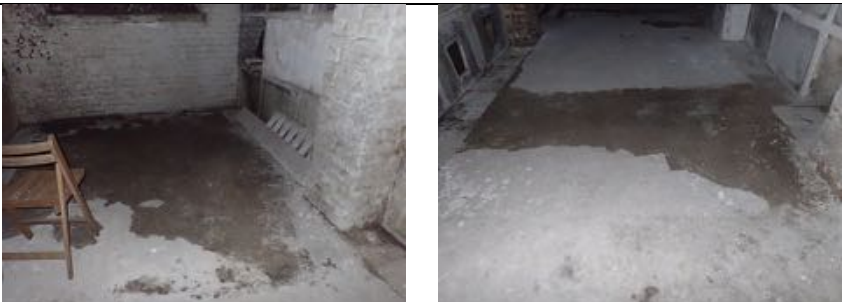
<p>The floor to the west section is much wetter in places than elsewhere. This probably correlates with the drainage form above... or lack of it.</p>

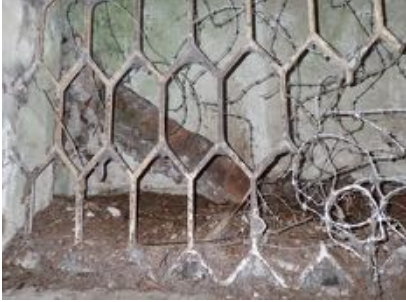
<p>The grille to the vent shaft at the western end is also broken, and here enmeshed in barbed wire, which could be removed. The shaft is full of very substantial debris, and this should be removed. It has no picturesque qualities.</p> <p>An iron grille in W8 has corroded in the most spectacular manner and should not on any account be disturbed.</p>

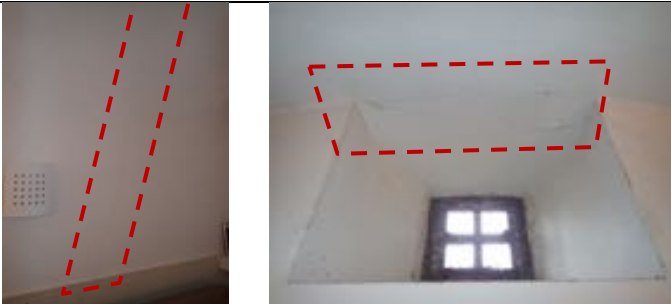
<p>All seem to be generally sound and unusually dry. It's assumed that there is a waterproofing system in place with the plaster lining. However, some areas ring hollow and there is a small vertical crack on the right hand wall (near the front) and hairline cracking in the opening above the door. Structural Engineer's advice needed.</p> <p>Some rust staining on angle beads at the door betrays damp issues within. All other finishes are neat and sound. Lighting/wiring not tested but working.</p>

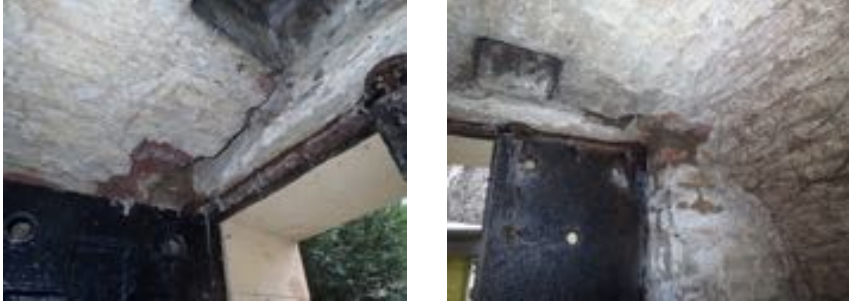
GENERAL	
	<p>In contrast to Simpson Vault 1, this vault is entirely 'unmodernised'. Brick tunnel vault and walls with a projecting course at the spring of the vault. Stone plinth and 1 shelf on 2 sides. The back wall is in modern concrete blocks (C20) and anecdotally the burials have been sealed behind it. There are no coffins in the vault.</p>	
	CEILING	
	<p>The brick vault is very damp and pointing very degraded. As a result, it is hard to identify any defects, but there are no obvious cracks or deformations. There are a lot of roots penetrating the brickwork, curtains of fine root structures all over the vault and some solid roots up to 12mm in diameter. There are a few locations where fixings into the vault have left holes/scars. At the abutment to the front wall (over the door), there is</p>

a displacement crack approx. 20mm wide, where the wall has moved outwards. Bricks have fallen from this area and it needs repair.

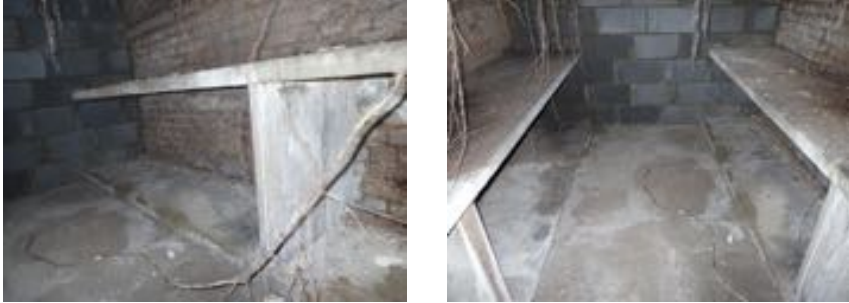
<b>WALLS</b>	
	In a similar condition to ceiling, very damp but less roots. The blockwork back wall is in good order. Shelves are dirty and damp but sound.

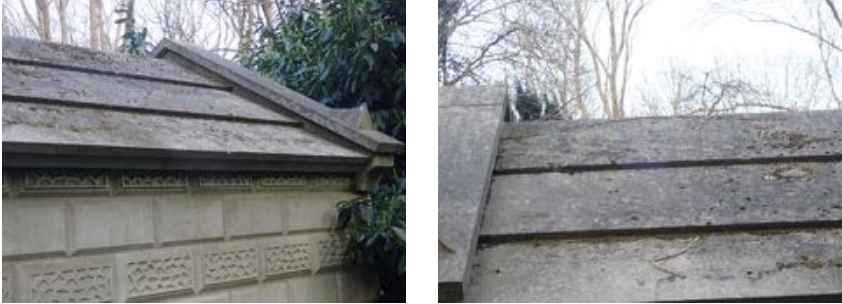
9a.1	EXTERNAL	
9a.1.1	ROOF	
	<p>The roof is constructed in 3 tiers of stone slabs each side, and is generally in good order where seen on the RH side (facing the entrance). The left hand side could not be seen from any vantage point due to the falling ground.</p> <p>On the side seen there is what looks like a crack at the front end of the top tier of stone. This should be checked with access and repairs expected.</p> <p>The further side should be inspected from access equipment in due course.</p>

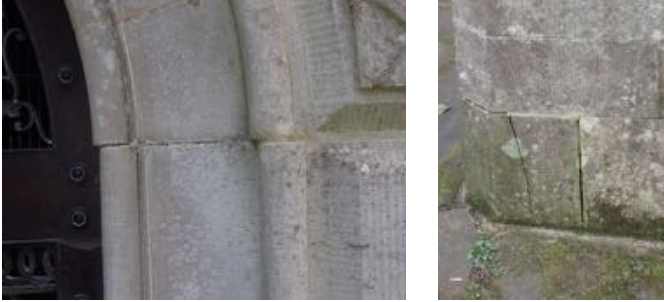
9a.1.2	WALLS	
	<p>High quality ashlar masonry with very tight joints should be cleared of ivy, and access arranged to the uninspected LH side.</p> <p>All the visible parts are in excellent order. The only defect noted is a very long-standing displacement at the RH spring of the entrance arch, which appears to be stable.</p>

<p>A stone drainage channel at the base of the side walls needs to be cleaed out and the water discharge from it managed.</p> <p>The bronze gates are in very good order.</p> <p>The low walls flanking the entrance are in good structural order but some open joints and cracked stones need pointing.</p>

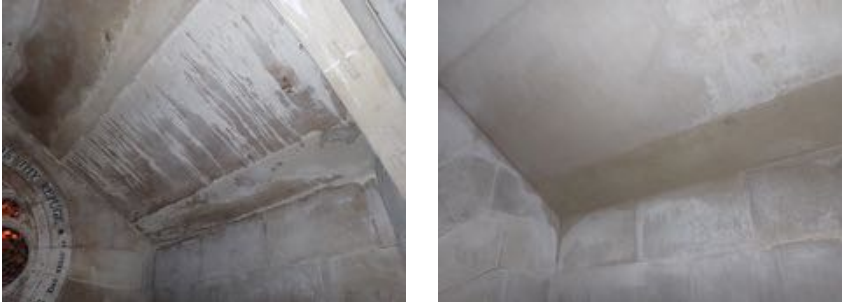
9a.2.1	<p><b>CEILING</b></p> <p>The stone roof appears to have leaked at joints in the past but not recently, so staining is residual. This should be checked after prolonged rain. The stone is damp in patches on the north side, probably corrlleating to moss and moisture retaining deposits on the roof outside.</p>

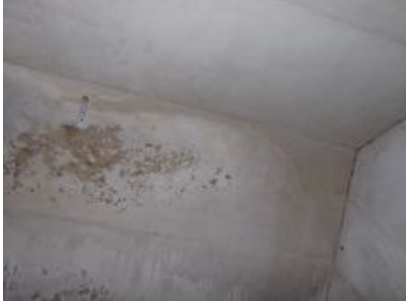
The crack noted from outside has been pointed and a telltale fitted. This has not moved since that was done.

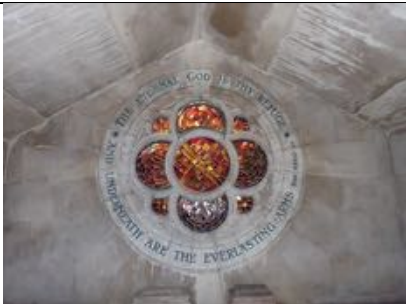
9a.2.2	<p><b>WALLS</b>  Similarly in good order. The displacement over the entrance arch has also been pointed and fitted with a telltale, and this is also stable. Signs of surface water migration on the stones is probably historic, or due to condensation (or both).</p> <p>The window glazing is bowed, but appears to be completely sound and secure. A few cracked panes are of no consequence</p>

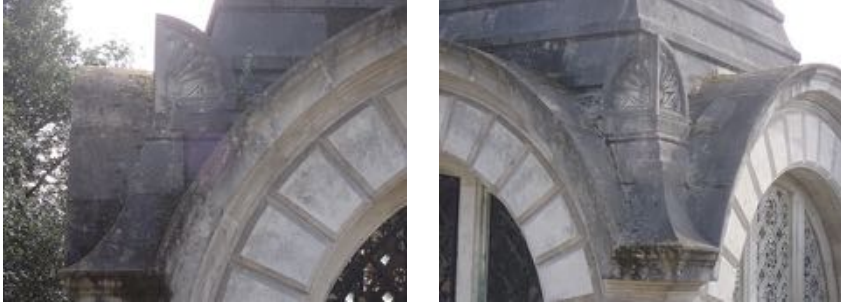
9b.1.1	<p><b>ROOF</b></p> <p>The stepped spire has circular glazed lucarne openings near the top, and at the base the four curved pediments abut it, so that water only runs off at the corners.</p> <p>From a n inspection from ground level and the adjacent terrace it can be seen that the stonework is generally in excellent condition, with few if any open joints or defects. There is however developing plant growth in the crevices at the base of the spire, and these will be rooting in open joints unseen, and affecting the run-off of water. They need to be removed and defects addressed, and at the same time the whole structure checked from close inspection.</p>

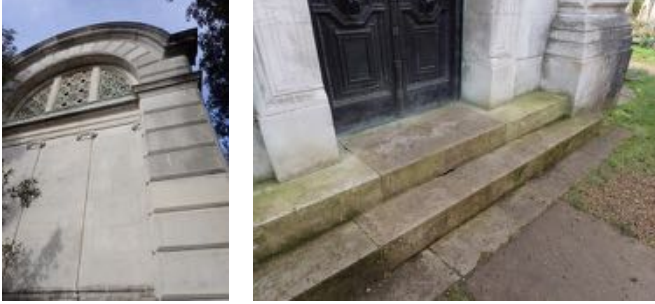
<p>At the plinth there is a substantial hole in the entrance steps which needs repair, with infill of any deeper void. Other pointing defects are very minor.</p>

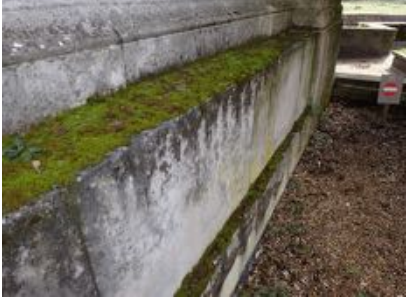
<p>The offsets at low level should be kept free of moss which retains moisture. This is particularly relevant at the corners, where the run-off from the roof is not controlled so it runs down the walls and splashes on the base. This relates to dampness inside and a review of details at roof level is recommended.</p>

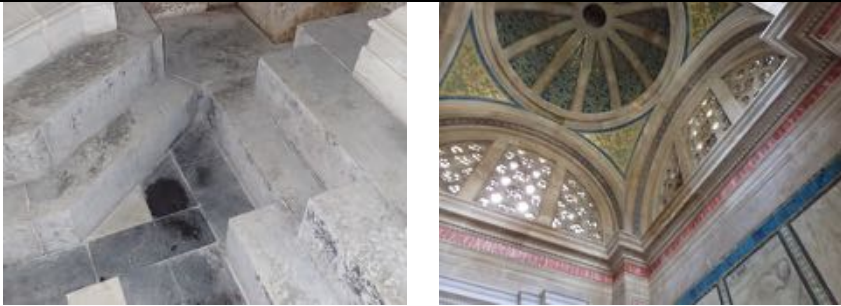
9b.2.2	<p><b>WALLS</b></p> <p>The limestone here also shows staining from being wet in the past, but now for the most part it is dry. This should be verified by monitoring after prolonged rain. Any defects that need addressing are outside, or at the lunette windows if the glazing leaks.</p>

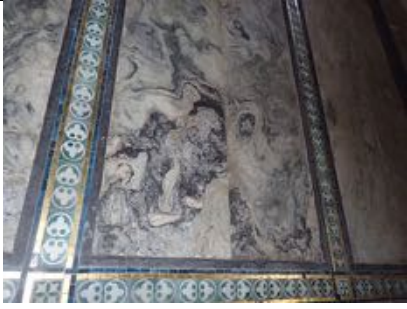
One marble panel has eroded as a result of salts action from wetting, but that is now dry.

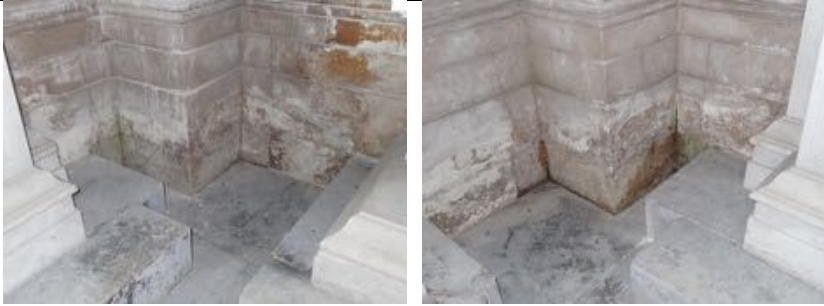
At the base there is concentrated staining and damp in the four corners, and there the stone faces are affected by salts and potentially frost. Mitigation may involve some revision of water run off at high level.

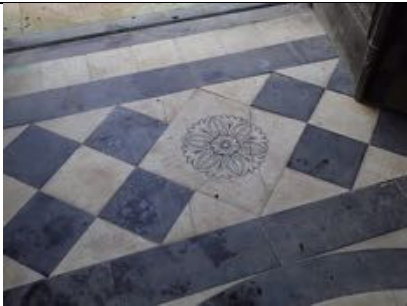
Even when dry staining will remain, and that can only be mitigated, even in part, by poultice cleaning.	
9b.2.3	<b>FLOOR</b> The floor has a few cracked tiles in the way of the entrance, but these are well fixed and stable.

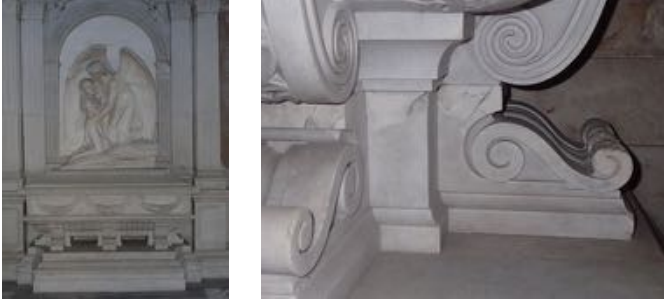
9b.2.5	<p><b>MONUMENTS</b></p> <p>The three sarcophagi are in very good order. There is some moisture migrating in to them from damp walls, but not to make them defective. One (RHS) has a small area of cracking of one carved support, which could be from an embedded ferrous fixing inside it.</p>

<p>The only defects noted to the internal features is small breakage of one stone support to a sarcophagus, which should be tackled before the problem intensifies.</p> <p>To the lower parts of the building the conservation works needed are really bound up with those for the Circle of Lebanon, where the conservation philosophy is different. There and adoption of the principle of 'conserve as found' will inform a less interventionist approach, and the main issues will be repointing and structural stability of retaining walls and the management of water discharge from the roof of the Circle Vaults. The conservation of gates etc will follow the comments for the Circle of Lebanon, see 7.3 above.</p>	
--	---	--

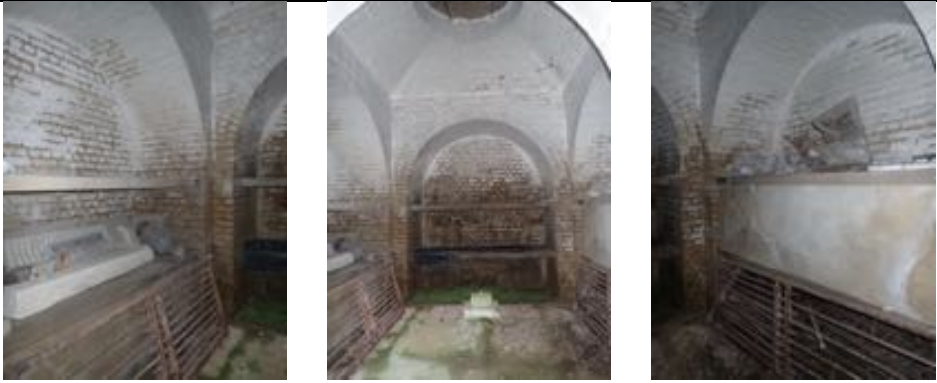
9b.3.2	<p><b>VAULT</b></p>	
	<p>No cracks or apparent defects and relatively dry. The two iron bars supporting the stone slabs in the oculus are rusty and need treatment.</p>

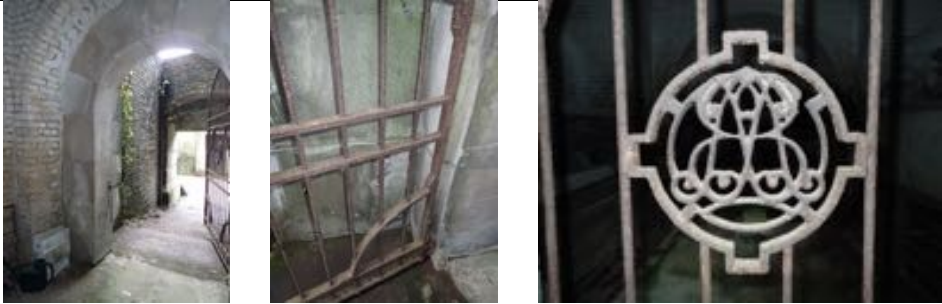
9b.3.3	<b>WALLS</b>	
	<p>Damp, particularly at the bottom where the limewash decorations are completely degraded. No structural defects. Some loss of pointing to faces. Stone arch to entrance is in good order inside. Shelves sound but damp at the walls and wet at the base. No contents other than potentially in sealed voids. Some loose material stored inside appears to come from this building and others.</p>

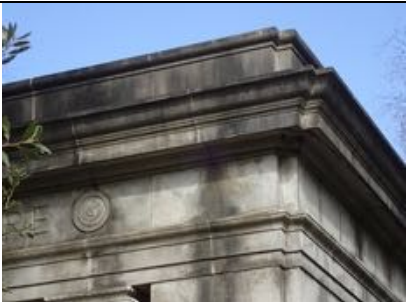
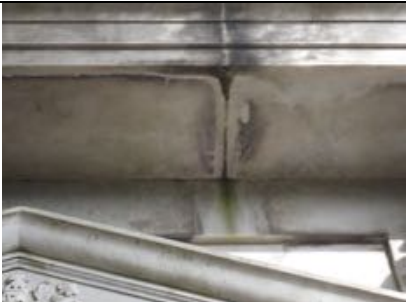
9c.1	EXTERIOR	
9c.1.1	<p><b>ROOF</b></p> <p>The roof should be inspected using access equipment when available. It should be assumed that there will be some work to be done. It is suspected that at least some of the moisture seen inside is from penetration at high level.</p> <p>Pattern staining to the wall below the cornice indicates that water is running through the joints to the cornice. A lead weathering to this should be seriously considered.</p>

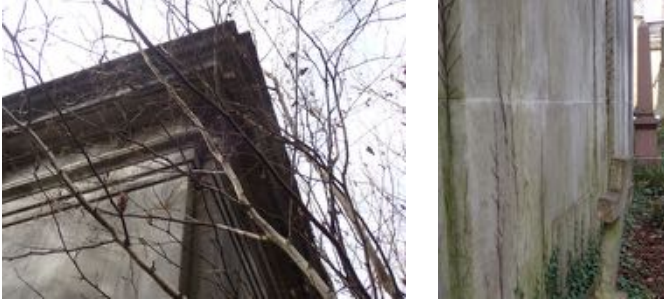
9c.1.2	<p><b>WALLS</b></p> <p>Extensive work in the early 1990's has left the masonry in good order, with no open joints.</p> <p>A tree impinging on the structure from the back should be cut back before it causes damage. Ivy growth should be strictly controlled</p>

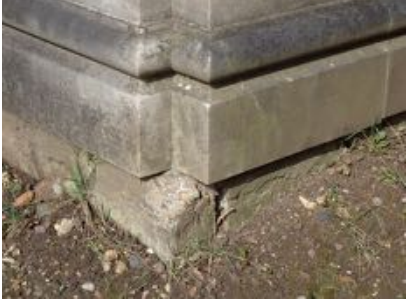
<p>Where ground has fallen away at the base of the walls it can be seen that the stonework overhangs what appears to be a concrete base. Where this is cracked at the front RH corner it should be repaired, and perhaps rendered for a better appearance.</p>

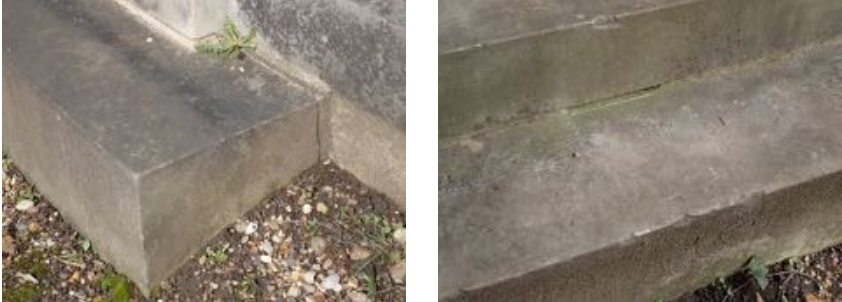
<p>The steps are sound. Hairline cracking at the RH end and a small pointing defect in the middle.</p>

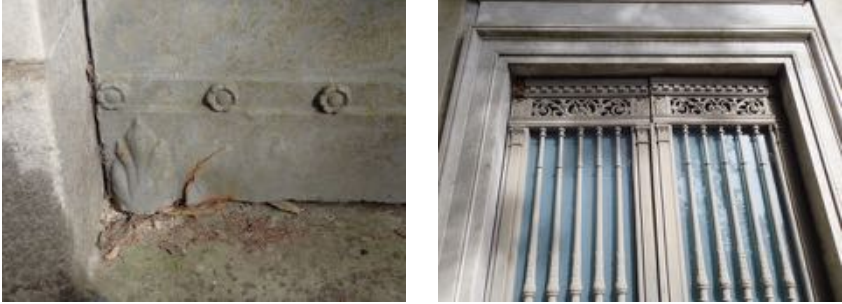
9c.1.3	<p><b>DOORS</b></p> <p>The cast iron doors with open grillage have been glazed from within. They are in need of some overhaul and painting. There are paint blisters in both bottom corners with corrosion under them.</p>

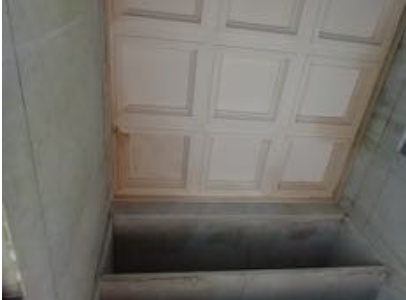
9c.2.1	<p><b>CEILING</b></p> <p>The whole interior suffers from moisture, much of it probably condensation, but the ceiling shows particular signs of water ingress around the edge.</p> <p>The detailing and rain water disposal should be carefully reviewed, and the ceiling itself checked for defects from access equipment.</p>

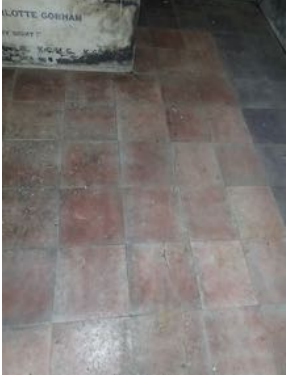
9c.2.3	<p><b>FLOOR</b></p> <p>There is a crack across the floor, front to back just to the right of the door. This probably the result of failure of the concrete floor slab, and it should be monitored with engineers advice. It is not large and does not appear to be progressive. The most likely result is a need to manage adjacent trees.</p>

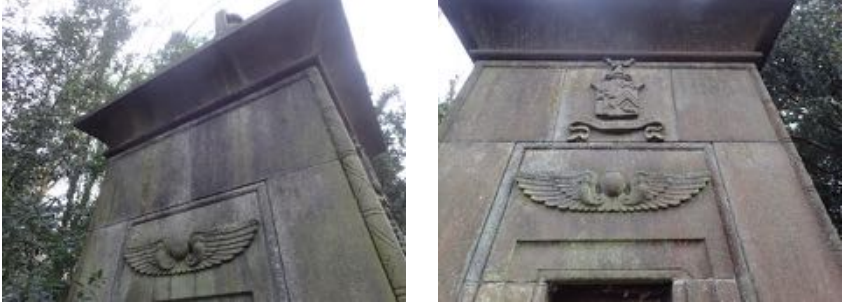
<p>10.1</p>	<p><b>ROOF</b></p> <p>The stepped stone slabs should be checked from access equipment, and the stability of the urn verified.</p>	
<p>10.2</p>	<p><b>WALLS</b></p> <p>There is no significant displacement of the stonework and the monument is in excellent structural order. Some small open joints should be grouted and pointed as a precaution.</p>

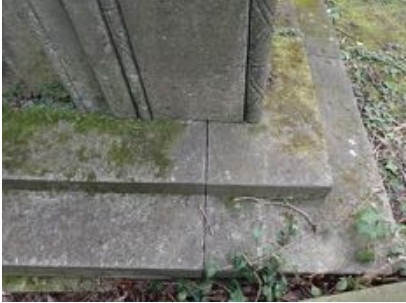
<p>10.3</p>	<p><b>PLINTH</b></p> <p>Steps and raised plinth are in satisfactory condition. Fine voided joints should be grouted and pointed.</p>

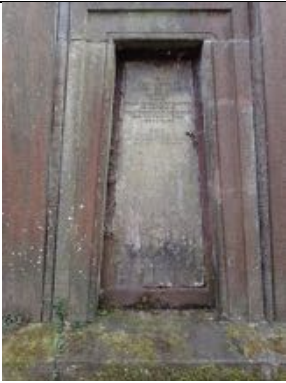
10.4	<p><b>DOOR</b>  The four sides have matching recessed panels, and that facing the path is clearly a door, with an iron frame with a keyhole framing a stone inscription slab. The frame is very rusty and it was considered injudicious to try opening it other than in the context of repair works with skilled operatives on hand. This should be done in due course, and repairs will then involve treatment and repair of corroded ironwork and the reactivation of opening mechanisms.</p>

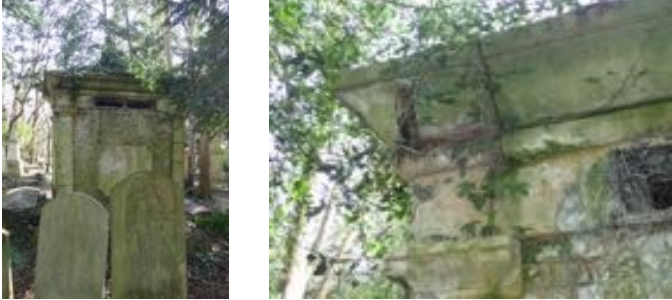
11.1	EXTERIOR	
11.1.1	<p><b>ROOF</b></p> <p>The roof was viewed only from ground level. Moss-covered and clearly leaking through the cornice joints, but there appears to be no displacement of stones other than in the rear right hand corner where ivy has rooted in the fabric.</p> <p>In this corner there is substantial displacement and open joints.</p> <p>Repairs are needed following proper and full removal of the vegetation.</p>

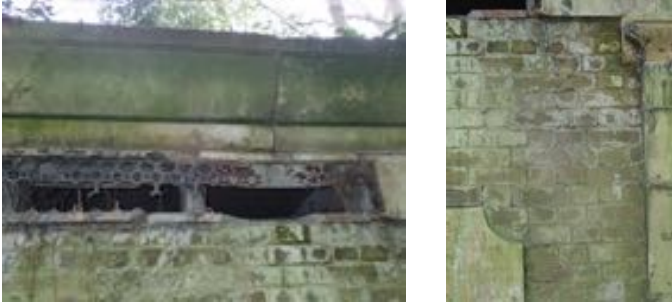
11.1.2	<p><b>WALLS</b></p> <p>The stonework to walls is very eroded and the brickwork very stained, but below the cornice, any cracks are modest and repointing locally is all that is needed.</p> <p>The cast iron grilles to the ventilation openings on 3 sides have disappeared to two sides, and there are scant remains at the back. This remnant should be properly conserved against loss.</p>

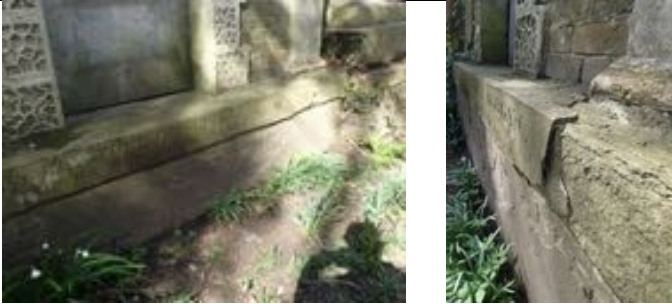
11.1.4	<p><b>STONework</b> The facing is delaminating to the main inscription on the plinth. This needs careful conservation repair before more is lost. The rendered brickwork below has lost much of the render, but that can be managed in decay.</p>

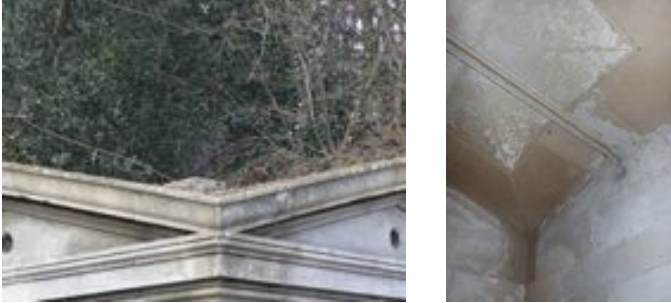
<p>12.1</p>	<p>EXTERIOR</p>	
<p>12.1.1</p>	<p>ROOF</p> <p>The top surface of the roof cannot be seen from any angle, but it is clearly of stone, and the interior shows how the four low-pitched gables are formed with cleverly jointed stone units.</p> <p>It should be cleared, inspected and any defects attended to, but there is no sign of localised leakage from inside.</p>

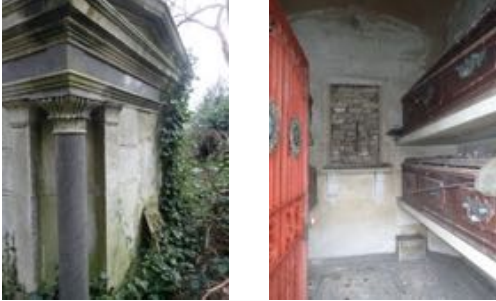
<p>A former window in rear elevation has been very crudely plastered over.</p> <p>Ivy growth should be better controlled.</p> <p>To conserve the mausoleum 'as found' without improvement the repairs will be limited to minor pointing and masonry repairs and substantial control of vegetation. Improvement of the treatment of the former window would be a benefit.</p>

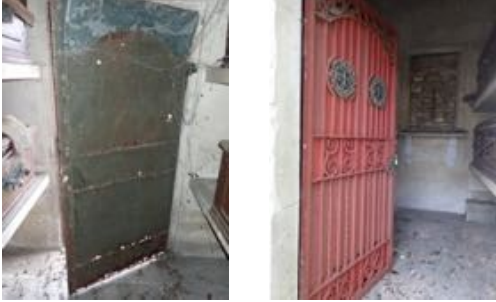
12.1.3	<p><b>GATES</b></p> <p>Wrought iron gates infilled with steel sheet have some corrosion, particularly inside and to the sheet overlay. These need conservation repair and repainting.</p>

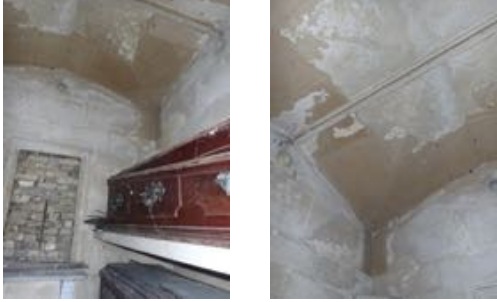
12.1.4	<p><b>STEPS</b></p> <p>In fair order.</p>	
12.2	<p><b>INTERIOR</b></p>	
12.2.1	<p><b>CEILING</b></p> <p>The ceiling shows no sign of localised water penetration, but there is some general dampness caused by slow run-off from an obstructed external surface.</p> <p>A light steel beam supports the ridge from side to side. It is vulnerable to corrosion, but only lightly affected. Long-cycle maintenance should include a pre-emptive treatment.</p>

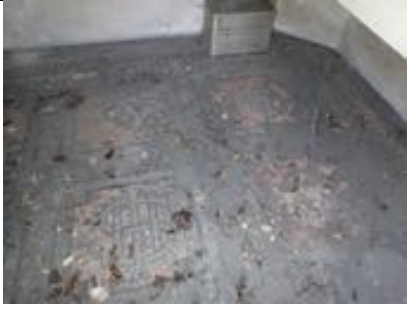
12.2.3	<p><b>FLOOR</b> The floor in mosaic has no cracks, but a thin coating of what appears to be cement slurry has hastened loss of surface from individual tesserae. This is not an issue to use, but has very poor appearance. It may be difficult to reverse, but cleaning and conservation now will mean that it is more likely to survive in the long term.</p>

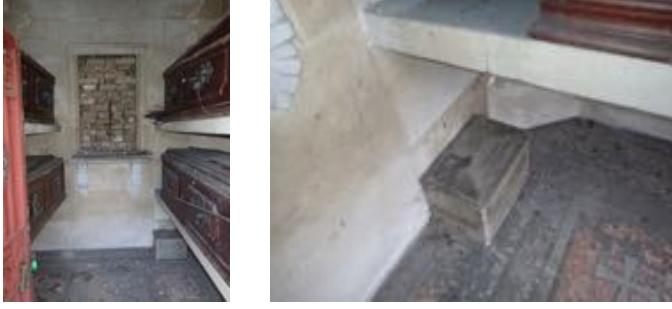
12.2.4	<p><b>CONTENTS</b> The two side walls have coffin shelves with 4 coffins and small boxes of pet parrot remains.</p>

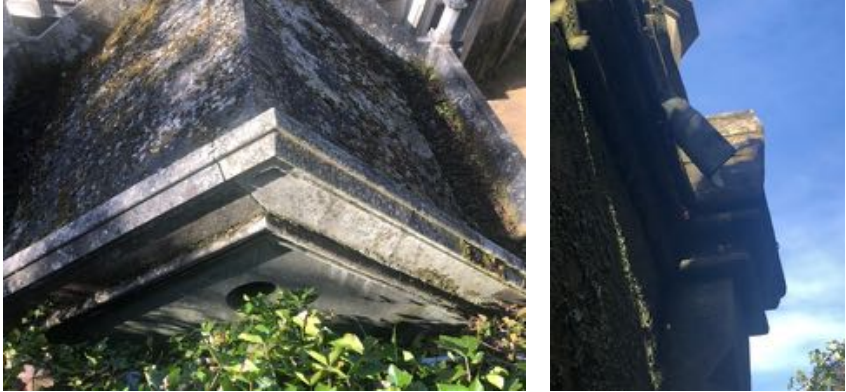
<p>13.1</p>	<p><b>ROOF</b></p> <p>Pitched roof in stone slabs with parapet upstand all round. It drains to parapet gutters each side which are full of leaf mould so construction is unclear. These in turn have tiny spouts through the rear parapet which cannot be anything but blocked.</p>

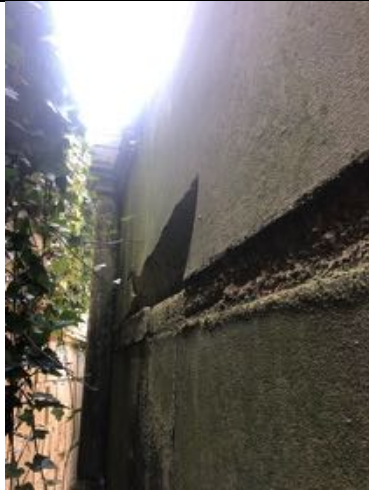
<p>No specific defects were noted in the stone roof.</p>	
<p>13.2</p>	<p><b>WALLS</b></p> <p>Stonework itself is in fair order with no obvious threat to structural integrity, but with open joints, old repairs (including bronze cramps) and a lot of moss and surface patina.</p> <p>There is one big breakage on the hidden rear elevation and this should be addressed by any programme of repair.</p>

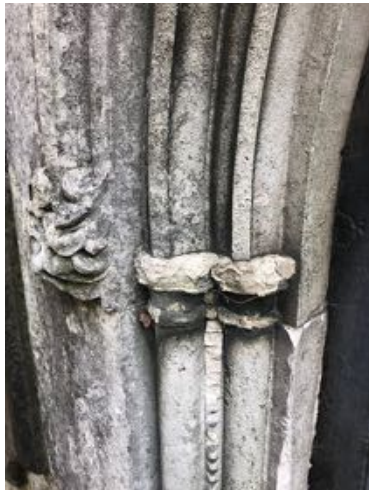
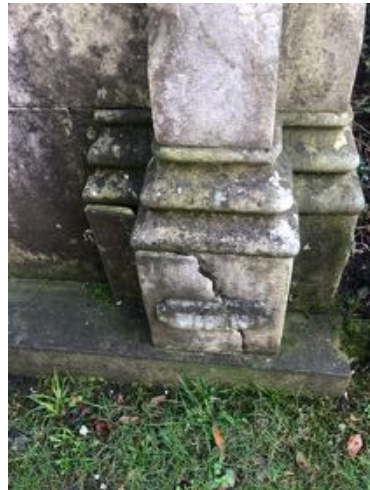
Moulded details to the entrance and corners are eroded and some exposed surfaces are unstable and still eroding.

Such problems as the fabric has are mainly derived from the unsatisfactory rain water disposal, and it is suggested that a change needs to be made to make this more robust, followed by a more diligent basic maintenance regime.

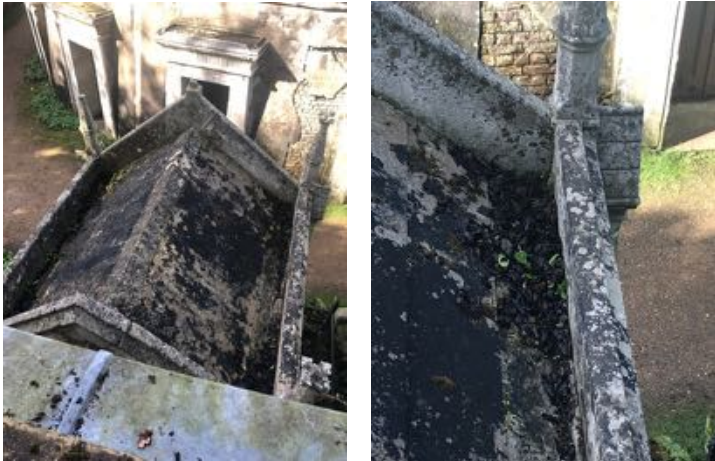
<p>14.1</p>	<p><b>ROOF</b></p> <p>Stone slabs and ridge appear sound from above, without open joints or displacement.</p>

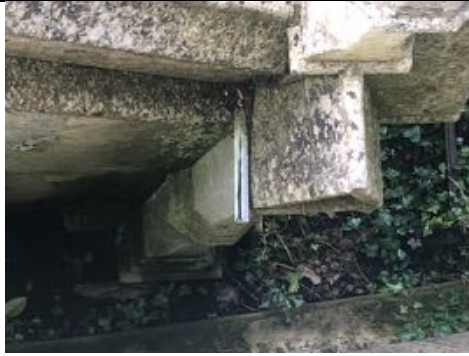
<p>The roof slopes drain to a parapet channel each side, lined with cement mortar, there is substantial build up of leaf mould in the parapet channels.</p> <p>From each roof channel a tiny pipe is supposed to discharge the accumulated rainwater. It has no chance of doing so adequately and looks very poor.</p>

This needs to be properly reviewed and a new more robust and elegant arrangement constructed.

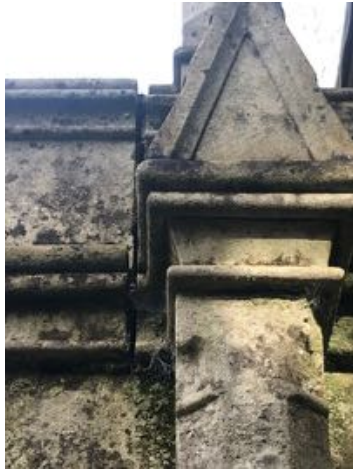
Parapets are much affected by mortar loss from joints, and one big displacement in rear right-hand corner relates to a crack in the wall below it.

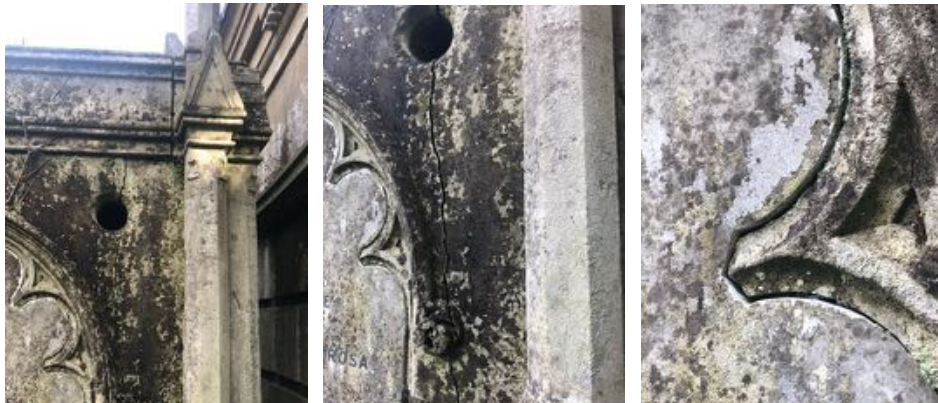
The walls are in limestone ashlar slabs and are generally sound, other than some mortar loss. However, the big and probably progressive crack in the rear right-hand corner needs urgent conservation repair, as the consequences of collapse are unpalatable.

Here the movement has also disrupted the sealing and fixing of the adjacent inscription slab. This, and others, may need refixing and grouting of voids.

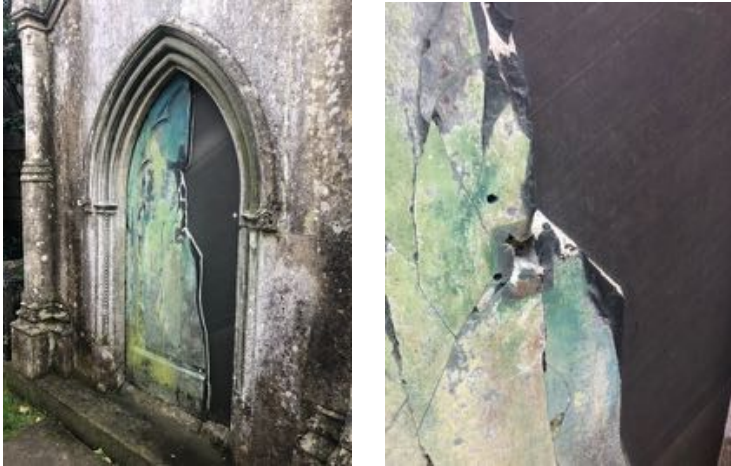
<p>Other decoration has a few breakages but remains sound and crisp for the most part.</p> <p>All the open joints need repointing.</p>	
14.3	<p><b>DOOR</b> The entrance door, in slate, was once badly broken and repaired with an 'honest repair' in 1990.</p>

<p>There is some loss of infill mortar from this repair which should be renewed before the problem escalates.</p>

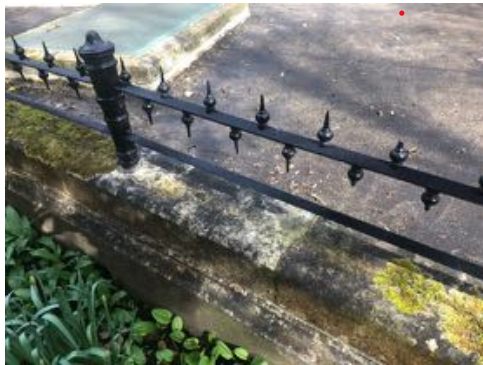
The perimeter railings have suffered some loss of detail, and were restored with some replacement quite recently. They are in good order.

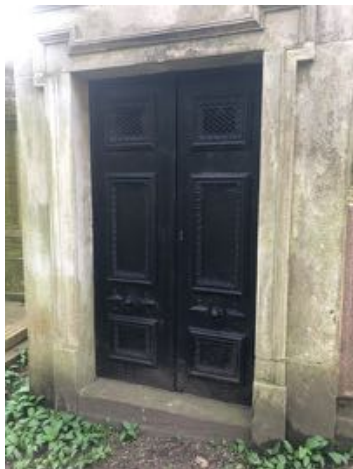
The cast iron doors are in good order, but marred by the fitting, now redundant, of cheap steel bolts. Ideally these should be removed and damage made good.

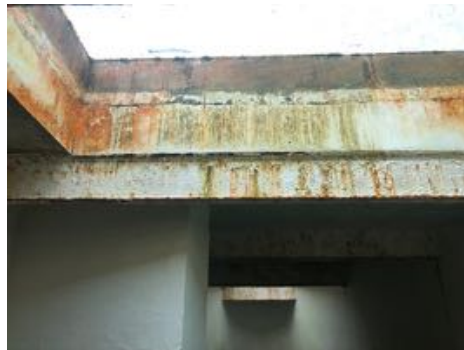
It is clear that water continues to permeate the structure, particularly around the rooflights, which leak.

Other surfaces are much affected by condensation.

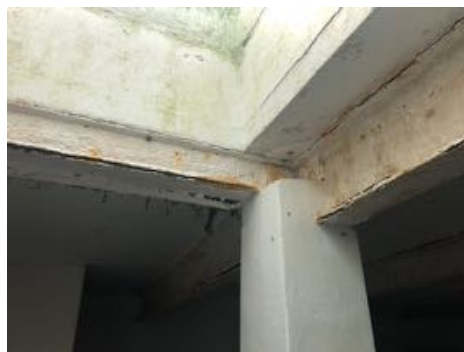
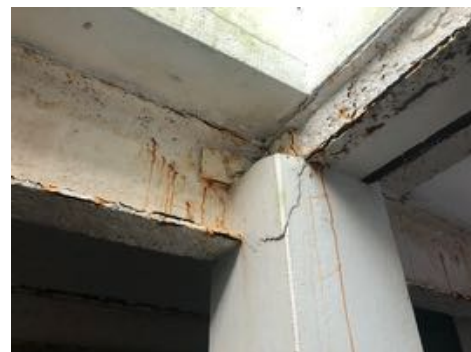
The stone roof slabs show no defects, but the steel beams, painted white, are corroding fast, and intervention is needed to arrest or slow down the decay, as they will shortly become structurally incompetent.

<p>Rust staining defaces many painted surfaces, and rust jacking is starting to affect render/concrete bearings of the beams.</p> <p>The walls have green algal growth, but probably more from condensation than leakage. Ventilation should perhaps be reviewed as well.</p> <p>The mosaic floor and steps are sound, but much affected by water ingress, manifested by green slime and dirt.</p>

15.6	<p><b>SUMMARY</b></p> <p>The Otway Mausoleum will need significant work if it is to remain structurally sound. At a minimum, this will include comprehensive (and more successful) treatment of corroding steelwork, further roof works to address leaks, and probably a better regime of ventilation.</p> <p>Decorative (paint) finishes might be specified that are more tolerant of the damp environment.</p>

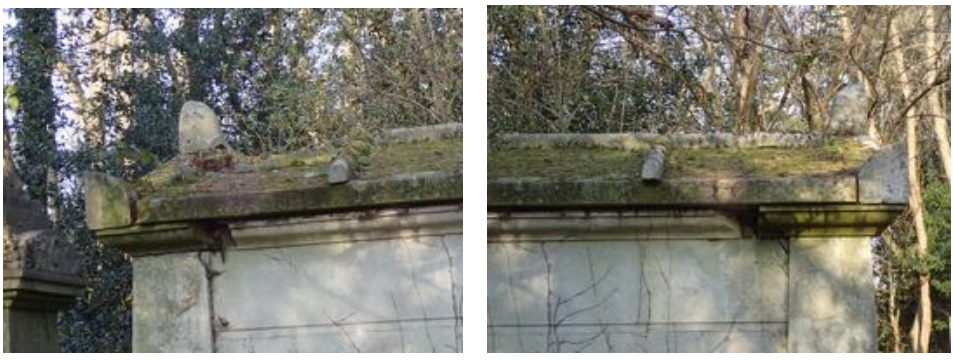
<p>The structure has been much disrupted by tree growth invading the structure itself, some but not all of it now removed. This has left some serious structural issues that need to be addressed by conservation work of some urgency.</p>	
<p>16.1</p>	<p><b>ROOF</b></p> <p>The roof, fundamentally of two large stone slabs, has been disrupted at the back, where the rear pediment coping has displaced with a big open joint that has plants growing in it. The front pediment has displaced less, but the woody growth is stronger and more worrying.</p>

<p>Stone strips mimic lead rolls, and those have broken and slipped down the roof slope. The rear part of the ridge roll is missing. All of this needs to be secured and stabilised, and open joints secured and pointed, even if the situation is simply to be maintained as status quo.</p> <p>Movement in the roof relative to the walls has caused some fracture and loss of the cornice moulding at the eaves.</p>

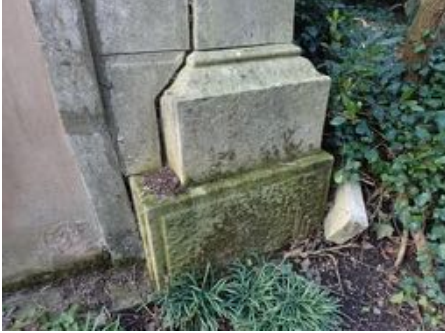
<p>16.2</p>	<p><b>WALLS</b>  The wall structure of corner columns engaging the edges of wall ‘planks’ has moved a lot to both the right-hand corners, where the columns have rotated and displaced, leaving the walls insecure.</p>
