# HIGHGATE CEMETERY

## INSPECTION AND REPORT ON THE CONDITION OF BUILDINGS AND STRUCTURES

### VOLUME 2 PARTS 5 to 12: THE FUNERARY BUILDINGS

JANUARY- MARCH 2022  
REVISION A: DECEMBER 2022

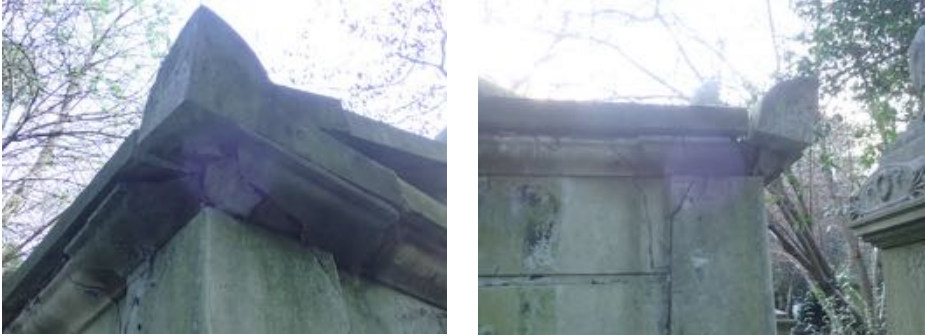
<p>At the top of the rear right-hand column, the cornice has broken and fallen away, undermining the pediment section. Much loose stonework is on the point of falling apart and being lost. Even without any intention to reinstate, structural repairs are needed to stabilise the structure, and conservation of the stonework to keep water and plant growth to a minimum.</p>

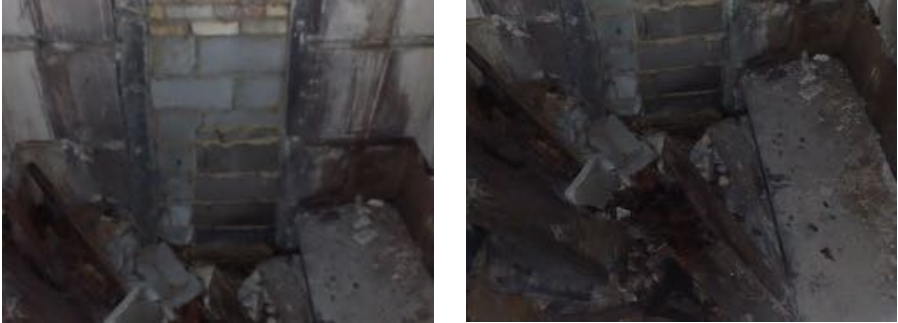
<p>16.3</p>	<p><b>INTERIOR</b>  The door is sealed, so interior inspection other than by photos through a small vent. This shows that coffin shelves have collapsed and the bottom of the vault is full of debris.</p>

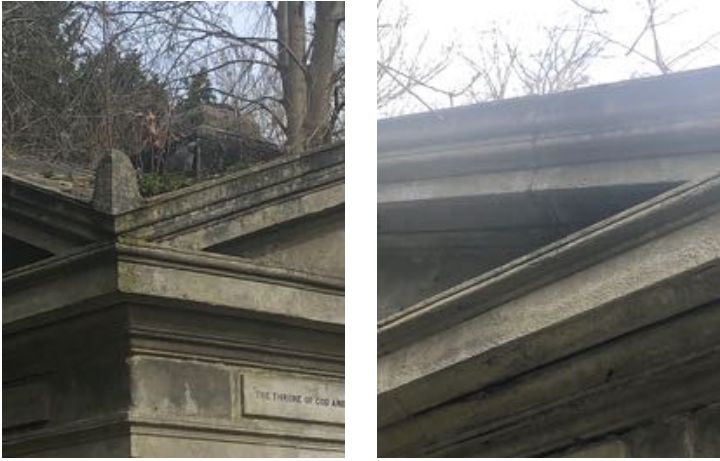
<p>17.1</p>	<p><b>ROOF</b></p> <p>Top surface not visible, but it is clear that established vegetation is rooting in the valleys and construction joints.</p>

<p>This needs to be cleared, inspected, repaired and kept clear. It is clear from the front pediment that at least one stone joint is opening up.</p> <p>Once the masonry has been cleaned it will be possible to assess the necessary repairs, which are not yet expected to be extensive.</p>	
<p>17.2</p>	<p><b>WALLS</b></p> <p>No structural defects and all the stonework details are sound and crisp.</p>

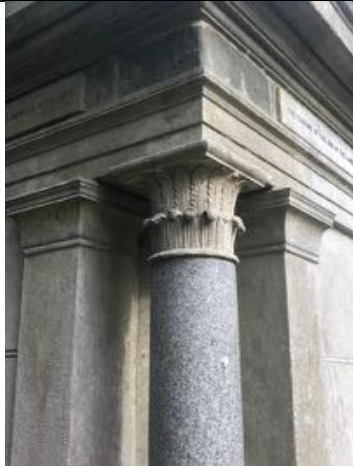
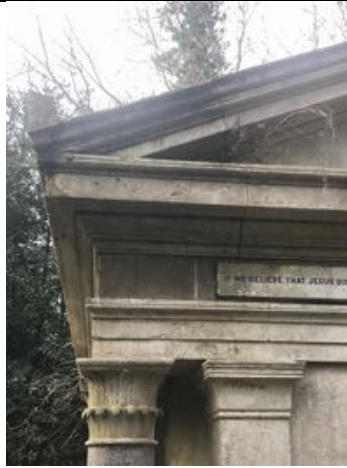
A few joints have mortar loss, notably at cornice/pediment level, where some plants rooted in open joints are starting to have an effect by displacing the masonry. The vegetation is as yet young and light, but it will not take long to become woody and disruptive. It needs to be removed and the pointing made good before that happens.

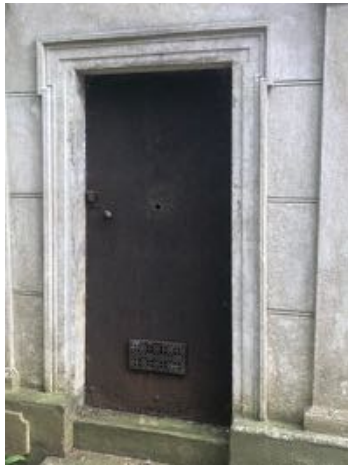
Door is a single plate of steel with a lot of surface corrosion, but nothing that makes it insecure.

Superficially it might appear that it needs to be eased and opened, but it was reported (Victor Herman) that fact it conceals the fact that the building has been sealed up in blockwork and it will not be that simple. If the interior is to be conserved it would be appropriate to reopen and replace the door.

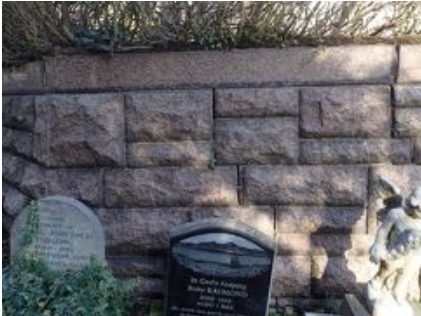
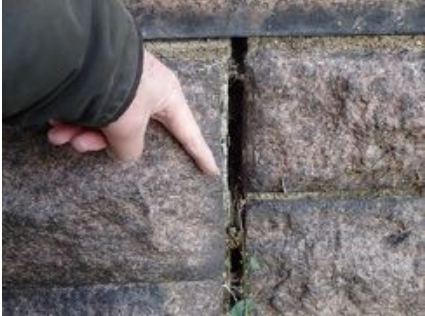
<p>The retaining wall in rough hewn stonework surrounding the plinth paving does have substantial cracks in the west and south face. That in the south face has the remains of woody plant roots in it. These need repair and probably some precautionary reinforcement.</p>

<p>There are other open joints. Repairs now will be minor, but these will need ongoing monitoring.</p>

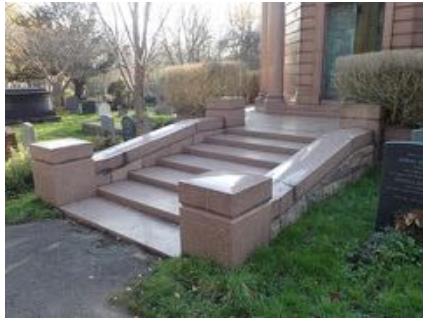
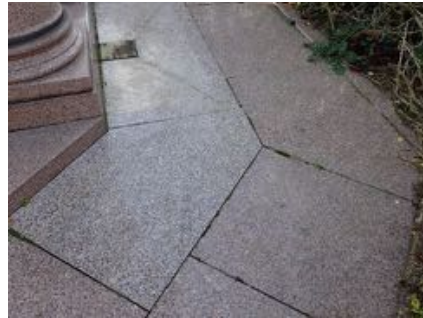
The paving and steps are generally in good condition with some minor movement historically, but stone slabs displaced not more than 8mm.

However, there are extensive open joints and a programme of regular minor repairs should delay the onset of any serious defects.

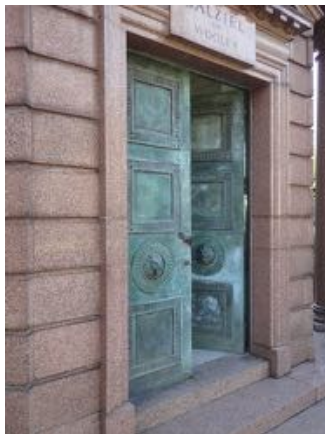
Bronze doors and fittings are all in excellent condition and the doors open easily. It is clear that there were once bronze gates to the steps, which are now missing.

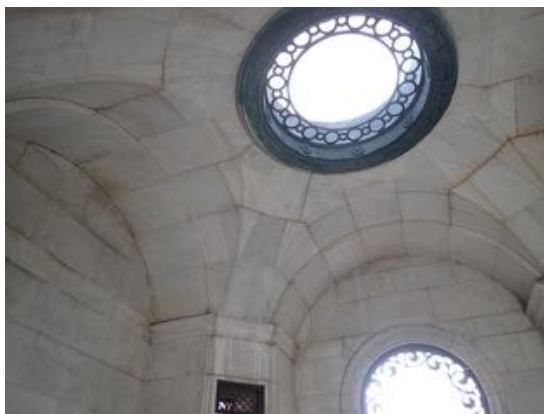
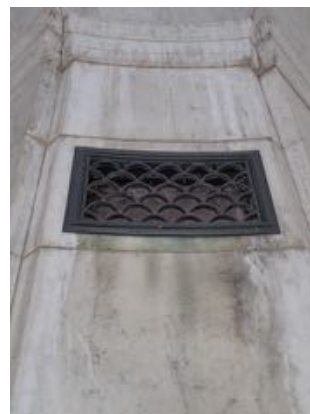
Interior shows signs (staining) of historic water ingress but not of structural defects. Any loss of jointing material to the marble is very minor.

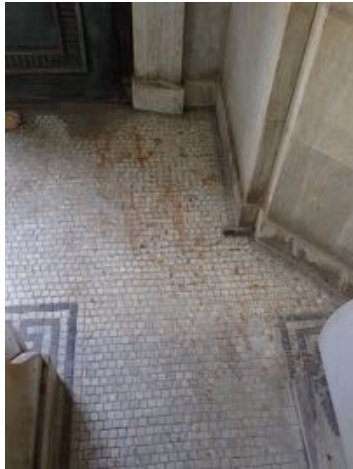
The floor is in good order, with some water staining, but no loose tesserae. It would certainly benefit from cleaning by a conservator.

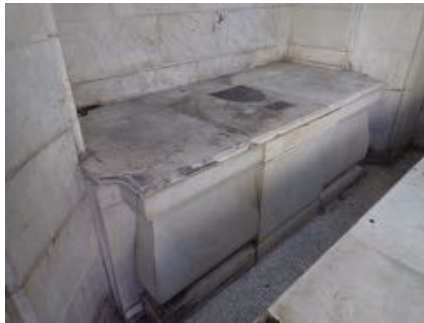
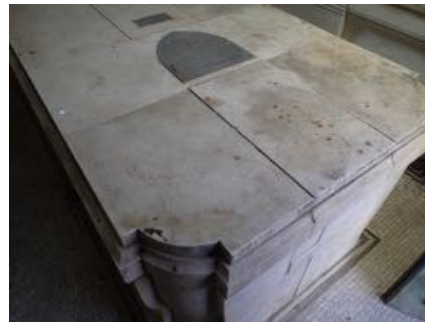
The central one has loose and slightly displaced and cracked slabs in the top, but repair to address these will be minor.

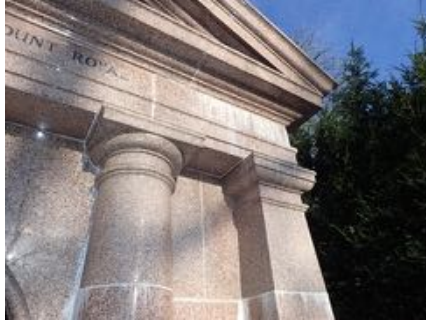
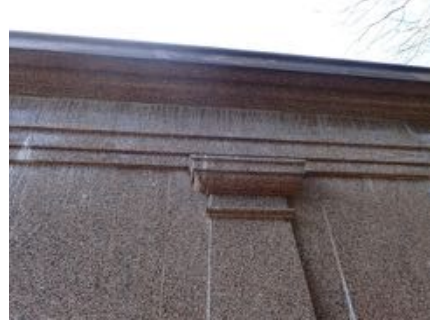
The external structure and fabric appear sound. Extensive repairs to the stone roof in quite recent past have stopped any water ingress, but the legacy of earlier decay remains with lime leaching visible at masonry joints. The joints themselves are all sound.

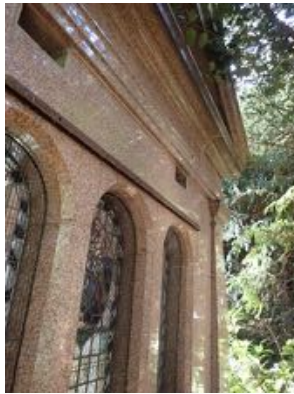
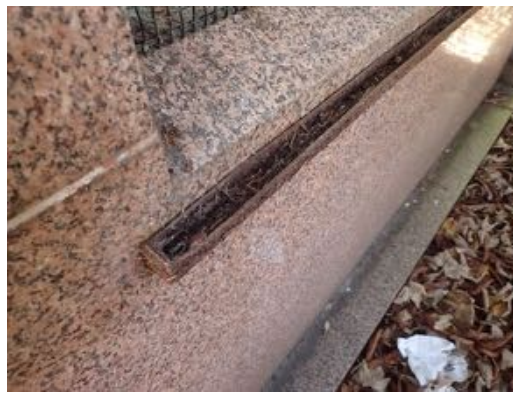
There are rusty steel channels mounted above and below the rear windows which are the remains of a security shutter. These are unsightly, and likely to cause damage, so they should be removed.

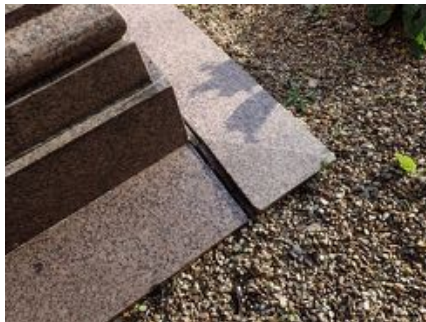
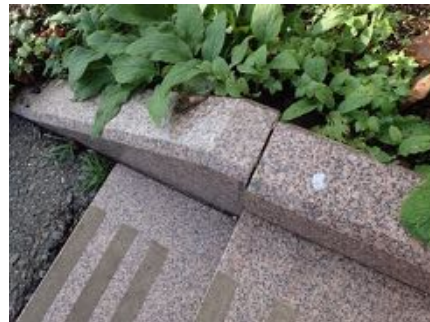
The step around the building has open joints and displaced stones. These do not threaten the wider fabric but need repair.

The entrance steps have similar minor defects and will also benefit from some attention.

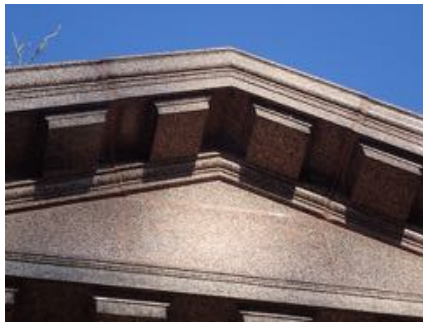
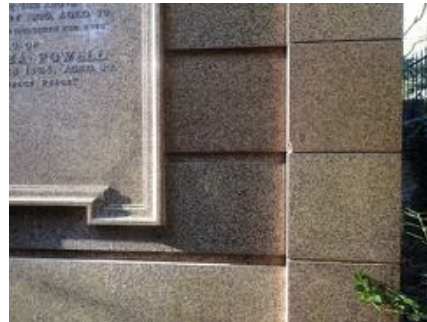
The external masonry of the mausoleum, including the roof, is in excellent condition with no signs of structural movement or open joints.

The same is largely true of the double-stepped plinth, but there are a few open joints and vegetation is starting to invade it, a process best nipped in the bud!

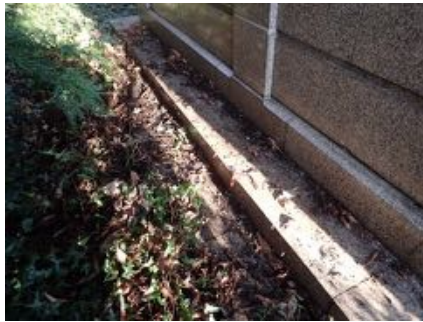
The perimeter wall and steps are sound enough in themselves, but there has been some substantial movement of the steps and joints between them and the plinth have opened by nearly 40mm. This needs to be monitored and stabilised. The steps remain entirely usable.

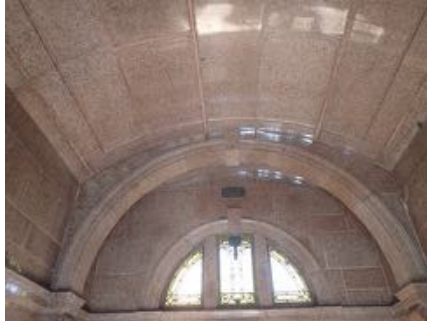
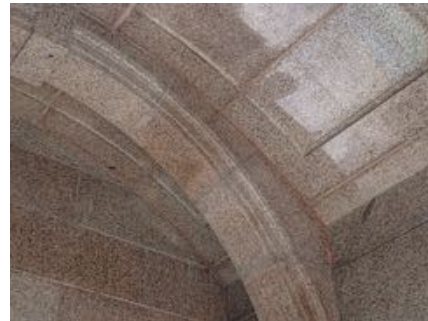
The interior of the roof shows signs of previous repair, which all remains sound.

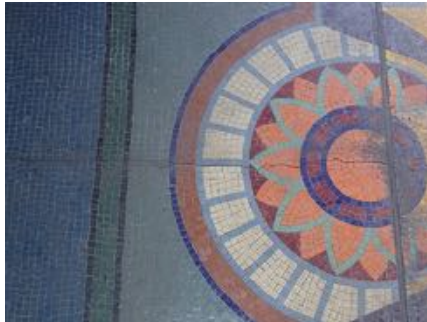
There is a 1mm crack across the floor on either side of the opening panel but there are no loose tesserae and it looks long-standing.

It should be monitored, and if any deterioration sets in it should be repaired before any fabric is lost or compromised.

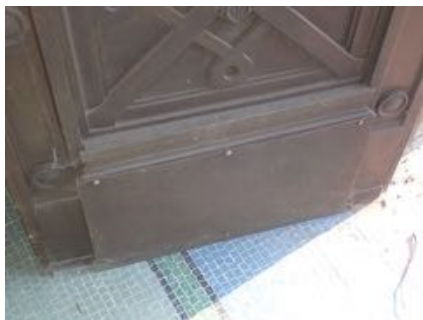
The doors open freely, but there is a loose panel at the bottom of the right-hand door, previously repaired with pop rivets and deserving of better repair.

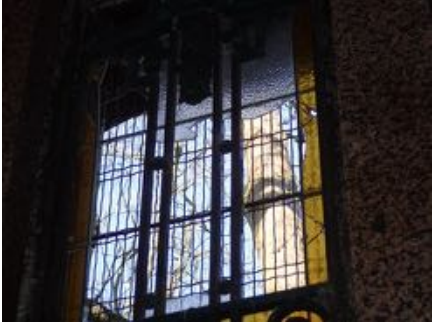
<p>There is broken glass in the rear window, which is glazed in a thin brass matrix. This should be repaired.</p>
