Project Name: Highgate Cemetery

Project Date: 06/03/2024

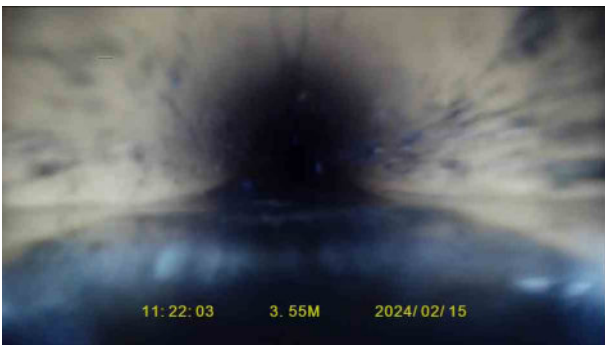
ea51794f-0e49-406f-a021-baaee9d72fa0.jpg, 00:00:47, 3.55 m
 Settled deposits, fine, 20% cross-sectional area loss, start

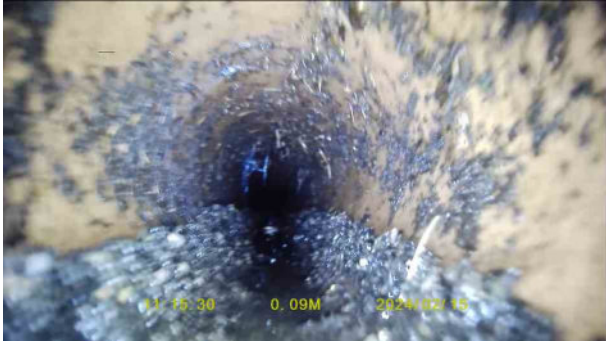
4ebcb5db-0fa7-472b-9e97-0df6afe2e321.jpg, 00:00:11, 0.01 m
Settled deposits, fine, 20% cross-sectional area loss, start

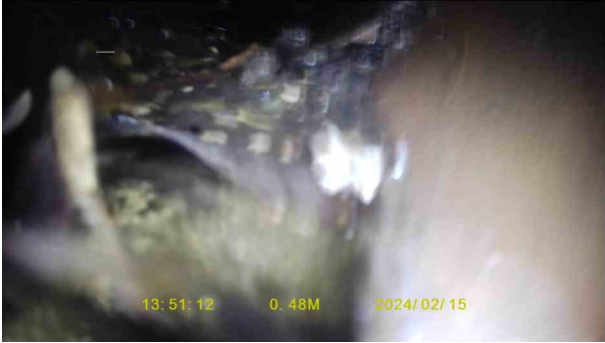
20c95e4e-6e9c-4eee-b96d-9d31401beb11.jpg, 00:00:22, 0.48 m
 Settled deposits, fine, 25% cross-sectional area loss, start

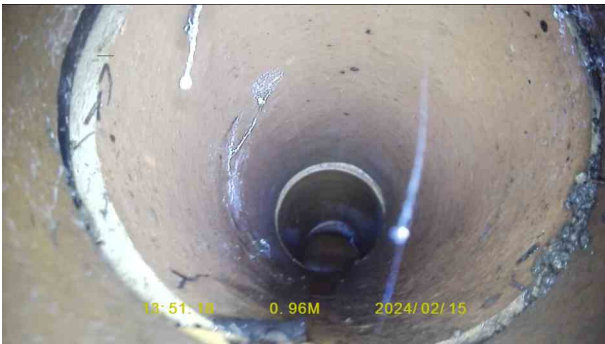
7b959420-30df-46fe-8b1c-021aa6c8dd4c.jpg, 00:00:28, 0.96 m
 Joint displaced, medium

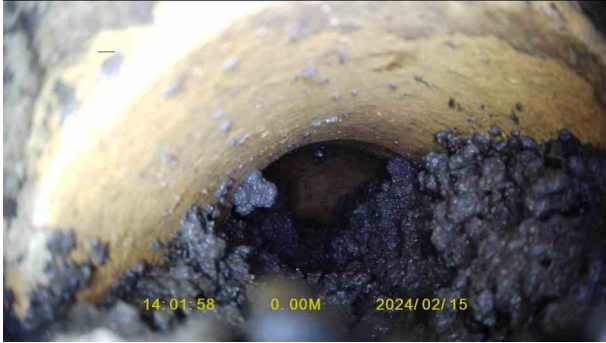
7ba87c9a-6b39-42d4-ae10-ec3c1a5078b6.jpg, 00:00:19, 0.01
m
Settled deposits, fine, 30% cross-sectional area loss

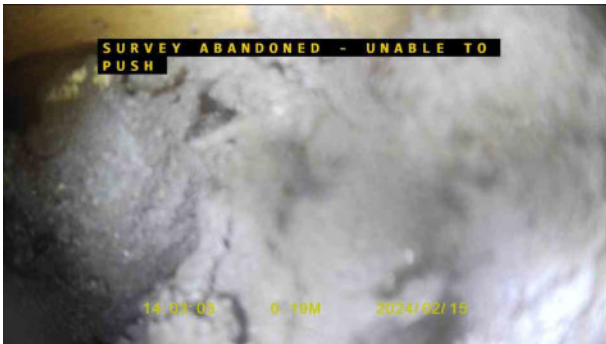
b3d517be-2c67-4ef1-a381-ccbc479d77ed.jpg, 00:00:58, 0.19
m
Survey abandoned, Camera unable to pass debris

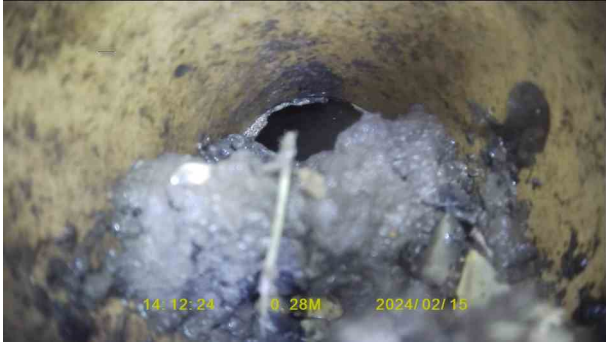
0b747a0b-873a-46c3-b4fc-464612ea82f8.jpg, 00:00:22, 0.28 m
Settled deposits, fine, 75% cross-sectional area loss

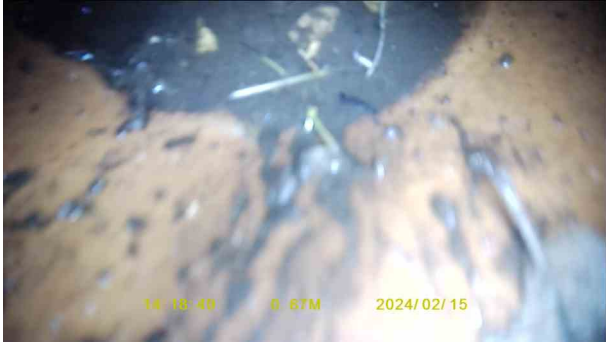
ccde89bb-de1f-44ef-bd98-8822d6aa2ec0.jpg, 00:00:28, 0.67
m
Settled deposits, fine, 25% cross-sectional area loss, start

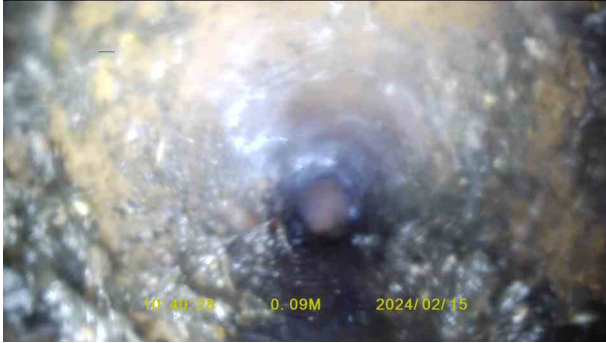
7d9258fa-146f-4850-be93-c5bf5397d76f.jpg, 00:00:10, 0.09 m
Settled deposits, fine, 20% cross-sectional area loss, start

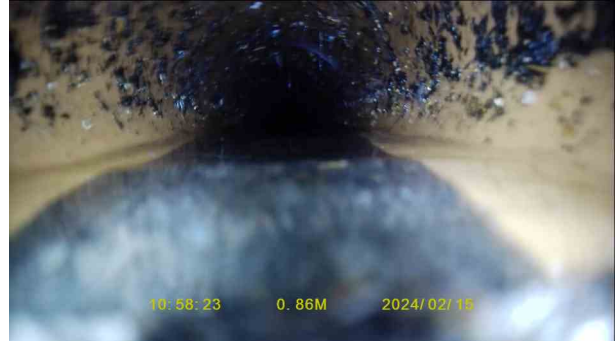
9139b476-f04d-427c-b933-e8b7d94a1fc7.jpg, 00:00:24, 0.86 m
Settled deposits, fine, 20% cross-sectional area loss, start

Comments:
Recommendations: Recommend HPWJ/Investigate possible bellies

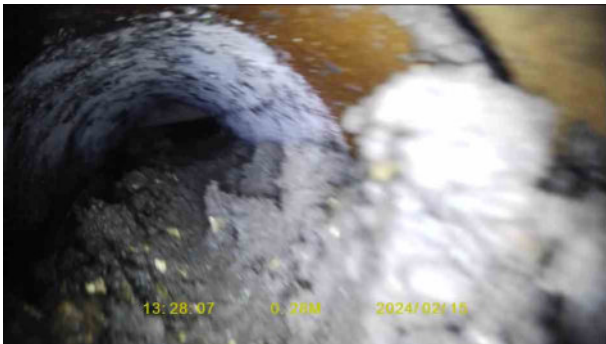
506d008a-a4ca-4920-9f11-68f6314c14b6.jpg, 00:00:21, 0.29 m
 Joint displaced, medium

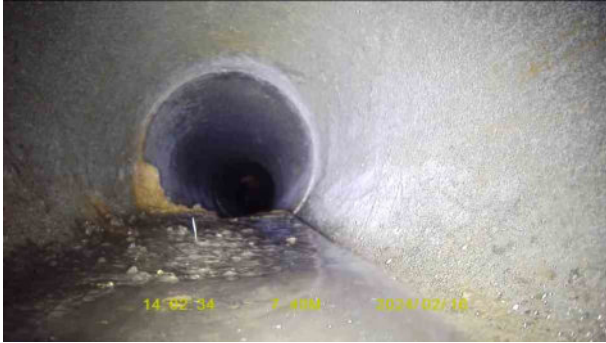
3d1525e2-dcc1-4be8-9519-7761d187d133.jpg, 00:01:04, 7.49 m
Settled deposits, fine, 20% cross-sectional area loss, start

Comments:
Recommendations: Recommend HPWJ/Resurvey

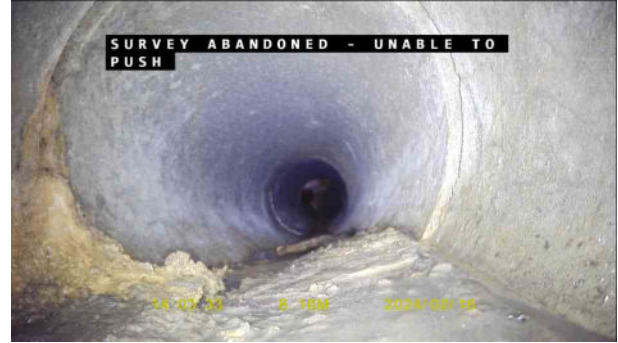
a0e355cb-3626-4767-b647-5fba654fe9cd.jpg, 00:01:59, 8.16 m
Survey abandoned, Camera unable to pass debris

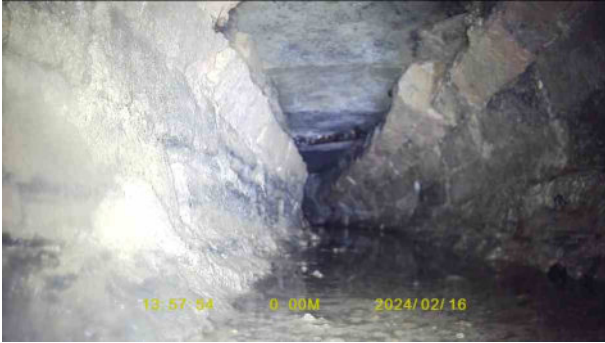
fe6ca740-4cf9-47e2-9136-ef9903ed7e3e.jpg, 00:00:09, 0.01
 m
 Hole in drain or sewer from 10 o'clock to 2 o'clock, start

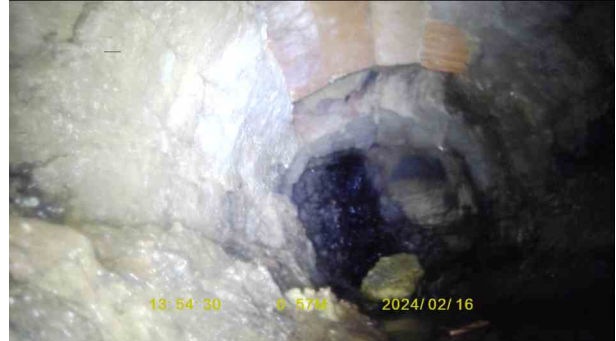
548a9801-4d4e-4b9c-8021-e88d28ad1322.jpg, 00:00:18, 0.57
 m
 Settled deposits, fine, 20% cross-sectional area loss, start

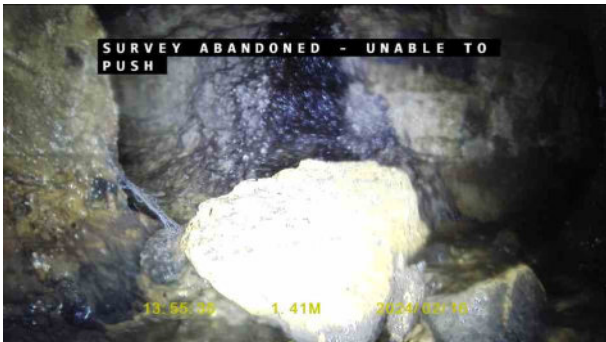
0231ad88-5588-41bb-b1e0-f9aa52024e8c.jpg, 00:01:04, 1.41
 m
 Settled deposits, coarse, 30% cross-sectional area loss

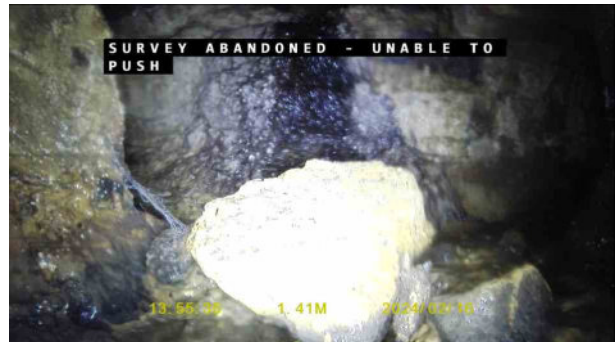
e442f1d8-f945-4c7a-9174-83f5532d3724.jpg, 00:01:04, 1.41
 m
 Survey abandoned, Camera unable to push further

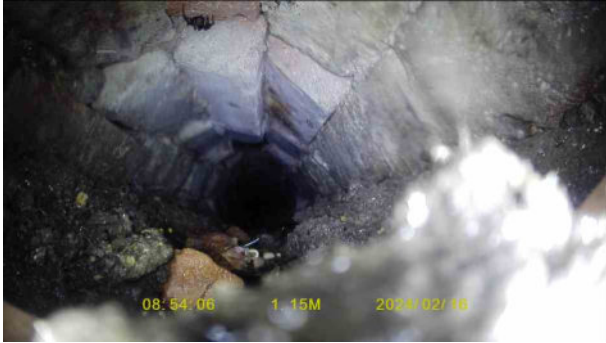
84b0b716-2f8d-4276-9b3f-552035c7ef7e.jpg, 00:00:19, 1.15 m
 Settled deposits, coarse, 20% cross-sectional area loss, start

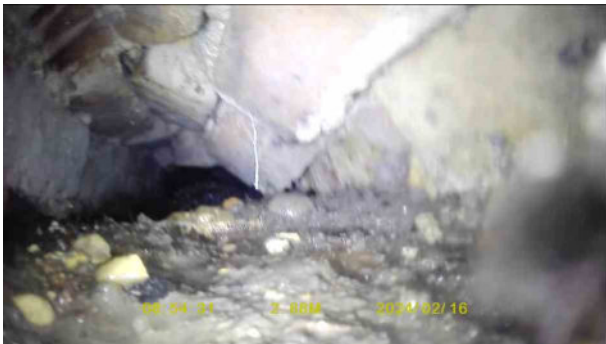
e31a2e52-a6f1-4f0a-b689-c60b44c4b2d1.jpg, 00:00:44, 2.69 m
 Settled deposits, coarse, 40% cross-sectional area loss,

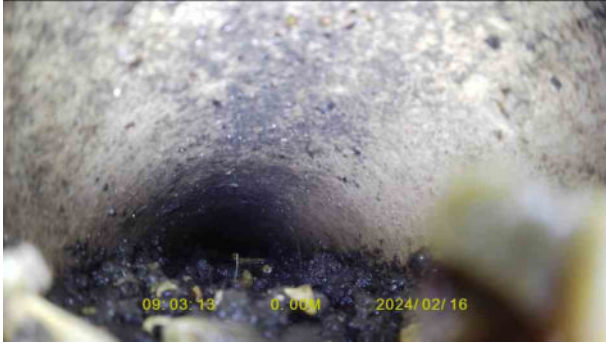
ba401d94-9d63-4eab-954e-07c8f4bf1f0e.jpg, 00:00:10, 0.01
m
Settled deposits, fine, 60% cross-sectional area loss, start

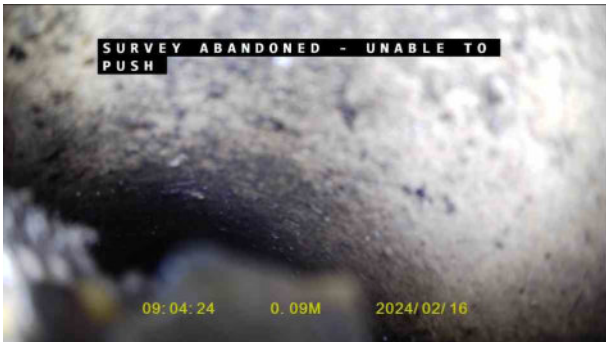
73afe08c-7a2a-4d40-8ce3-037b55db0272.jpg, 00:00:41, 0.19
m
Survey abandoned, Camera unable to pass debris

Comments:
Recommendations: Recommend HPWJ/LSR/Possible excavation

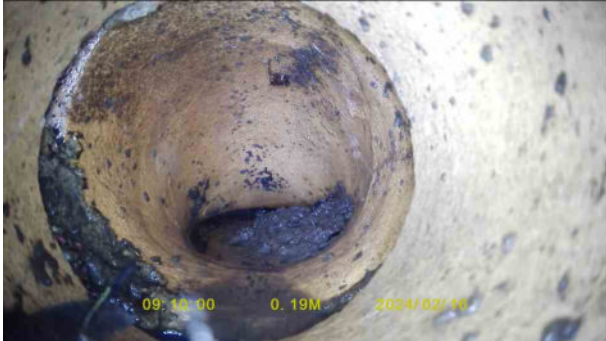
8f0bf5e6-2d78-4aa6-8b3c-8a2c8bccca296.jpg, 00:00:20, 0.19 m
Joint displaced, medium

Comments:
Recommendations: Recommend HPWJ/Resurvey

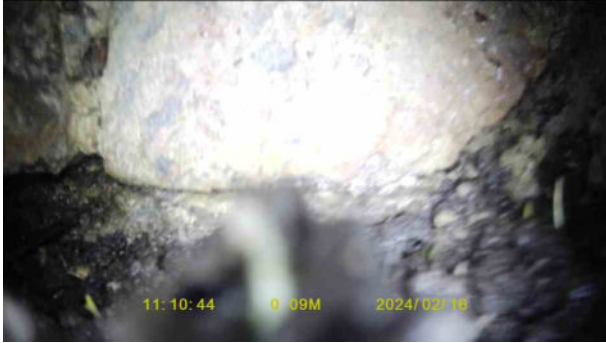
f02a77e9-e2f1-4c09-8064-3d1f006b46ec.jpg, 00:00:26, 0.09
m
Settled deposits, fine, 30% cross-sectional area loss

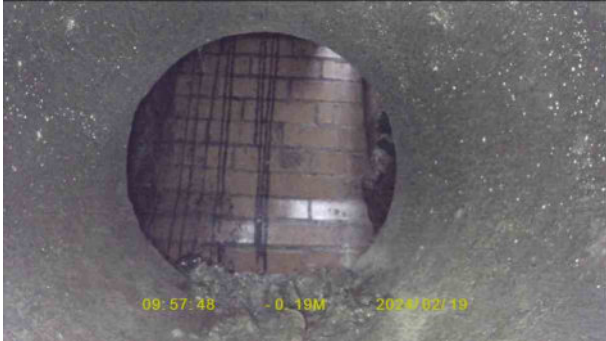
a193fc46-fa23-471b-ba4e-6ba2f7f41d1e.jpg, 00:00:14, 0.19 m
Settled deposits, fine, 15% cross-sectional area loss

Comments:
Recommendations: Recommend HPWJ

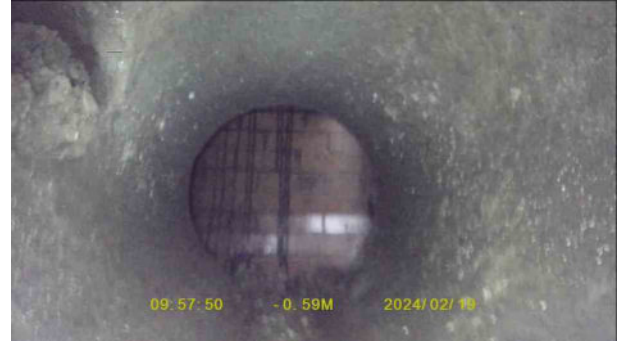
7d35edb2-a981-4e3e-9490-ae5dee594a66.jpg, 00:00:16, 0.59 m
Junction, blocked at 10 o'clock, 150mm dia

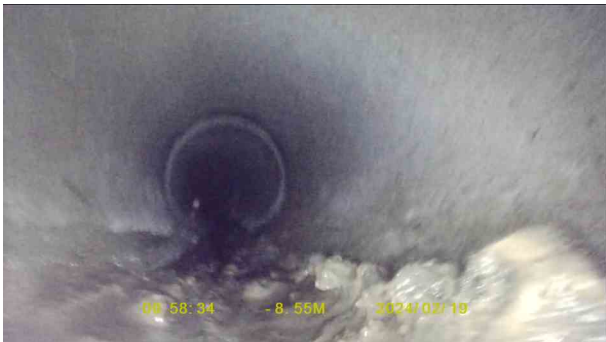
1cdcae68-ac06-4b81-8169-bb18b55dd423.jpg, 00:01:00, 8.55 m
Settled deposits, fine, 20% cross-sectional area loss, start

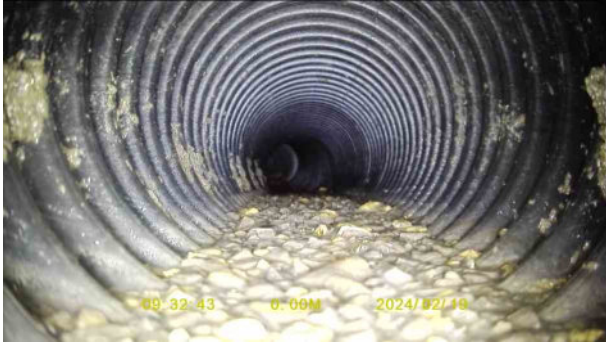
a2dc3797-f61a-4ba7-bb9a-1e1d3a959971.jpg, 00:00:11, 0.01
m
Settled deposits, fine, 20% cross-sectional area loss, start

Comments:
Recommendations: Recommend HPWJ/LSR/Resurvey

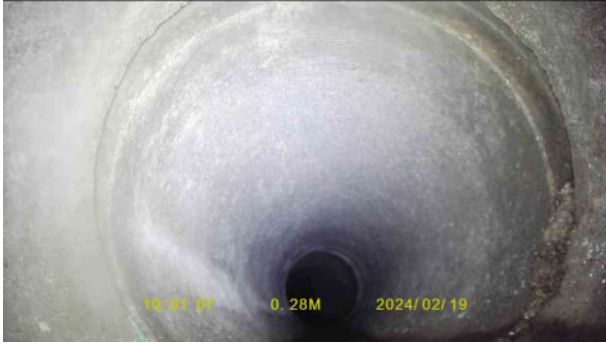
665fee94-ec28-4250-ae46-7b492f39d699.jpg, 00:00:39, 0.28 m
 Joint displaced, medium

Comments:
Recommendations: Recommend HPWJ/Further investigation required

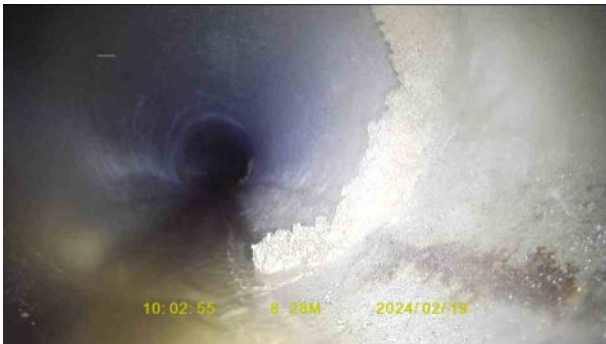
40adf8c3-9121-4654-9bc3-ba28ca5e23bb.jpg, 00:02:26, 8.28 m
 Attached deposits, encrustation at joint from 12 o'clock to 5

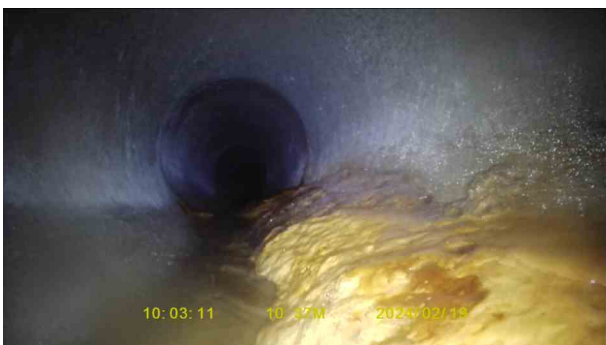
4af5cef2-5db1-4131-aa13-0ebe6428aa7f.jpg, 00:02:43, 10.00 m
 Attached deposits, encrustation from 3 o'clock to 6 o'clock,

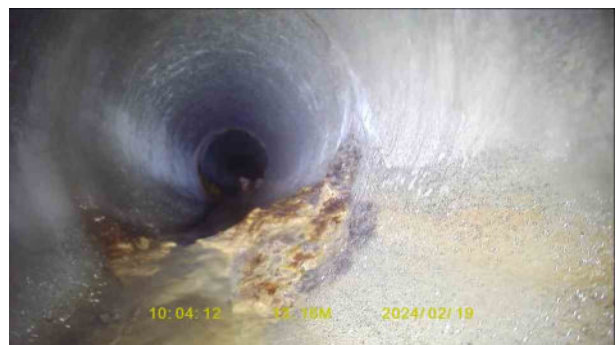
f43cf5ae-dbc6-46d7-a8e2-2457b71d9616.jpg, 00:03:44, 13.16 m
 Attached deposits, encrustation at joint from 3 o'clock to 8

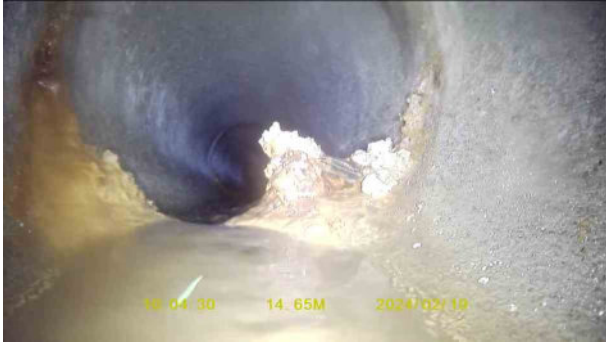
9b1df465-ba5a-4281-bed4-713f3c375753.jpg, 00:04:53, 14.65
m
Attached deposits, encrustation at joint from 3 o'clock to 7

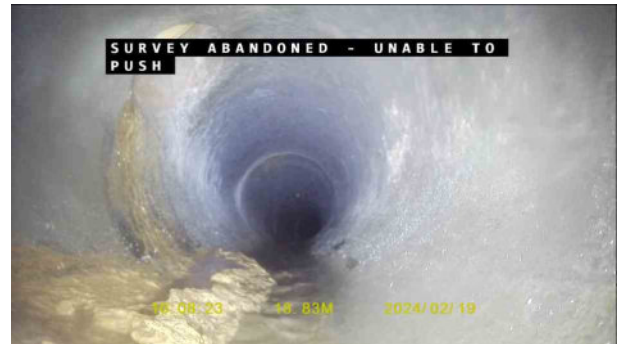
de9b4cd7-f0d2-432a-b32e-be68fcb09be2.jpg, 00:07:00, 18.83
m
Survey abandoned, Camera unable to push further

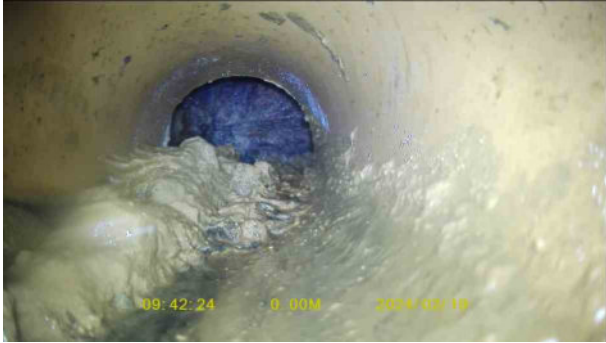
bd3cb6e8-d3e1-4268-9cfc-2e375bdc3a05.jpg, 00:00:11, 0.01
m
Settled deposits, fine, 30% cross-sectional area loss, start

Recommendations: Recommend HPWJ/Further investigation required

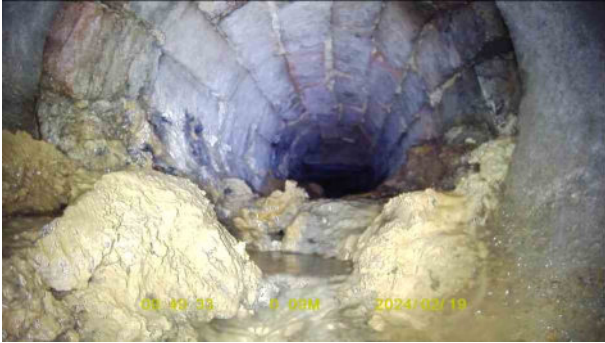
21	MH5X	4	Multiple defects
23	Branch DX	4	Settled deposits, coarse, 40% cross-sectional area loss, start

2749778e-e127-4fee-85d2-547ac9196837.jpg, 00:00:14, 0.09
m
Settled deposits, coarse, 40% cross-sectional area loss, start

Comments:
Recommendations: Recommend HPWJ/Resurvey

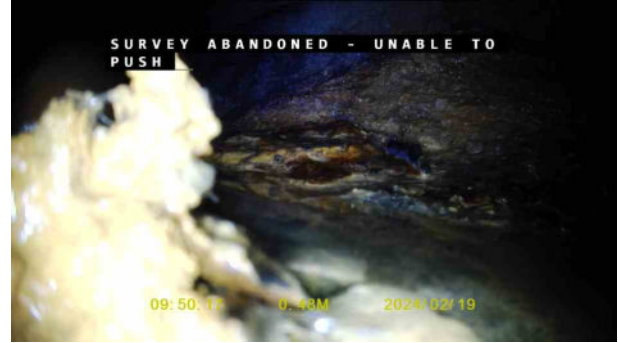
d284b3ad-28d3-422e-9f95-585843d0d021.jpg, 00:00:39, 0.48
m
Survey abandoned, Camera unable to pass debris

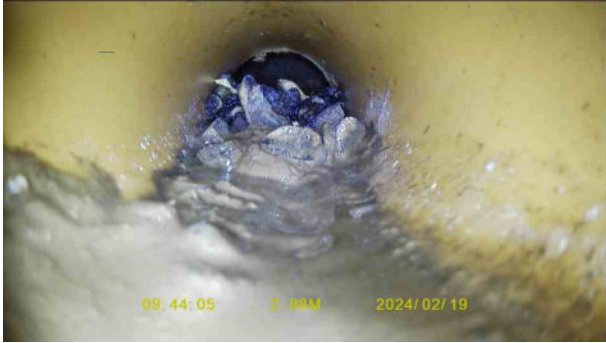
f4d6a904-8467-4fc3-94f9-5545c6fd43c2.jpg, 00:00:36, 2.88 m
Settled deposits, coarse, 70% cross-sectional area loss

Comments:
Recommendations: Recommend Picote/2XLSR's/Investigate possible bellies

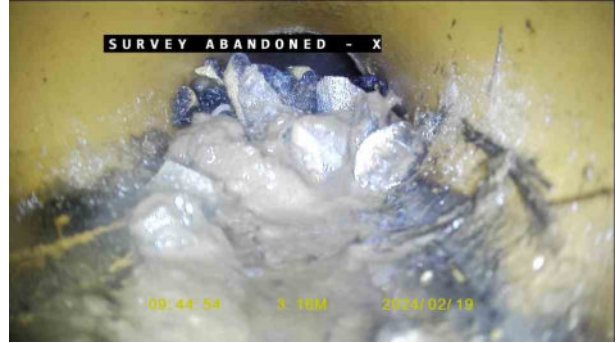
0f000214-7f3c-4309-82b6-efbfe00a12e8.jpg, 00:00:49, 3.16 m
Survey abandoned, Camera unable to pass debris

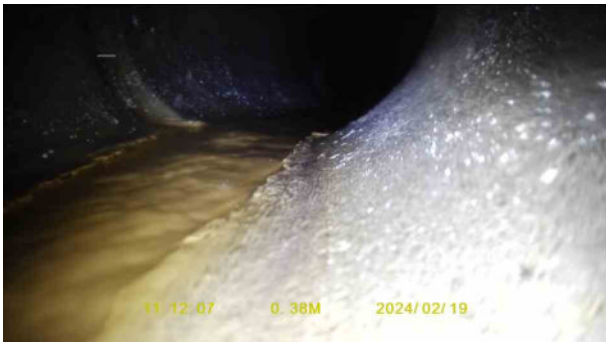
43fb38b2-6110-4a95-8fd4-09d5dc22a300.jpg, 00:00:13, 0.38 m
 Joint displaced, medium

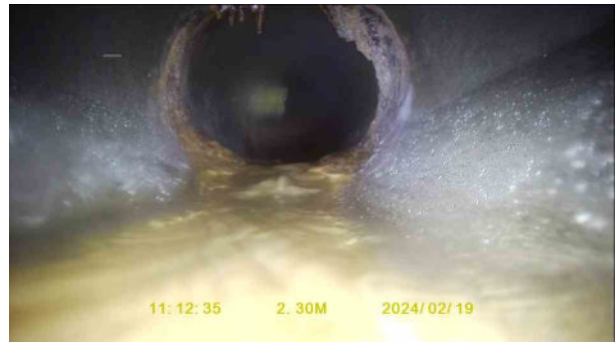
32e4f982-7d43-48bf-8c44-f932a7952cc4.jpg, 00:00:41, 2.30 m
 Attached deposits, encrustation at joint from 12 o'clock to 12 o'clock, 15% cross-sectional area loss

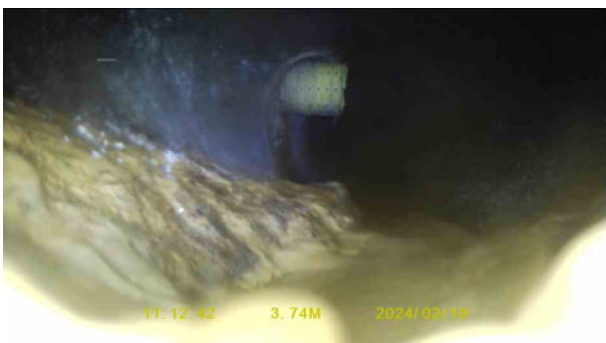
3.74	S02	DEE	Attached deposits, encrustation from 6 o'clock to 9 o'clock, 30% cross-sectional area loss, start	00:00:48	
	3.74	CXI	Connection defective, connecting pipe is intruding at 10 o'clock, 150mm dia, intrusion: 20%	00:00:53		4

e94015b3-ed59-45f9-848b-a6e22f99c630.jpg, 00:00:48, 3.74 m
 Attached deposits, encrustation from 6 o'clock to 9 o'clock,

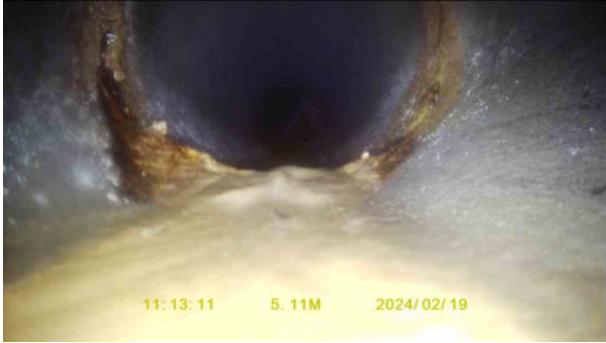
5.11	DEEJ	Attached deposits, encrustation at joint from 12 o'clock to 12 o'clock, 10% cross-sectional area loss	00:01:17		3
	6.80	CXI	Connection defective, connecting pipe is intruding at 1 o'clock, 150mm dia, intrusion: 50%	00:01:37		4

d7657106-80da-4f98-885f-3660c731a98d.jpg, 00:01:17, 5.11 m
 Attached deposits, encrustation at joint from 12 o'clock to 12

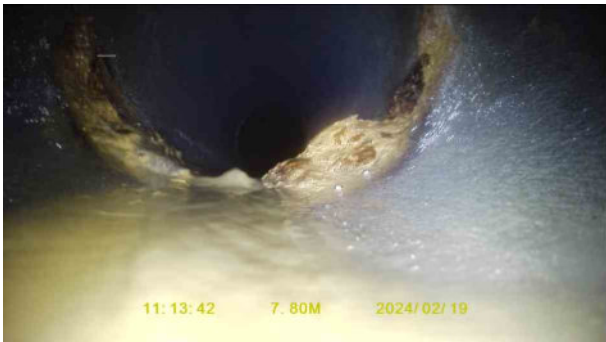
2e4e80b4-c8d3-4cd7-ae00-f610bb2f986c.jpg, 00:01:49, 7.80 m
 Attached deposits, encrustation at joint from 12 o'clock to 12

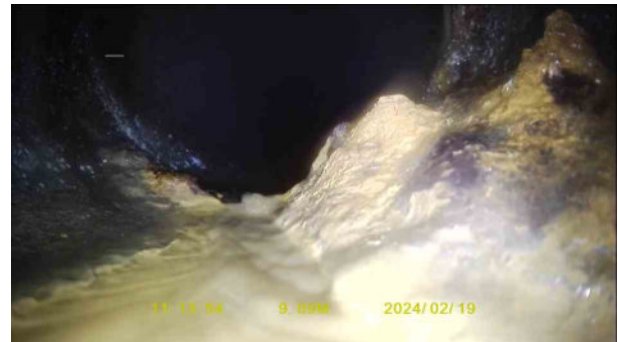
25845356-a660-487b-aea4-d6a70e377d5f.jpg, 00:02:00, 9.09 m
 Attached deposits, encrustation at joint from 4 o'clock to 8

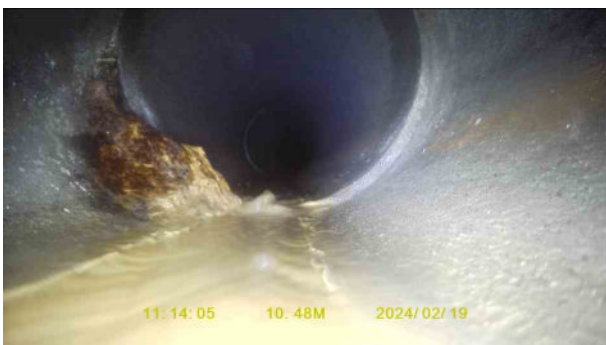
974cc9ab-f178-4677-8b46-f403d2fa1616.jpg, 00:02:11, 10.48 m
 Attached deposits, encrustation at joint from 7 o'clock to 9

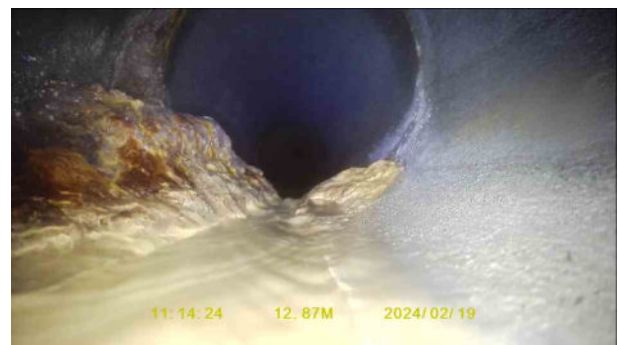
22f12925-390f-4c45-80db-538b3d662c09.jpg, 00:02:31, 12.87 m
 Attached deposits, encrustation at joint from 4 o'clock to 11

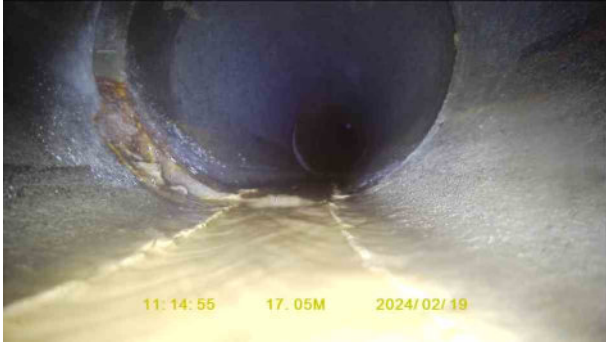
26c73e70-8711-4829-a15d-ed0453455f97.jpg, 00:03:02,
17.05 m
Joint displaced, medium

Comments:
Recommendations: Recommend HPWJ/Resurvey

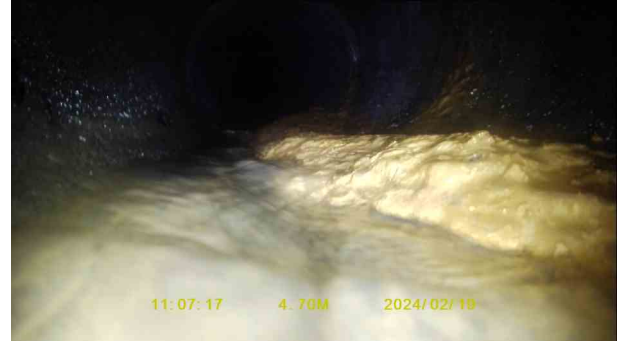
ac3e9b83-6581-407c-a00c-a1c81769c22a.jpg, 00:01:01, 4.70 m
 Attached deposits, encrustation from 3 o'clock to 5 o'clock,

Comments:
Recommendations: Recommend HPWJ/Further investigation required

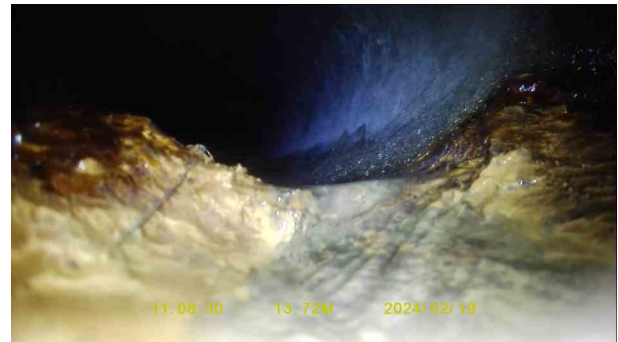
73255367-82f0-46a0-ae9f-d90a988d73ae.jpg, 00:02:14, 13.72 m
 Attached deposits, encrustation from 3 o'clock to 5 o'clock,

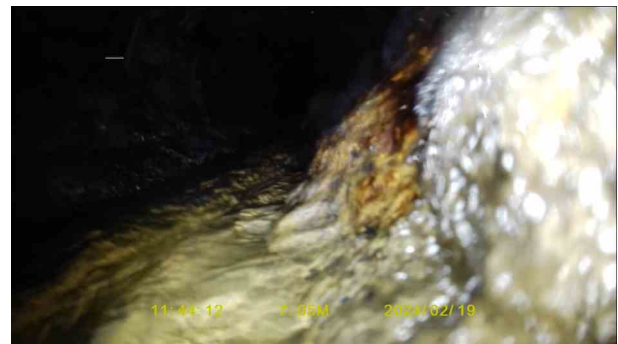
ed780d85-16dd-4e26-8e1c-0f15d63ba222.jpg, 00:02:16, 7.05 m
 Attached deposits, encrustation from 3 o'clock to 7 o'clock,

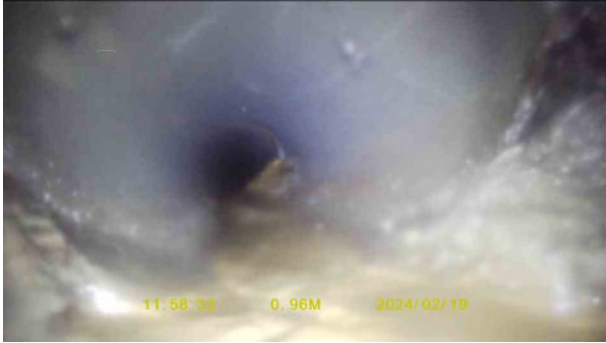
7a5d2fc7-f41c-4101-9c53-568f3bec3a03.jpg, 00:00:14, 0.96 m
 Attached deposits, encrustation at joint from 2 o'clock to 7 o'clock, 20% cross-sectional area loss, start

Comments:
Recommendations: Recommend HPWJ/Root cut/Relining

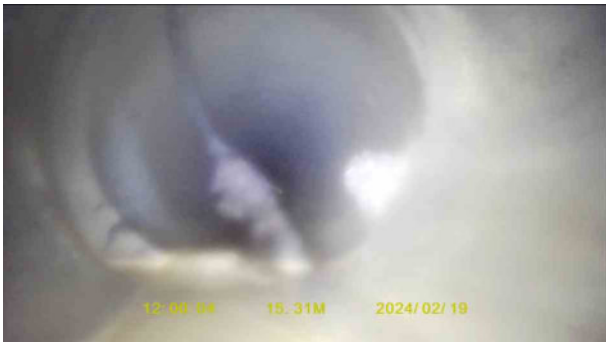
cfd37089-f5b5-48ce-ac96-437949ebdf9e.jpg, 00:01:44, 15.31 m
 Roots, tap at joint

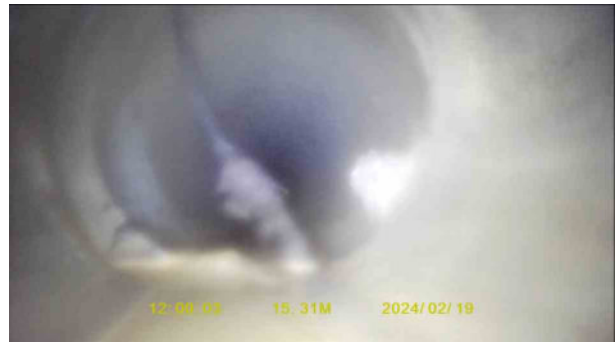
5bc5e9c3-7372-459e-bec9-e99023f639ba.jpg, 00:01:44, 15.51 m
 Joint displaced, large

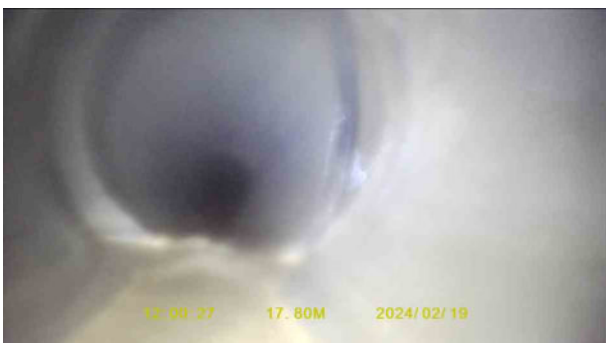
6aaf9e92-ed2e-4459-af05-5463ec3b53e4.jpg, 00:02:08, 17.89 m
 Roots, tap at joint

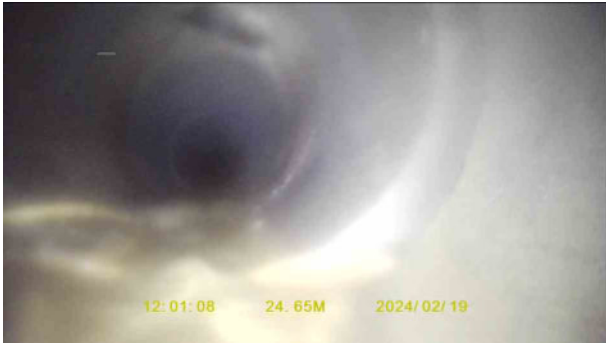
48778814-9246-4c73-ba73-c912ead5b075.jpg, 00:02:49,
24.65 m
Joint displaced, large

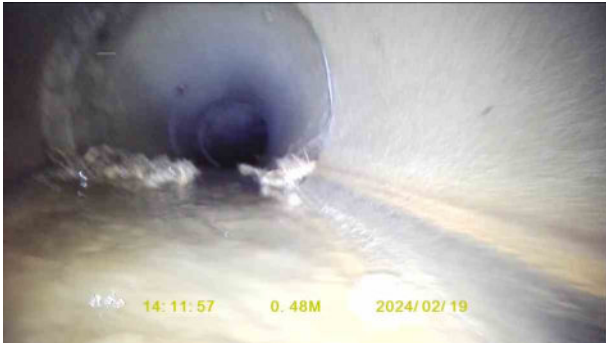
9ef8f719-6f34-4061-9c71-530c3ecf69fb.jpg, 00:00:12, 0.48 m
Joint displaced, large

Comments:
Recommendations: Recommend HPWJ/Relining/Resurvery

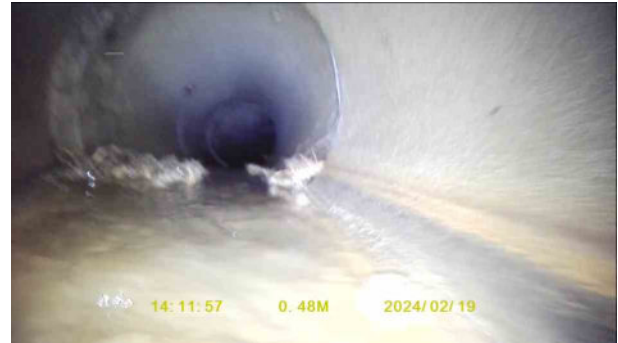
66386fb9-964f-40e2-b990-b4504dcca0eb.jpg, 00:00:12, 0.48 m
Attached deposits, encrustation at joint from 5 o'clock to 8

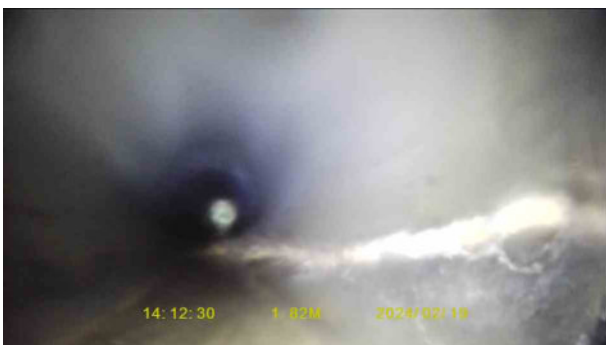
5769829f-e1f7-44b6-84d6-26706f8fbbf2.jpg, 00:00:46, 1.82 m
Roots, tap at joint

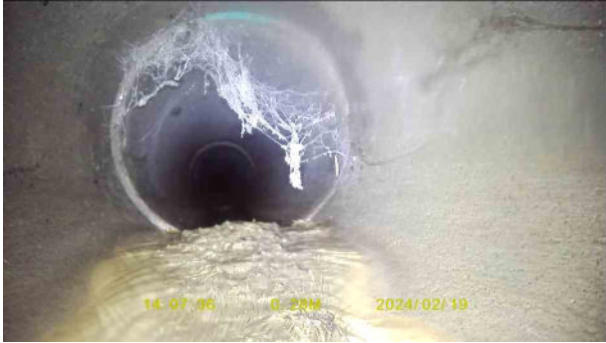
c90c49cb-90c8-4c29-b9e6-25c9edb953bc.jpg, 00:00:15, 0.28 m
 Settled deposits, fine, 20% cross-sectional area loss

Comments:
Recommendations: Recommend HPWJ

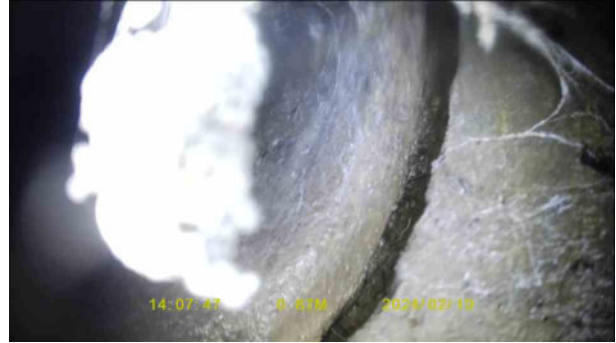
ef996390-ddfa-4960-9671-61ea9d940e87.jpg, 00:00:24, 0.67 m
 Joint displaced, medium

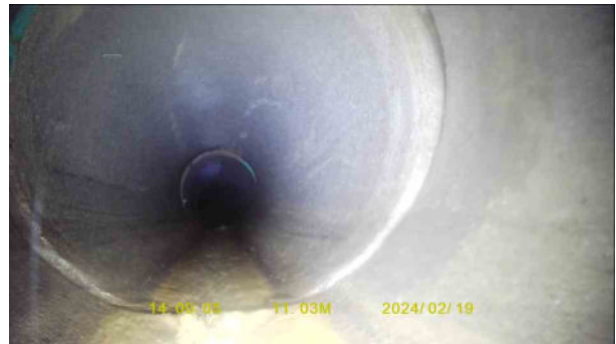
c0b29321-b805-4a0e-ad8a-f4155bced4b7.jpg, 00:01:41, 11.03 m
 Joint displaced, medium

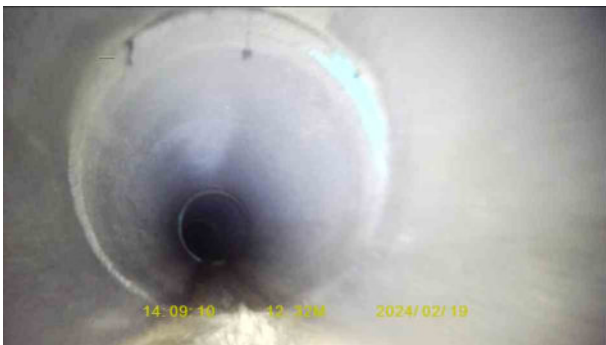
e3ef380b-964e-4a72-a3f0-f538712dbf1e.jpg, 00:01:47, 12.32 m
 Joint displaced, medium

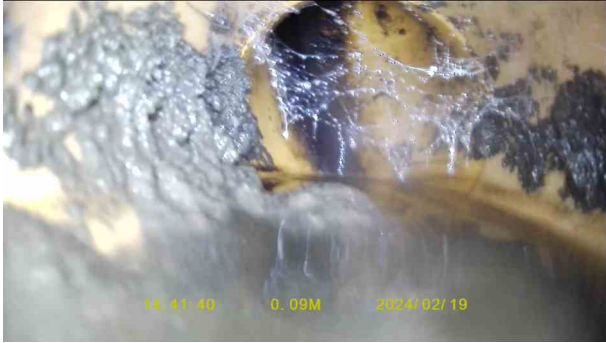
f07e7265-1a78-4885-83d7-e3071f993674.jpg, 00:00:10, 0.09 m
Settled deposits, fine, 15% cross-sectional area loss

Comments:
Recommendations: Recommend LSR/Resurvey

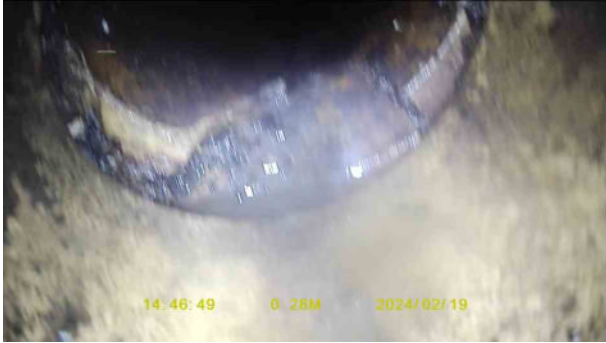
19414010-d444-4786-ba73-fbb897affb06.jpg, 00:00:18, 0.28
m
Joint displaced, large

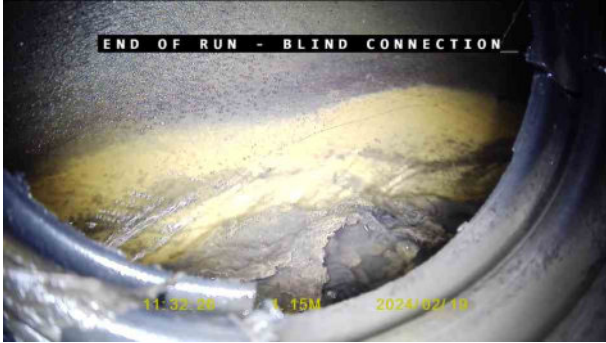
1dea0eed-7dfc-4c31-91b7-6f84a9db01eb.jpg, 00:00:30, 1.15
m
Finish node, manhole, reference: Downstream, Blind

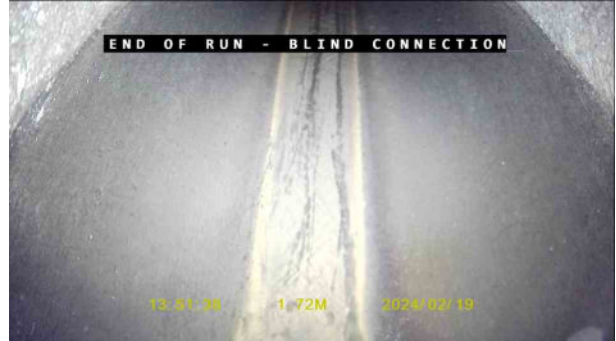
d49db12e-7dcc-40d2-ac65-b00e8a8d0aed.jpg, 00:00:25, 1.72
m
Finish node, manhole, reference: Downstream, Blind junction

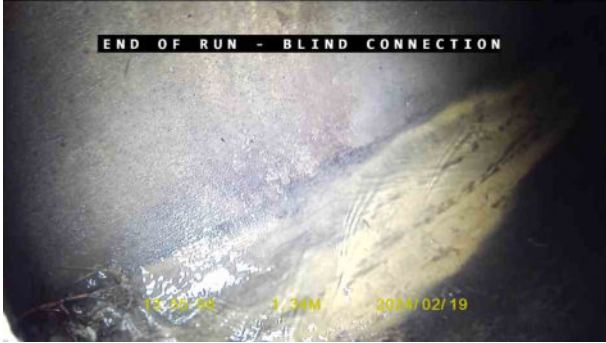
308ae893-16fb-4795-88ba-b6aba68d58e3.jpg, 00:00:30, 1.34
m
Finish node, manhole, reference: Downstream, Blind

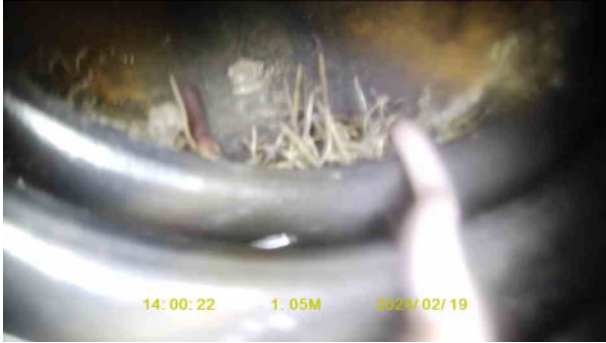
75738fd2-057a-42e3-8af6-84ea17b29526.jpg, 00:00:21, 1.05
m
Roots, fine at joint

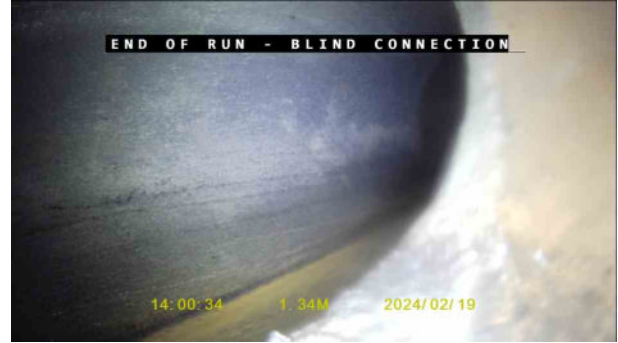
baeccc9c-6492-4e2f-8d1a-066f5c7e8907.jpg, 00:00:29, 1.34
m
Finish node, manhole, reference: Downstream, Blind junction

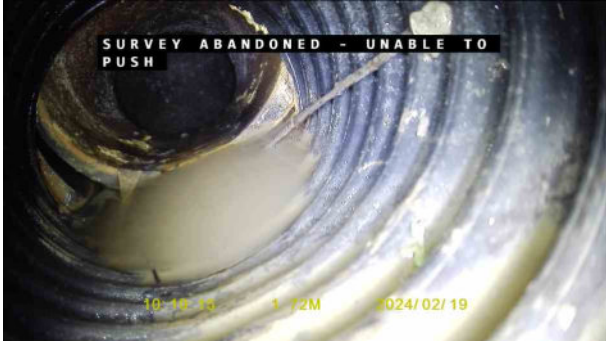
46a9c229-a384-4b90-8825-e392ff907ccf.jpg, 00:00:21, 1.72 m
Pipe material changes to vitrified clay at this point

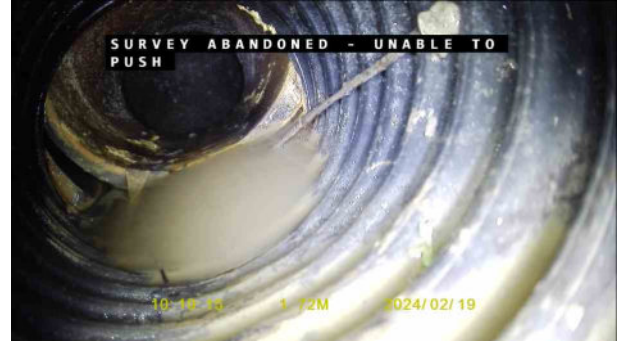
46a9c229-a384-4b90-8825-e392ff907ccf.jpg, 00:01:00, 1.72 m
Joint displaced, large

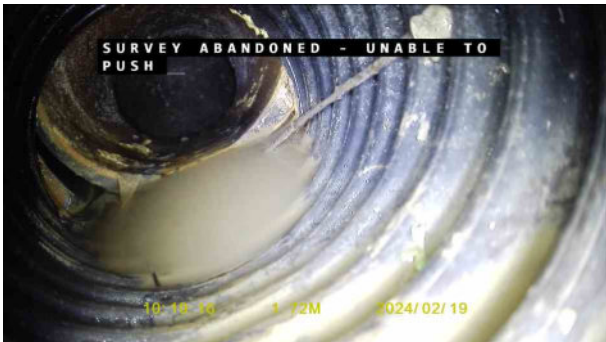
a12f9621-363e-4716-a179-4259851e7146.jpg, 00:01:00, 1.72 m
Open joint, large

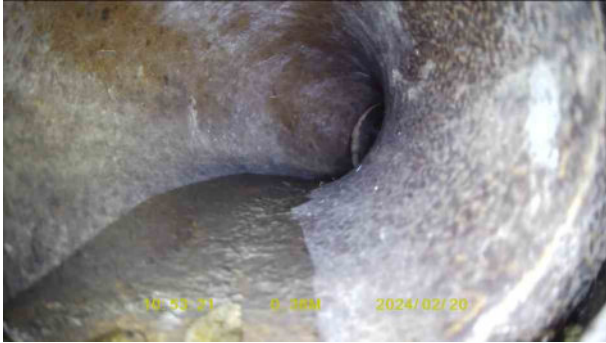
94c4cd49-8989-4d64-ba70-694f6b00c783.jpg, 00:00:15, 0.38 m
 Joint displaced, medium

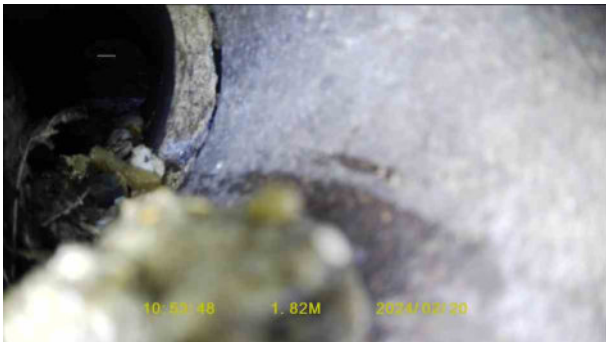
d2831d65-8e38-403f-8a5f-c8cc4d858d74.jpg, 00:00:42, 1.82 m
 Joint displaced, medium

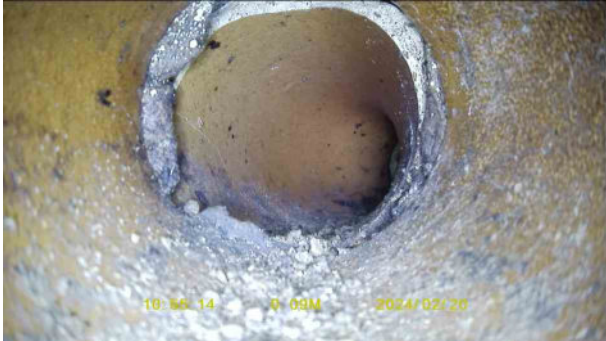
c9179bda-0f0a-4f25-a2db-2d0fef5be277.jpg, 00:00:13, 0.09 m
Attached deposits, encrustation at joint from 7 o'clock to 11 o'clock, 15% cross-sectional area loss

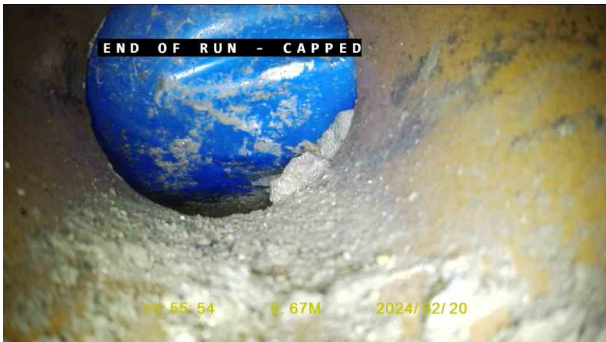
aea4d164-a499-4ccc-8d45-8b070c3022a0.jpg, 00:00:36, 0.67 m
Finish node, manhole, reference: Branch B, Capped

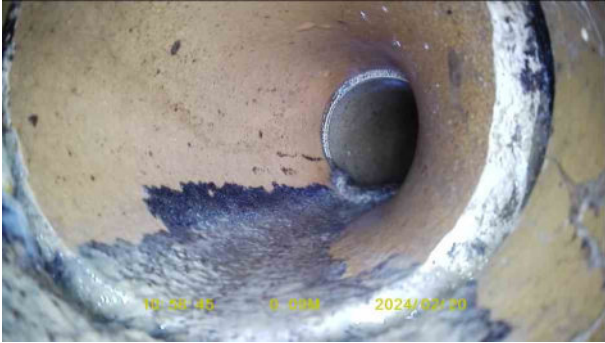
7076801a-6240-41d9-a416-603246e932b2.jpg, 00:00:10, 0.09 m
 Joint displaced, medium

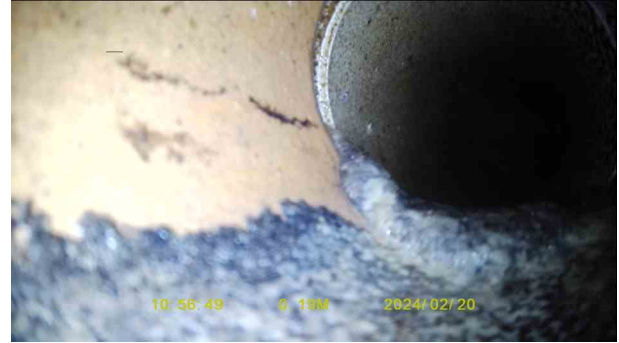
4bff65e0-e500-4552-8682-5a6f3d023944.jpg, 00:00:14, 0.19 m
 Attached deposits, encrustation at joint from 4 o'clock to 8

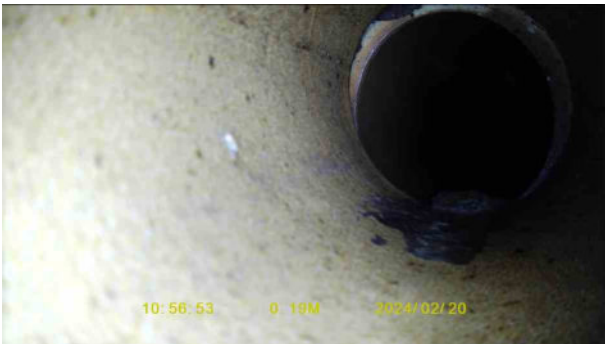
205e2d51-6137-455f-aa65-6f6f489f32b0.jpg, 00:00:18, 0.28 m
 Joint displaced, medium

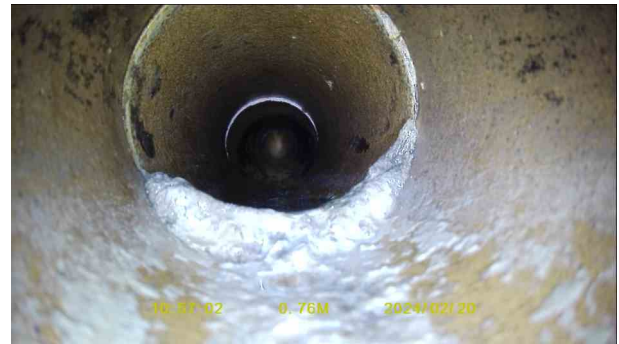
c49eab87-a58d-4fd3-9800-c705466255a4.jpg, 00:00:26, 0.76 m
 Attached deposits, encrustation at joint from 4 o'clock to 7

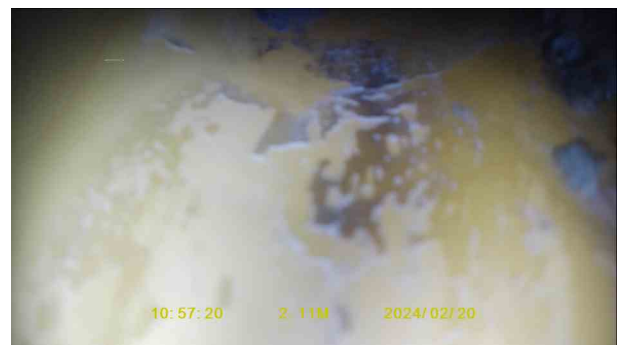
c6a34fc5-3739-4efc-8d4c-76213357c26a.jpg, 00:00:45, 2.11 m
 Finish node, manhole, reference: Branch C, Rest bend

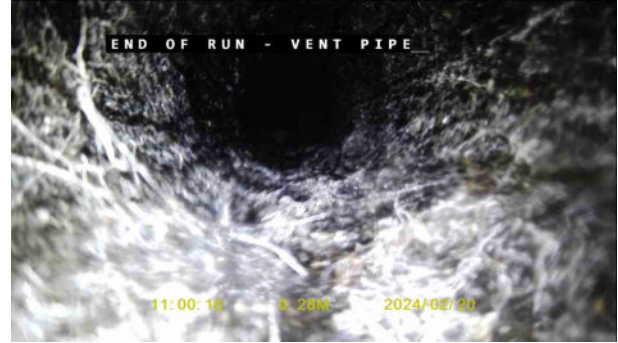
e4e9475f-69f9-45d8-8f38-04630cbdbdc6.jpg, 00:00:19, 0.28
m
Finish node, manhole, reference: Branch D, Vent pipe

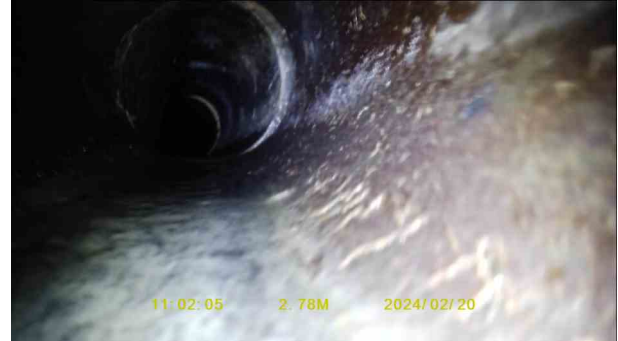
f655621c-2490-4b57-b90c-2478f909dfd8.jpg, 00:00:39, 2.78 m
 Joint displaced, medium

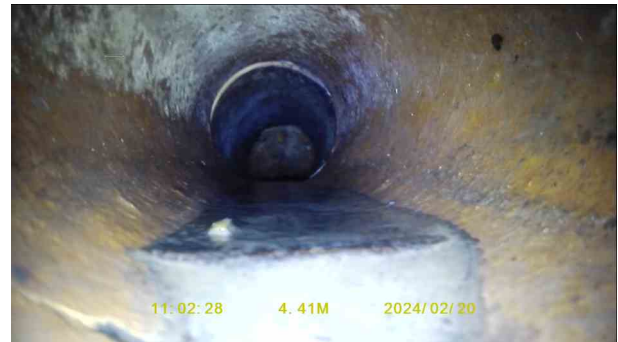
46a8db89-2395-4346-b1ab-494535b5cd78.jpg, 00:01:02, 4.41 m
 Attached deposits, encrustation from 5 o'clock to 7 o'clock,

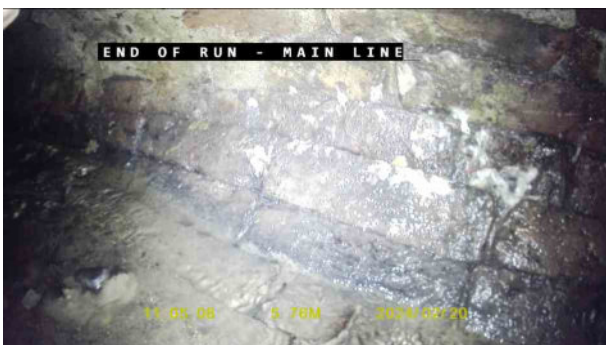
e878b872-6e34-410d-afb7-adb481f5e729.jpg, 00:01:32, 5.76 m
 Finish node, manhole, reference: Main line

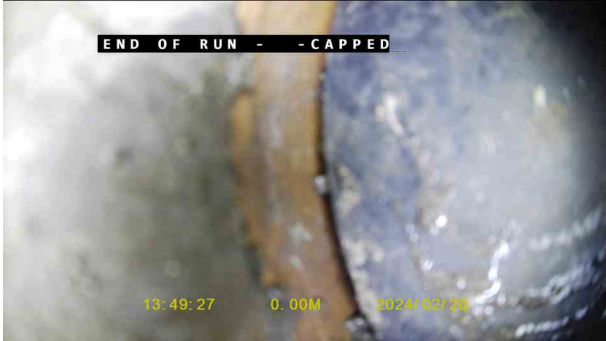
fc91452-5e55-4616-9fb5-a1479d9cbaa1.jpg, 00:00:39, 0.01
m
Finish node, manhole, reference: Capped

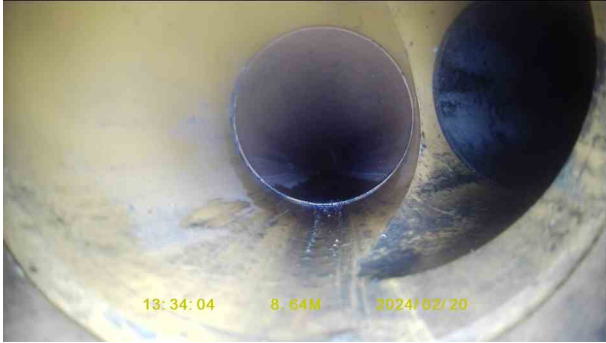
1cff4279-29bc-41d9-a284-c0b1df4fa83c.jpg, 00:01:28, 8.64 m
 Junction at 3 o'clock, 100mm dia

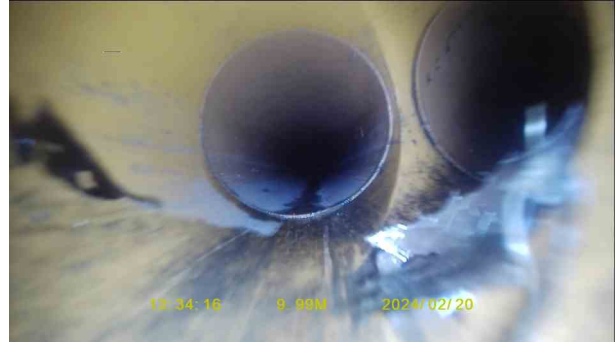
f28f0d2e-5a81-457a-95b7-6385d09598fa.jpg, 00:01:41, 9.99 m
 Junction at 3 o'clock, 100mm dia

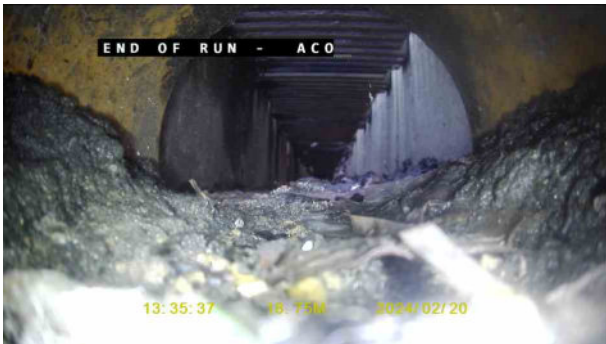
863abe23-34c2-4e95-8c46-44d1baf7e004.jpg, 00:02:46, 18.75 m
 Settled deposits, fine, 45% cross-sectional area loss, Aco

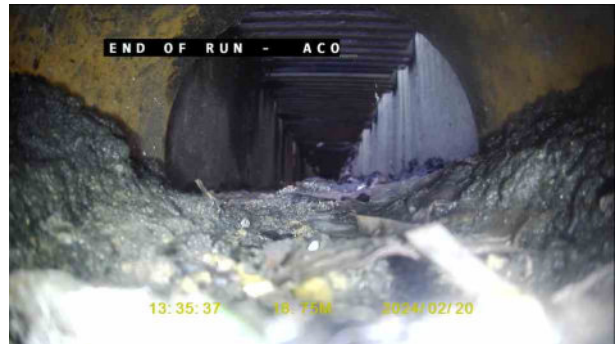
22bee4a0-d2d3-4263-8716-67b4931eaa3c.jpg, 00:02:46, 18.75 m
 Finish node, manhole, reference: Branch B, Aco
