**Vale of Health Public Conveniences,
Hampstead Heath, London**

**Preliminary Diagnostic Non - Destructive
Environmental Timber Decay Survey**

Site Visit: 11th November 2024

Job No: HL/BC/3247/001
Reference: JS/pk
Date: November 2024

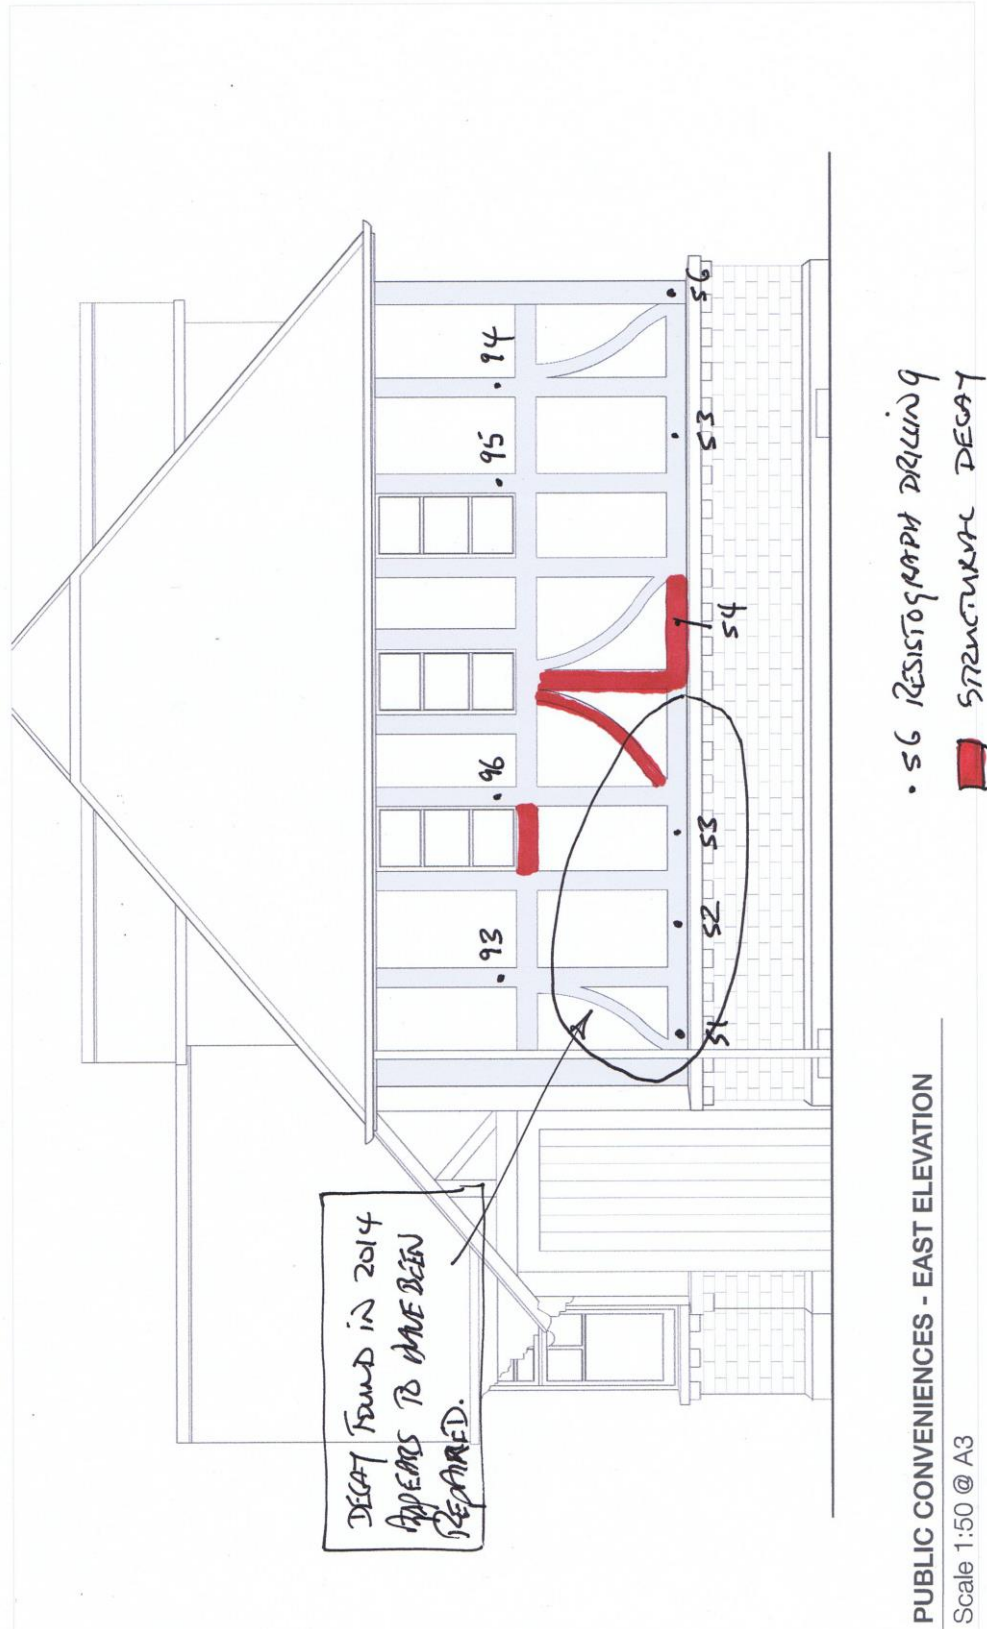
The timber frame was found to be structurally decayed by wet rot at the west side of the elevation, see plans for location. The type of decay was not identified as no fruiting bodies were found. The rafter ends above the west window were not accessible but could be decayed in the location shown on the plans. The west corner post was decayed at the base up to 150mm from the base, see plans and Resistograph drilling 103.

Allow for renewal of the decayed sections of the timber frame and west window, see plans for location. Expose the rafter ends above the decayed west window for inspection. Allow for partnering the rafter ends if decayed.

Allow for a splice repair to the base of the west corner post to 150mm from the base.

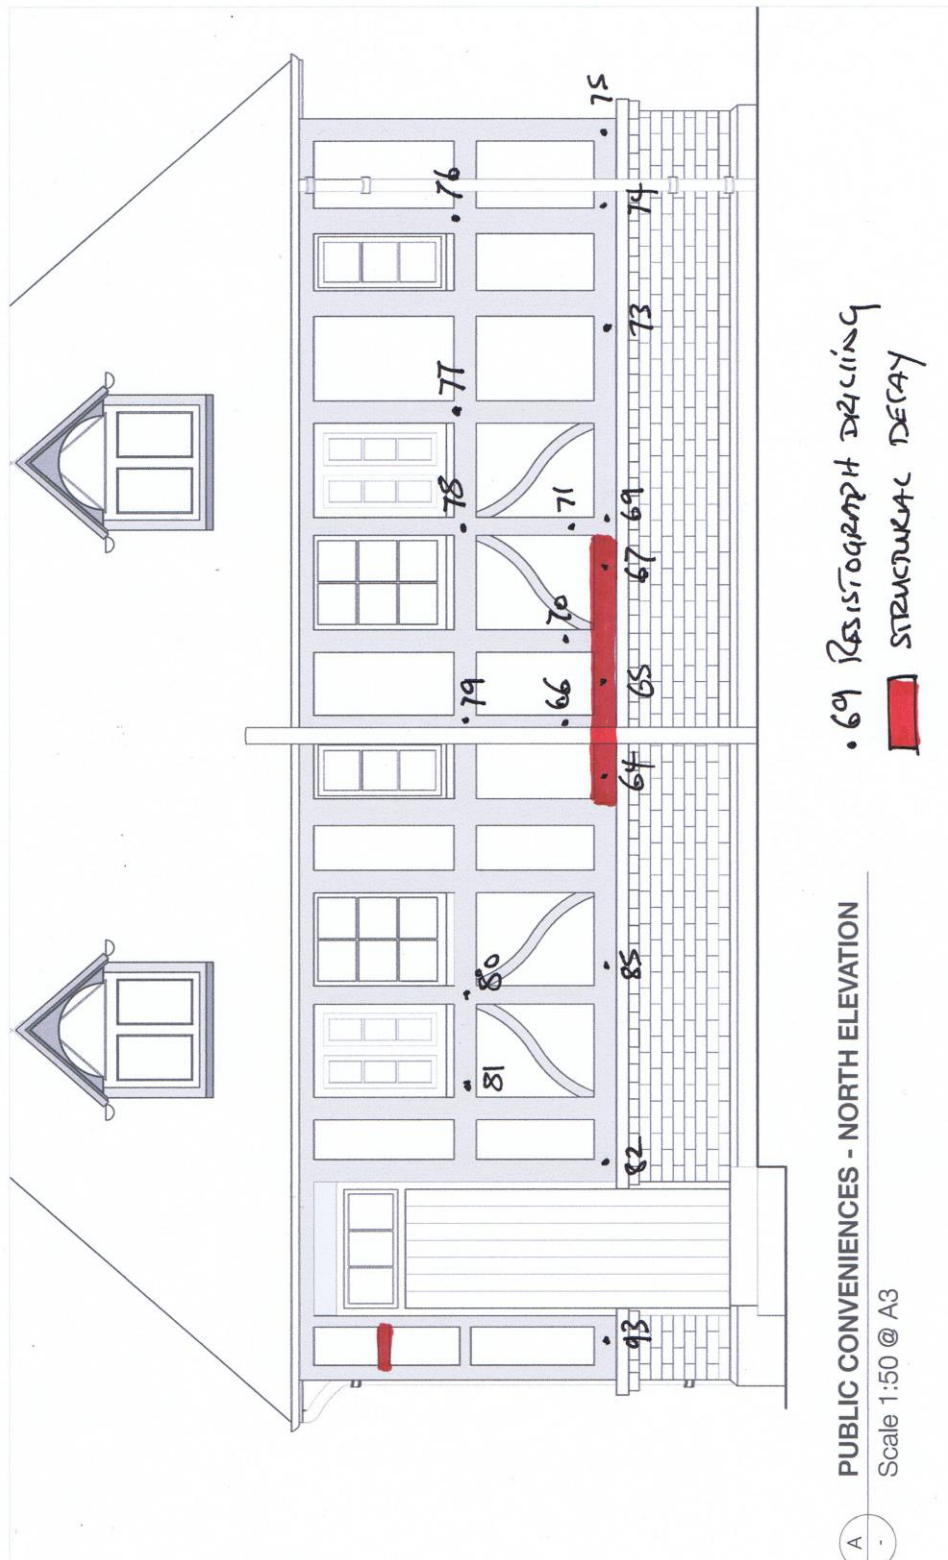
The timber frame was found to be structurally decayed by wet rot below the south and central window, see plans for location. The type of decay was not identified as no fruiting bodies were found. The report of 2014 identified decay to the frame at the south end of the elevation. These timbers were found to be sound which suggests that repairs must have been carried out.

Allow for renewal of the decayed sections of the timber frame below the south and central window, see plans for location.

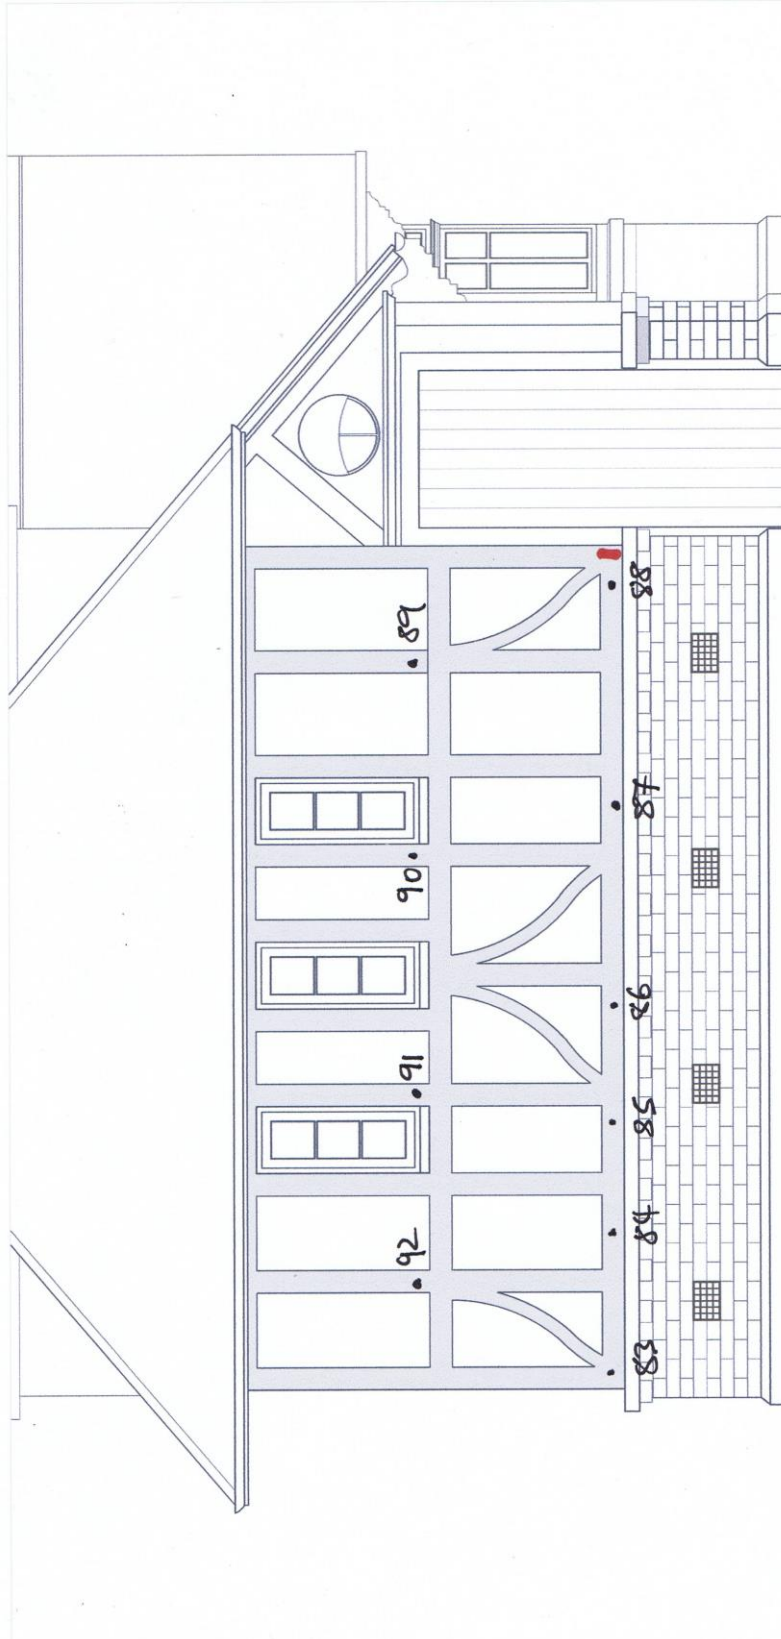
VENIENCES - WEST ELEVATION

The timber frame was found to be sound. The south corner post was decayed at the base, see south elevation.

The south corner post was decayed at the base, see south elevation.
