Memorandum

To	Chris Ray, YOO Capital
Copy	Andy Ball, Ian Crossley, Gary Earl
From	Thomas Holt
Office	London
Date	14 January 2025
File/Ref	CW000014 Saville Theatre
Subject	Initial Intrusive Investigations – Observations and Recommendations

1.0 - THE SAVILLE THEATRE 42638 - OUTLINE STEEL FRAME CORROSION INVESTIGATIONS METHODOLOGY

Project: THE SAVILLE THEATRE
135-149 SHAFTESBURY AVE, LONDON WC2H 8AH

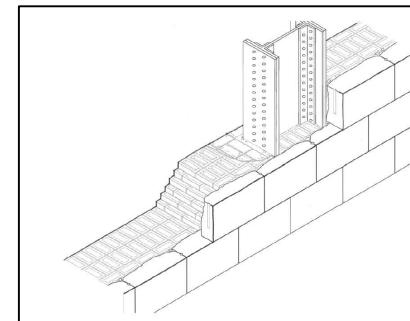
STEP 1 INVESTIGATIONS: WE ARE PROPOSING TO EXPOSE STRUCTURAL STEELS FOR INVESTIGATION VIA THE REMOVAL OF INDIVIDUAL BRICK UNITS (ACROSS APPROXIMATE 300X300MM AREAS) TO THE NORTH AND SOUTH OF THE EAST ELEVATION FACING SHAFTESBURY AVENUE. PLEASE REFER TO FIGURE 3 WHICH SHOWS AN EXAMPLE IMAGE OF A PROPOSED LOCATION. THE BRICKWORK IN THE PROPOSED LOCATIONS COMPRISES SIMPLE BACKING BRICK UNITS, LOCATED BEHIND A FORMER RENDERED BAND COURSE. THERE IS EXISTING FAILURE TO THE RENDER IN THIS LOCATIONS EXPOSING THE CORE BRICKWORK.

FIG.2 / FIG.3 - STREET-VIEW PHOTOGRAPH OF SUBJECT ELEVATION / CLOSE-UP OF PROPOSED INVESTIGATION AREA A. NOTE: SWL RED ANNOTATION SHOWS PROPOSED LOCATIONS FOR INITIAL INVESTIGATIONS.
