**Internal Paint Assessment**  
**at**  
**25 Neal Street, London, WC2H 9PR**

Report produced by: Richard Williams MRICS  
FOR AND BEHALF OF : Heritage Consulting Chartered Surveyors

**Report Date – REV C 22<sup>nd</sup> January 2025**

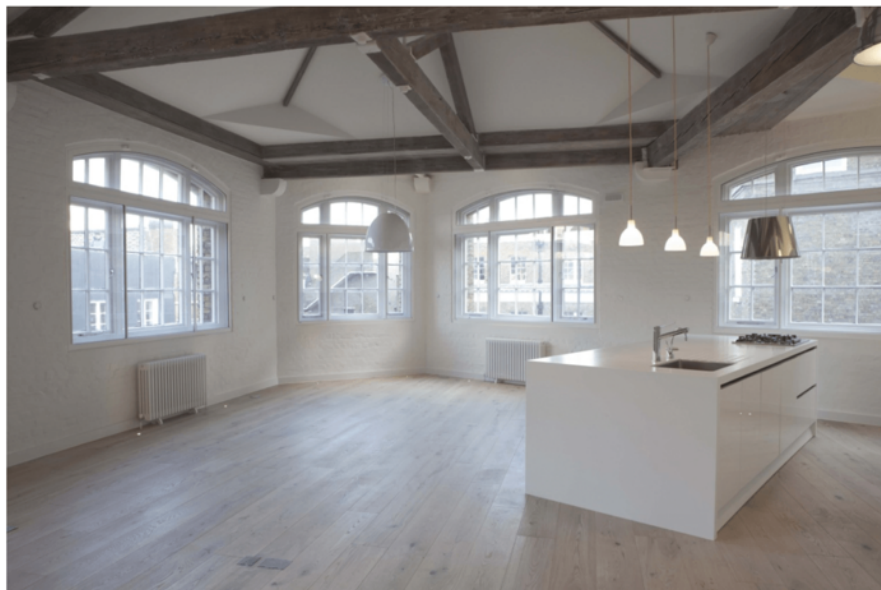
### 25 Neal Street

*Photo extract from circa 2010 works to refurbish 25A self-contained unit.*

The cellar area to No. 25 retains a painted finish. The 1st and 2nd floor external walls behind where shop fitting from the previous tenant fit out have been removed also retains a painted finish.
