30 September 2020
20-016-01-AR02

Symal House, 423 Edgware Road

BOUNDARY ASSESSMENT 10 ADAMSON ROAD, LONDON NW3 3HR

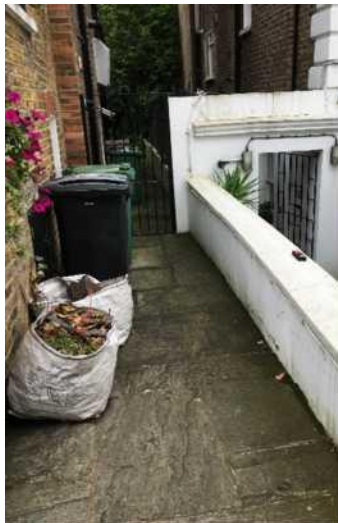
Fig. 11 Wall between 10 and 12 - viewed from the pavement on the No.12 side facing No. 58 towards the rear with 10 to the right.

The ground level on each side varies significantly with the wall retaining the land of No.12. We could not get any measurements on the No. 12 side except for adjacent to the front where ground level was approximately 1.2m lower on the No.10 side than that on the No.12 side. The wall is therefore a retaining wall holding back the higher ground at No.12 The ground level to the No.10 side varies sloping down towards the rear.

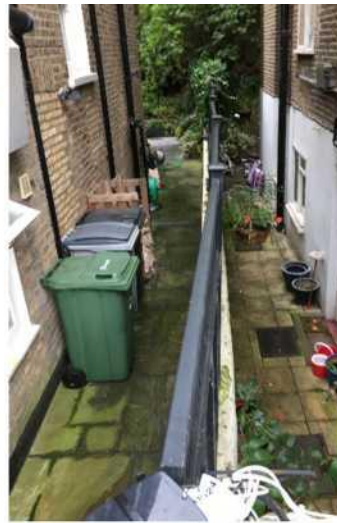
Fig.12 Wall between 10 and 12 - viewed from above the wall facing No.58 towards the rear with No. 12 to the left and No. 10 to the right.

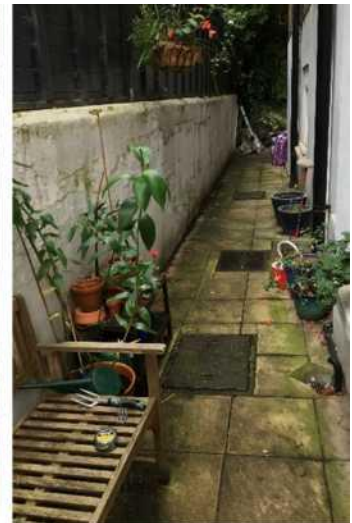
Fig. 13 Wall between 10 and 12 - viewed from the No. 10 side facing 58 towards the rear.
