Tree Structural Integrity Report

15 Akenside Rd,
London
NW3 5BT

GD.240769.R

Submitted on 7th November 2024

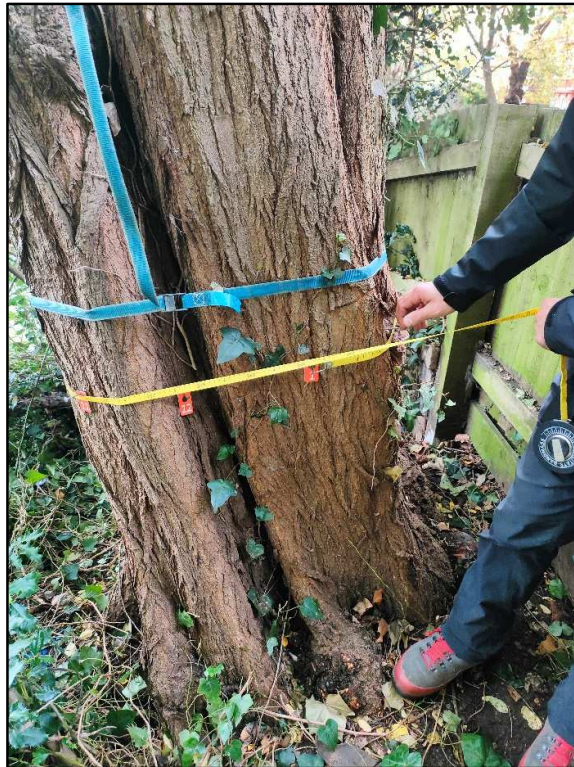
Figure 5: Image of PiCUS Test Plane conducted on Robinia

Following the VTA, one test was conducted on the main stem of the Robinia

When conducting the assessment, after establishing the 80 centimetre height of the test plane, Sensor 1 was positioned on the northern side of the main stem, with the subsequent 11 sensors then spaced at regular intervals at the same height to create a level test plane.

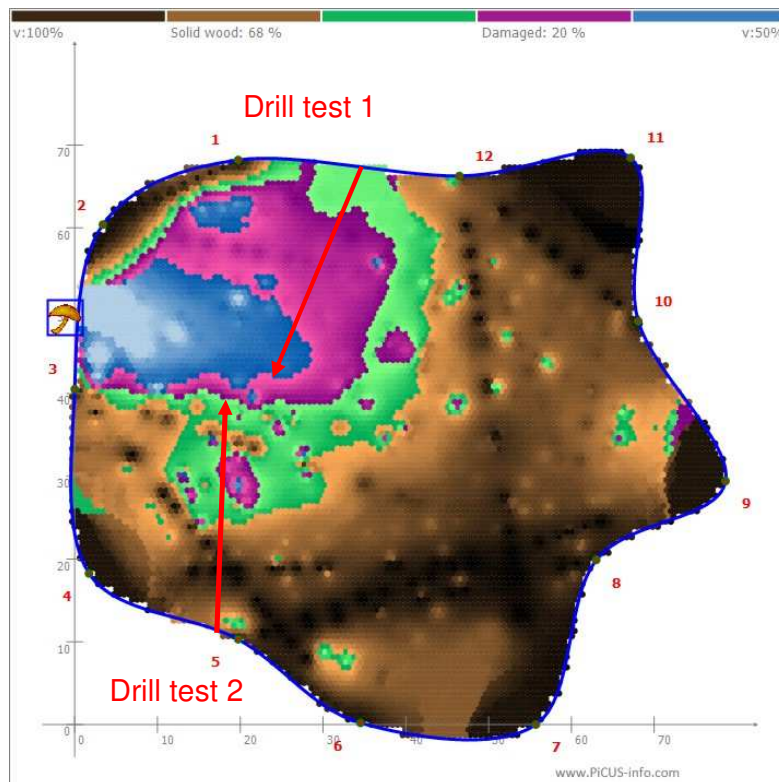
Figure 7: Image of IML-RESI Powerdrill® Test Locations on Robinia

A total of 2 tests were conducted of the Robinia at the 80cm test plane. The test positions were chosen based on the sonic tomography results in order to back up their findings. Test 1 was taken between sensors 1-12 and Test 2 was taken at sensor 5 as shown in figure 7 below.

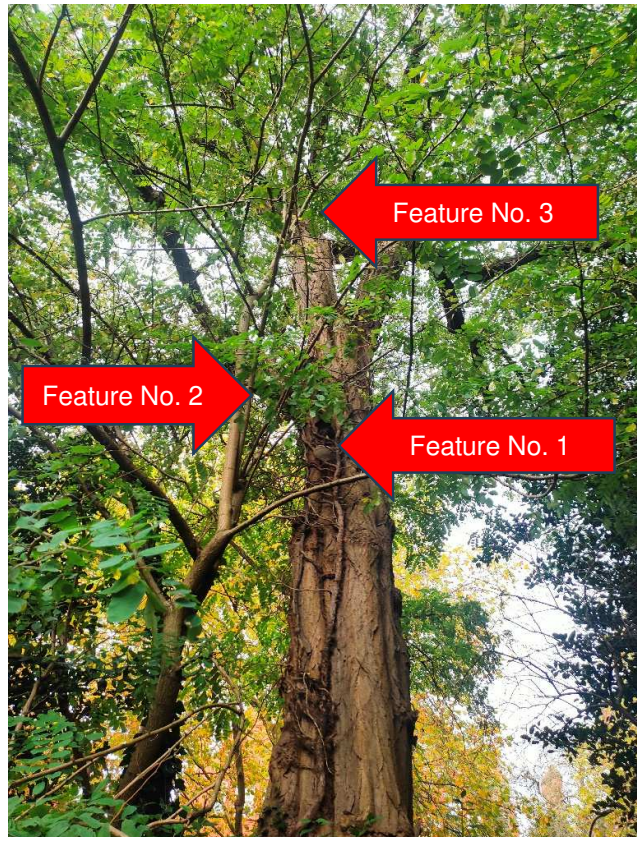
Figure 8 : Picture of The Robinia with marked location of features

Feature No. 2 – Union between the main stem and lower western lateral scaffold limb at 6.0m

Feature No. 3 – Suspected decay at 7.5m of southwestern co-dominant leader due to poor resonance

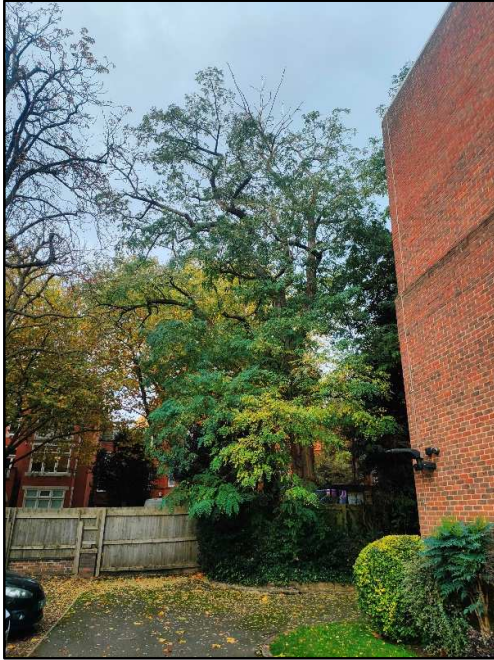
Figure 13: Image showing Robinia in landscape viewed from Carpark
