Heritage Statement

10 Chalcot Crescent, London NW1 8YD

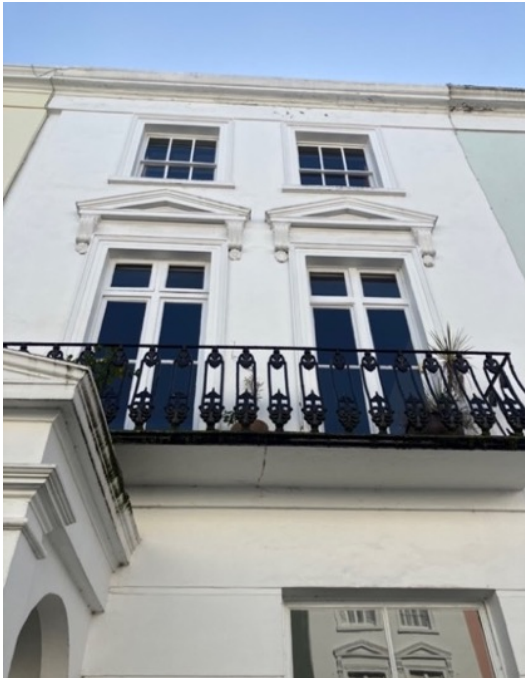
Front Façade

At first floor are paired casement French windows with fanlights over and pedimented surrounds (W1.1 & W1.2). These have one fixed and one opening door. W1.1 has top hung fanlights, whereas W1.2 has fixed fan lights. The fanlights are in good condition but the casement doors have significant water damage and rot along the panels, lower frame and cills. The casement doors open onto a cantilevered balcony with cast iron decorative balustrade. The underside of the balcony has an exposed joint and the surface has extensive mould and water damage.

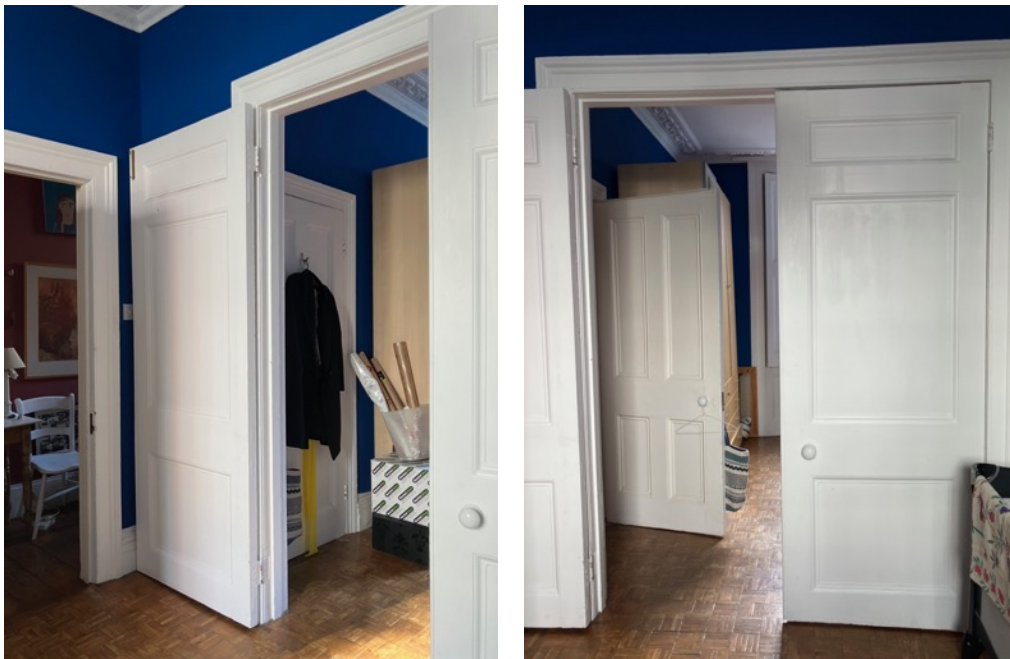
Double doors (DG4) fold back flat and DG3 seen beyond into rear reception

- 4.2.1 It is proposed to relocate the kitchen and dining to the ground floor. To enable this, the proposals seek to remove fireplace FP2 and relocate it to the first floor living room. DG3 will be sealed shut in situ and the kitchen units fitted behind.
- 4.2.2 DG1 the front door has had multiple locks and fittings to its edge damaging the integrity of the door and jamb. It is proposed to be replaced with a new replica 3 panel door to match existing and provide a robust and thermally efficient entrance.
- 4.2.3 The existing floors to both reception rooms have been overlaid with adhesive parquet timber tiles. These will be removed and the original sub-floor boarding exposed. If original boards remain in situ these will be carefully taken up, numbered and stored on site.

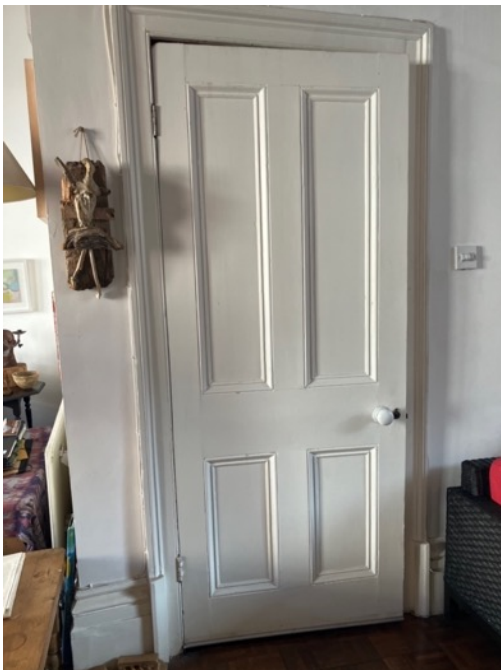
The first floor has been opened up with a beam inserted across the spine wall, to create a single living space. The original windows and joinery remain, along with door D1.1 and its architraves. Both chimney breasts remain but the original fireplaces and hearths are missing.

D1.1 panel door to living room

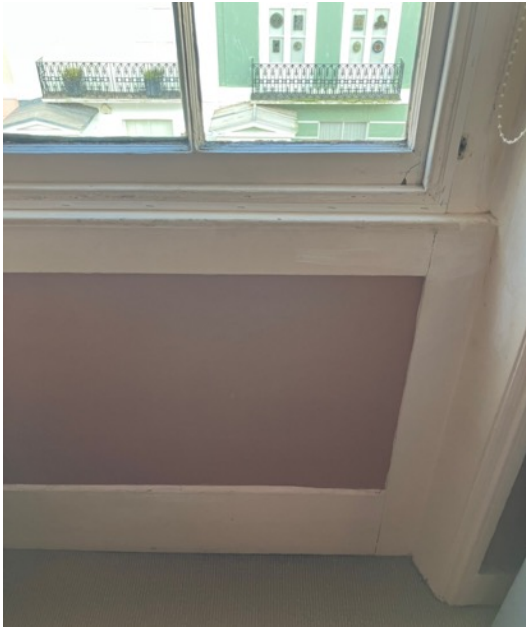
The front bedroom has its original panel door, D2.2 but parts of its architraves are missing. Windows W2.1 & W2.2 are intact, with all joinery and panelling below. These have previously had secondary glazing, which remains affixed to window W2.1

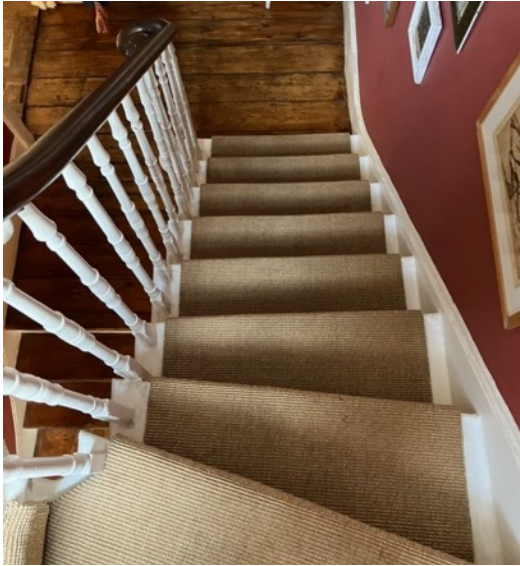
1st half landing to ground

The original staircase is intact from lower ground to second floor. The strings, handrail and balusters are in good condition. There is a slight fall inwards to the staircase and cracks can be seen on the underside of the staircase windows and where the stairwell meets the rear wall, which will be repaired.
