Site Visit Record

Project: 11 Cannon Lane
Date: 30th September 2024
Main Contractor: Enbuild Construction
Architect: Serena Mignnatti and Darling Associates
Weather: Sunny
Photos Taken: Yes, refer to the report below

THIS DRAWING IS TO BE READ IN CONJUNCTION WITH ALL RELEVANT ARCHITECTS, ENGINEERS AND SPECIALISTS DRAWINGS AND SPECIFICATIONS.					Drawing title Garden Wall Inspection				Project 11 Cannon Lane			
DO NOT SCALE FROM THIS DRAWING.					Scale 1:50 @ A3				ElliottWood			
C1 39/09/24 ET SB Construction					EWP Project 2230325				Fitzrovia • Wimbledon • Nottingham			
Rev Date By Chk Description					Date September 2024				•info@elliottwood.co.uk •+44 (0) 20-7499-5888			
					Drawn ET				Design Phase Construction			
									Status S4			
									Revision C1			
									[Project]-[Origin]-[Function]-[Spatial]-[Form]-[Discipline]-[No.]			
									2230325 - EWP - ZZ - 00 - SK - S - 0003

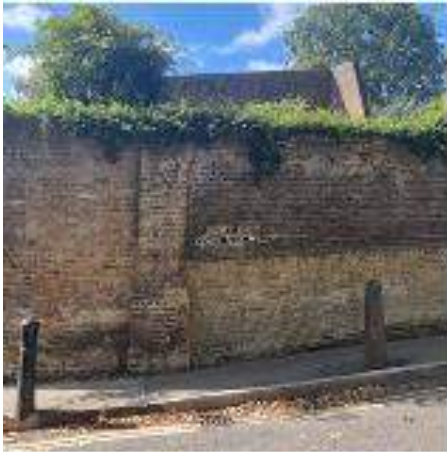
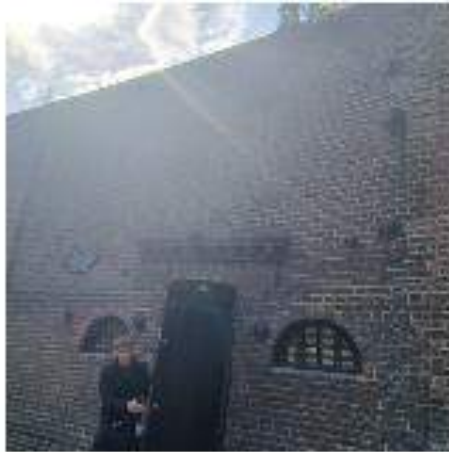
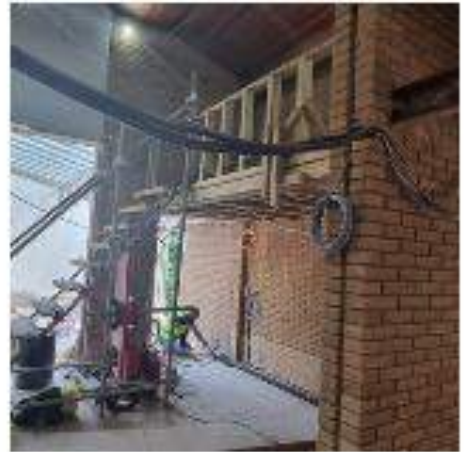
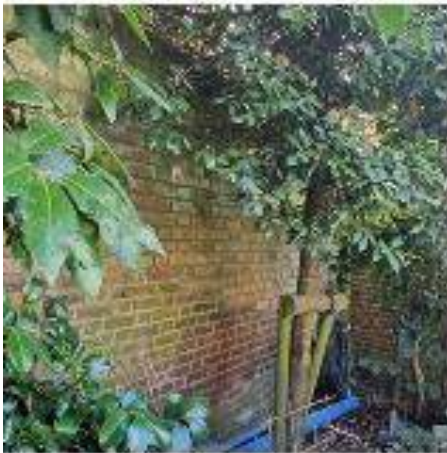
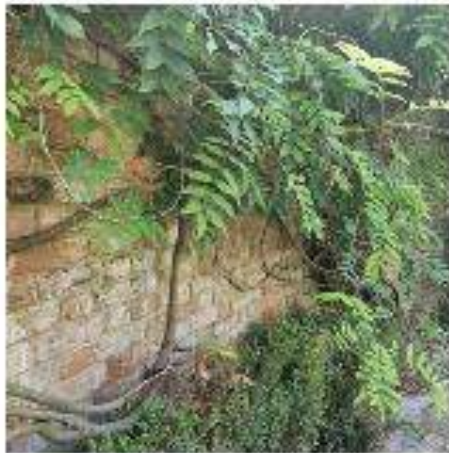
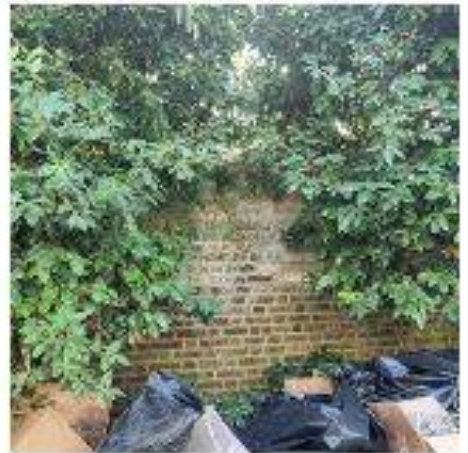
- Crack Stitching:** Some cracks have been observed in the masonry, potentially due to historical settlement or the pressure exerted by the soil behind the wall. While these cracks do not appear to indicate recent movement, crack stitching should be undertaken to stabilise these areas.

Re-point masonry to BS 8221-2. Mortar mix to be non-hydraulic lime mortar to be compatible with existing masonry units and match the existing mortar characteristics and colour, Class B1 or better, to specialists specification to BS 890. Joints to be raked out, removing any loose mortar to between 38mm and 50mm, with non-mechanical tools. Joints to be cleaned and wetted before placement of new mortar. Clean surfaces as noted in Type 1.

A crack in masonry is considered minor if it has a thickness of less than 5.0mm **and** an extent of less than 500mm. Remove finishes around cracking to determine thickness and extent. Any masonry units that are cracked are to be replaced, replacement brickwork should match the originals in material, size, colour, texture, density, hardness and porosity according to Section 9.2 and 9.3 of BS 8221-2. Cracks in mortar limited in extent to 500mm in both directions on the face of the masonry to be repaired by raking out and making good, as noted in Type 2. If existing mortar has disintegrated, or the crack penetrates, to a large depth, all loose mortar to be removed, replacement mortar should be deep tamped in layers according to 7.3.4 of BS 8221-2.

A crack in masonry is considered major if either the thickness is greater than 5.0mm **or** its extent is greater than 500mm. Remove finishes around cracking to determine thickness and extent. Insert non-ferrous or austenitic stainless steel ties as shown in detail 1 and according to manufacturers instructions. Mortar repair to match existing but in accordance with tie manufacturers instructions. Carry out general repairs elsewhere as Type 1, 2 and 3 as appropriate.
