**26 Rosslyn Hill
London – NW3**

**Structural Engineering Strategy
Stage 2 Report**

Date:	14/12/2022	Prepared by:	TS
Reference:	1031-rep-001	Checked by:	JD
Filename:	1031-rep-001-P1-Stage 2 Report.docx	Status:	Stage 2 - PRELIMINARY
Revision:	P1		
Revision Date:	14/12/2022		
Revision:	P2		
Revision Date:	10/03/2025		
Kiosque Ltd, 20-22 Wenlock Road, London, N1 7GU t. 020 3740 0745 – e: mail@kiosque.co.uk

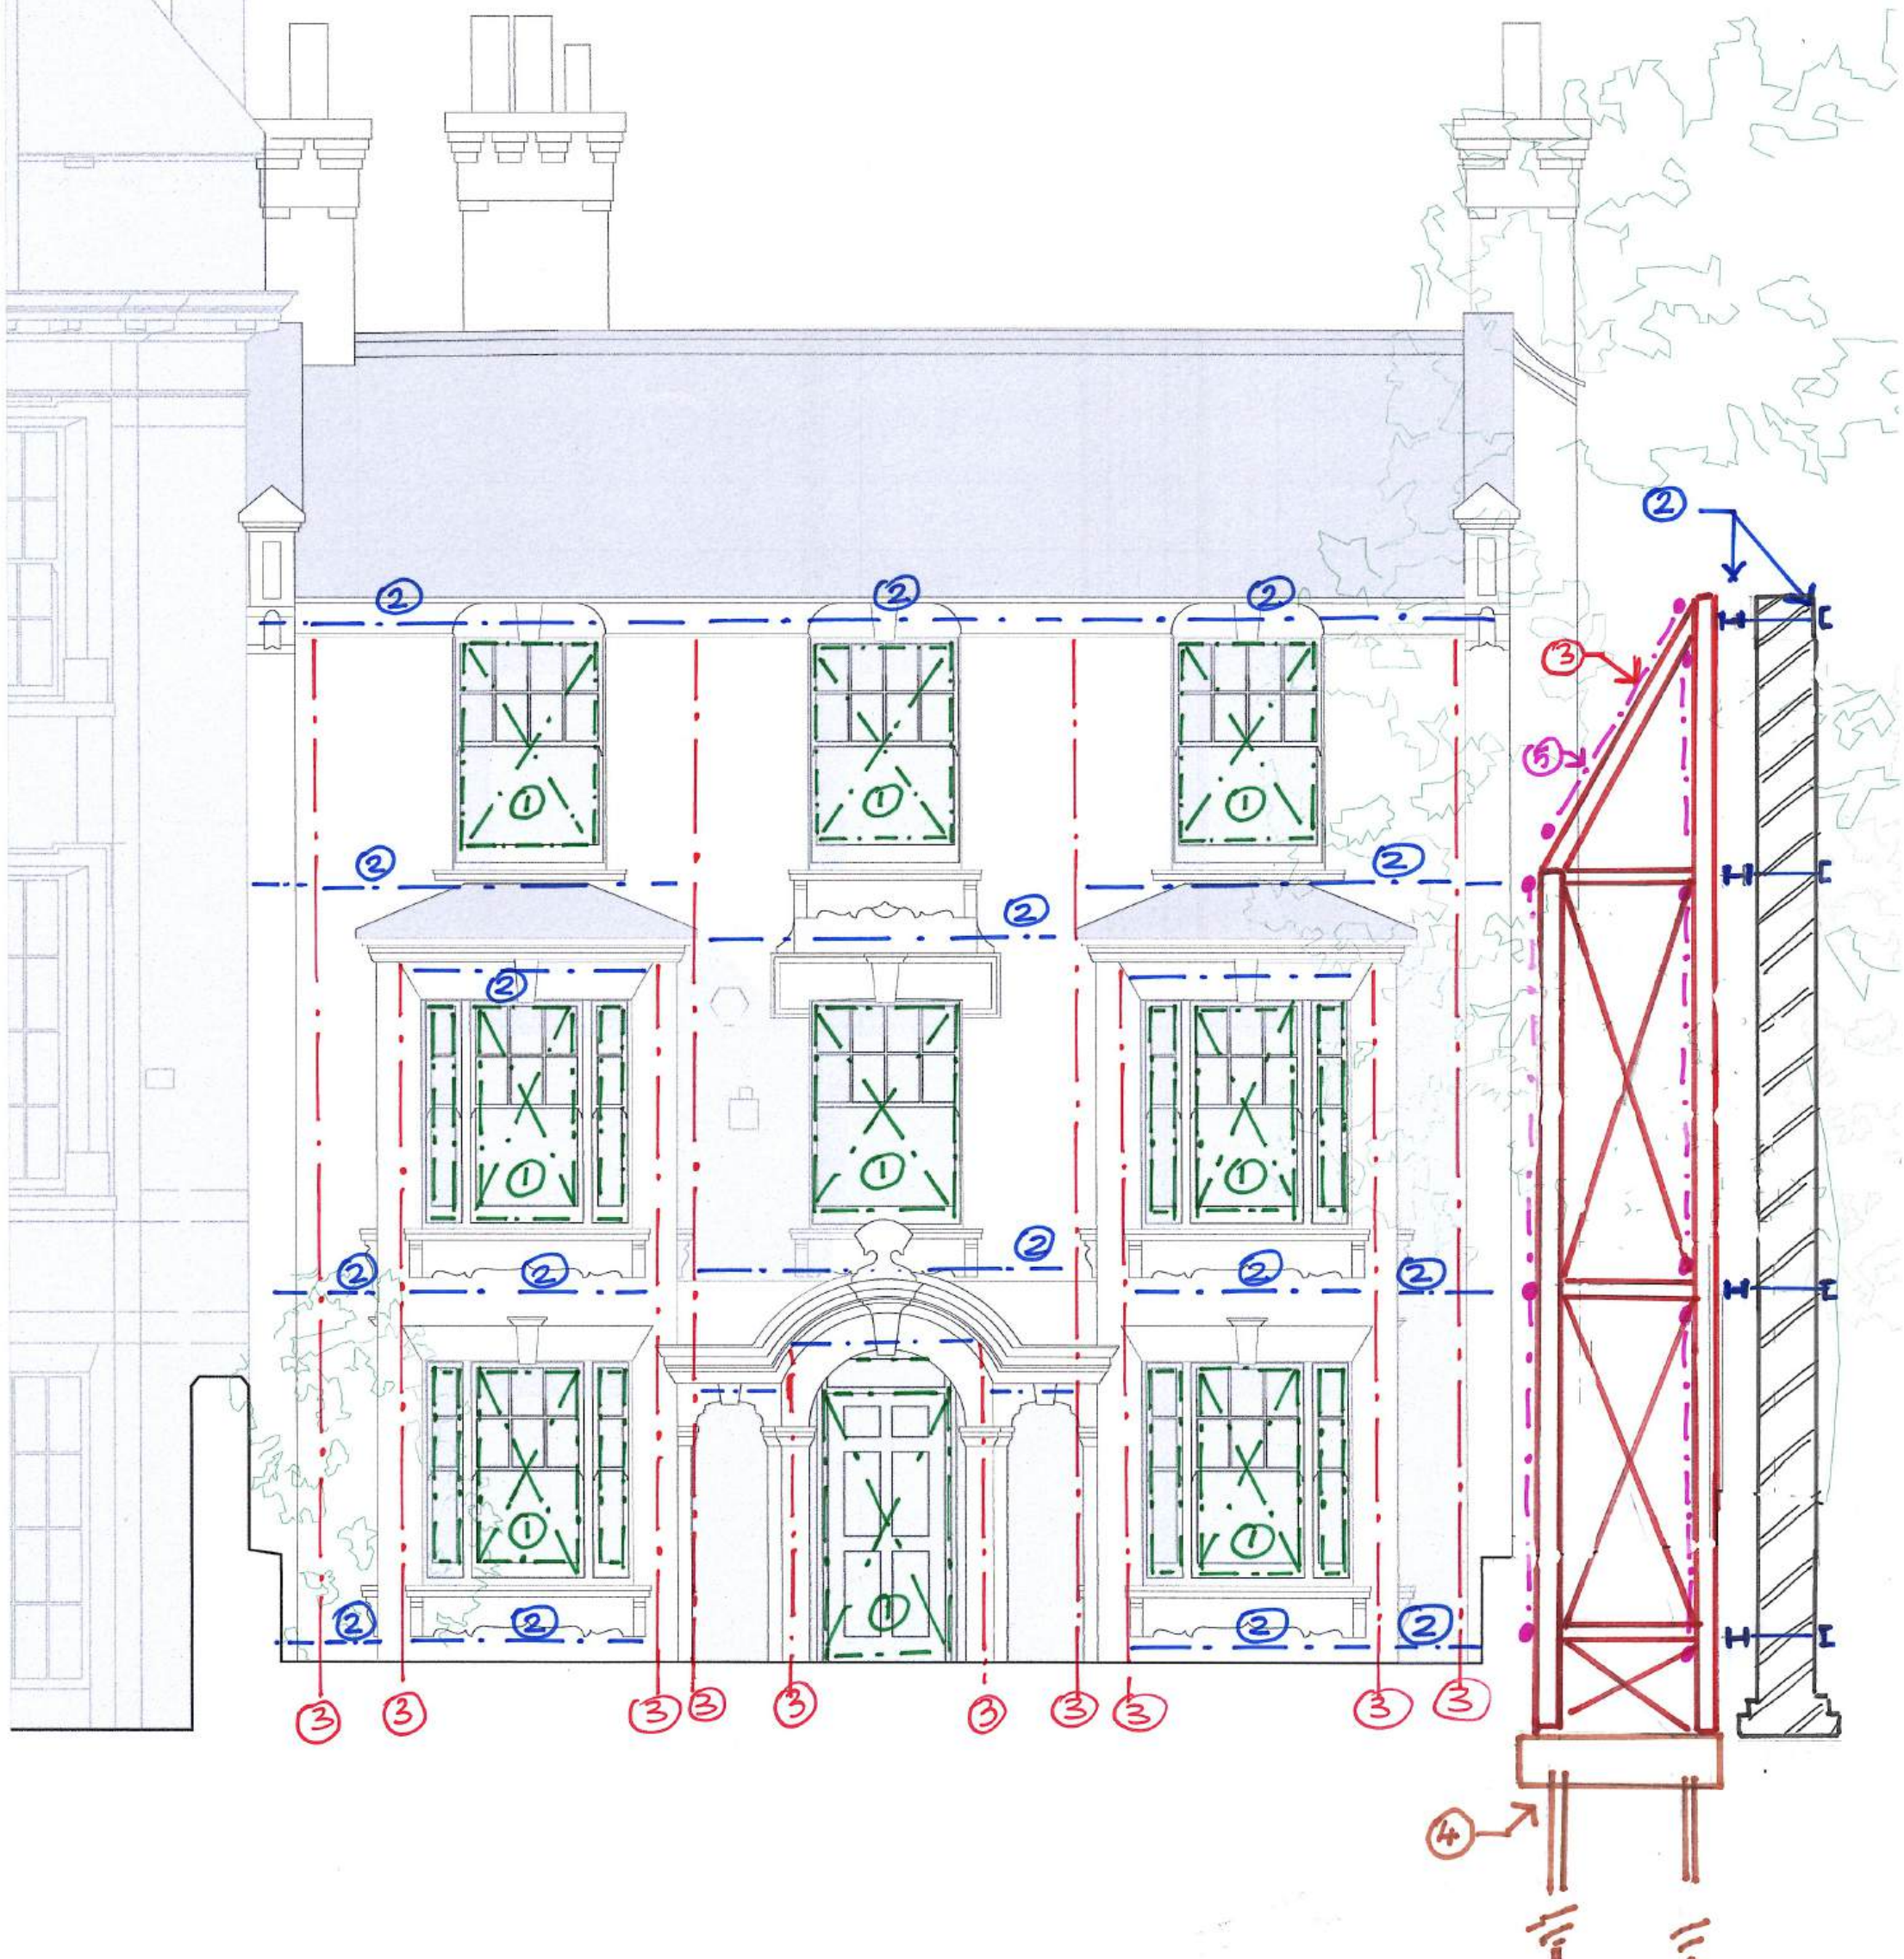
Project:	26 Rosslyn Hill – NW3	Project No:	1031
Description:	Façade retention system Schematic	Date:	12/2022
		By:	TS
Filename:	1031-SK-221214-001	Page:	1

Consequently, in the temporary condition the three storey façade will be left with no lateral restraints and supports after the demolition of the internal floors, and walls.

The lateral stability of the façade in the temporary conditions is provided by a series of steel frames three storey high installed on the outside of the façade one new foundations.

As the front of the property is partly within tree T2 root protected area (RPA), the new foundations for the temporary façade retention system consist of a series of reinforced concrete pad foundations / ground beams on screw piles. Therefore, this option minimises the amount of excavations within the RPA.

Prior to installing the façade retention system all windows and door frames will be removed and replaced by braced timber frames installed tight within the door and windows apertures. This will ensure that the existing openings will not distort during the demolition and in the temporary conditions.

- ① Remove existing window and door frames and install braced timber frames tight within aperture.
- ② Waling beams bolted through wall and clamping wall.
- ③ Braced steel towers.
- ④ New RC footings / ground beams on mini piles / screw pile foundations
- ⑤ Cross bracing between braced steel towers.

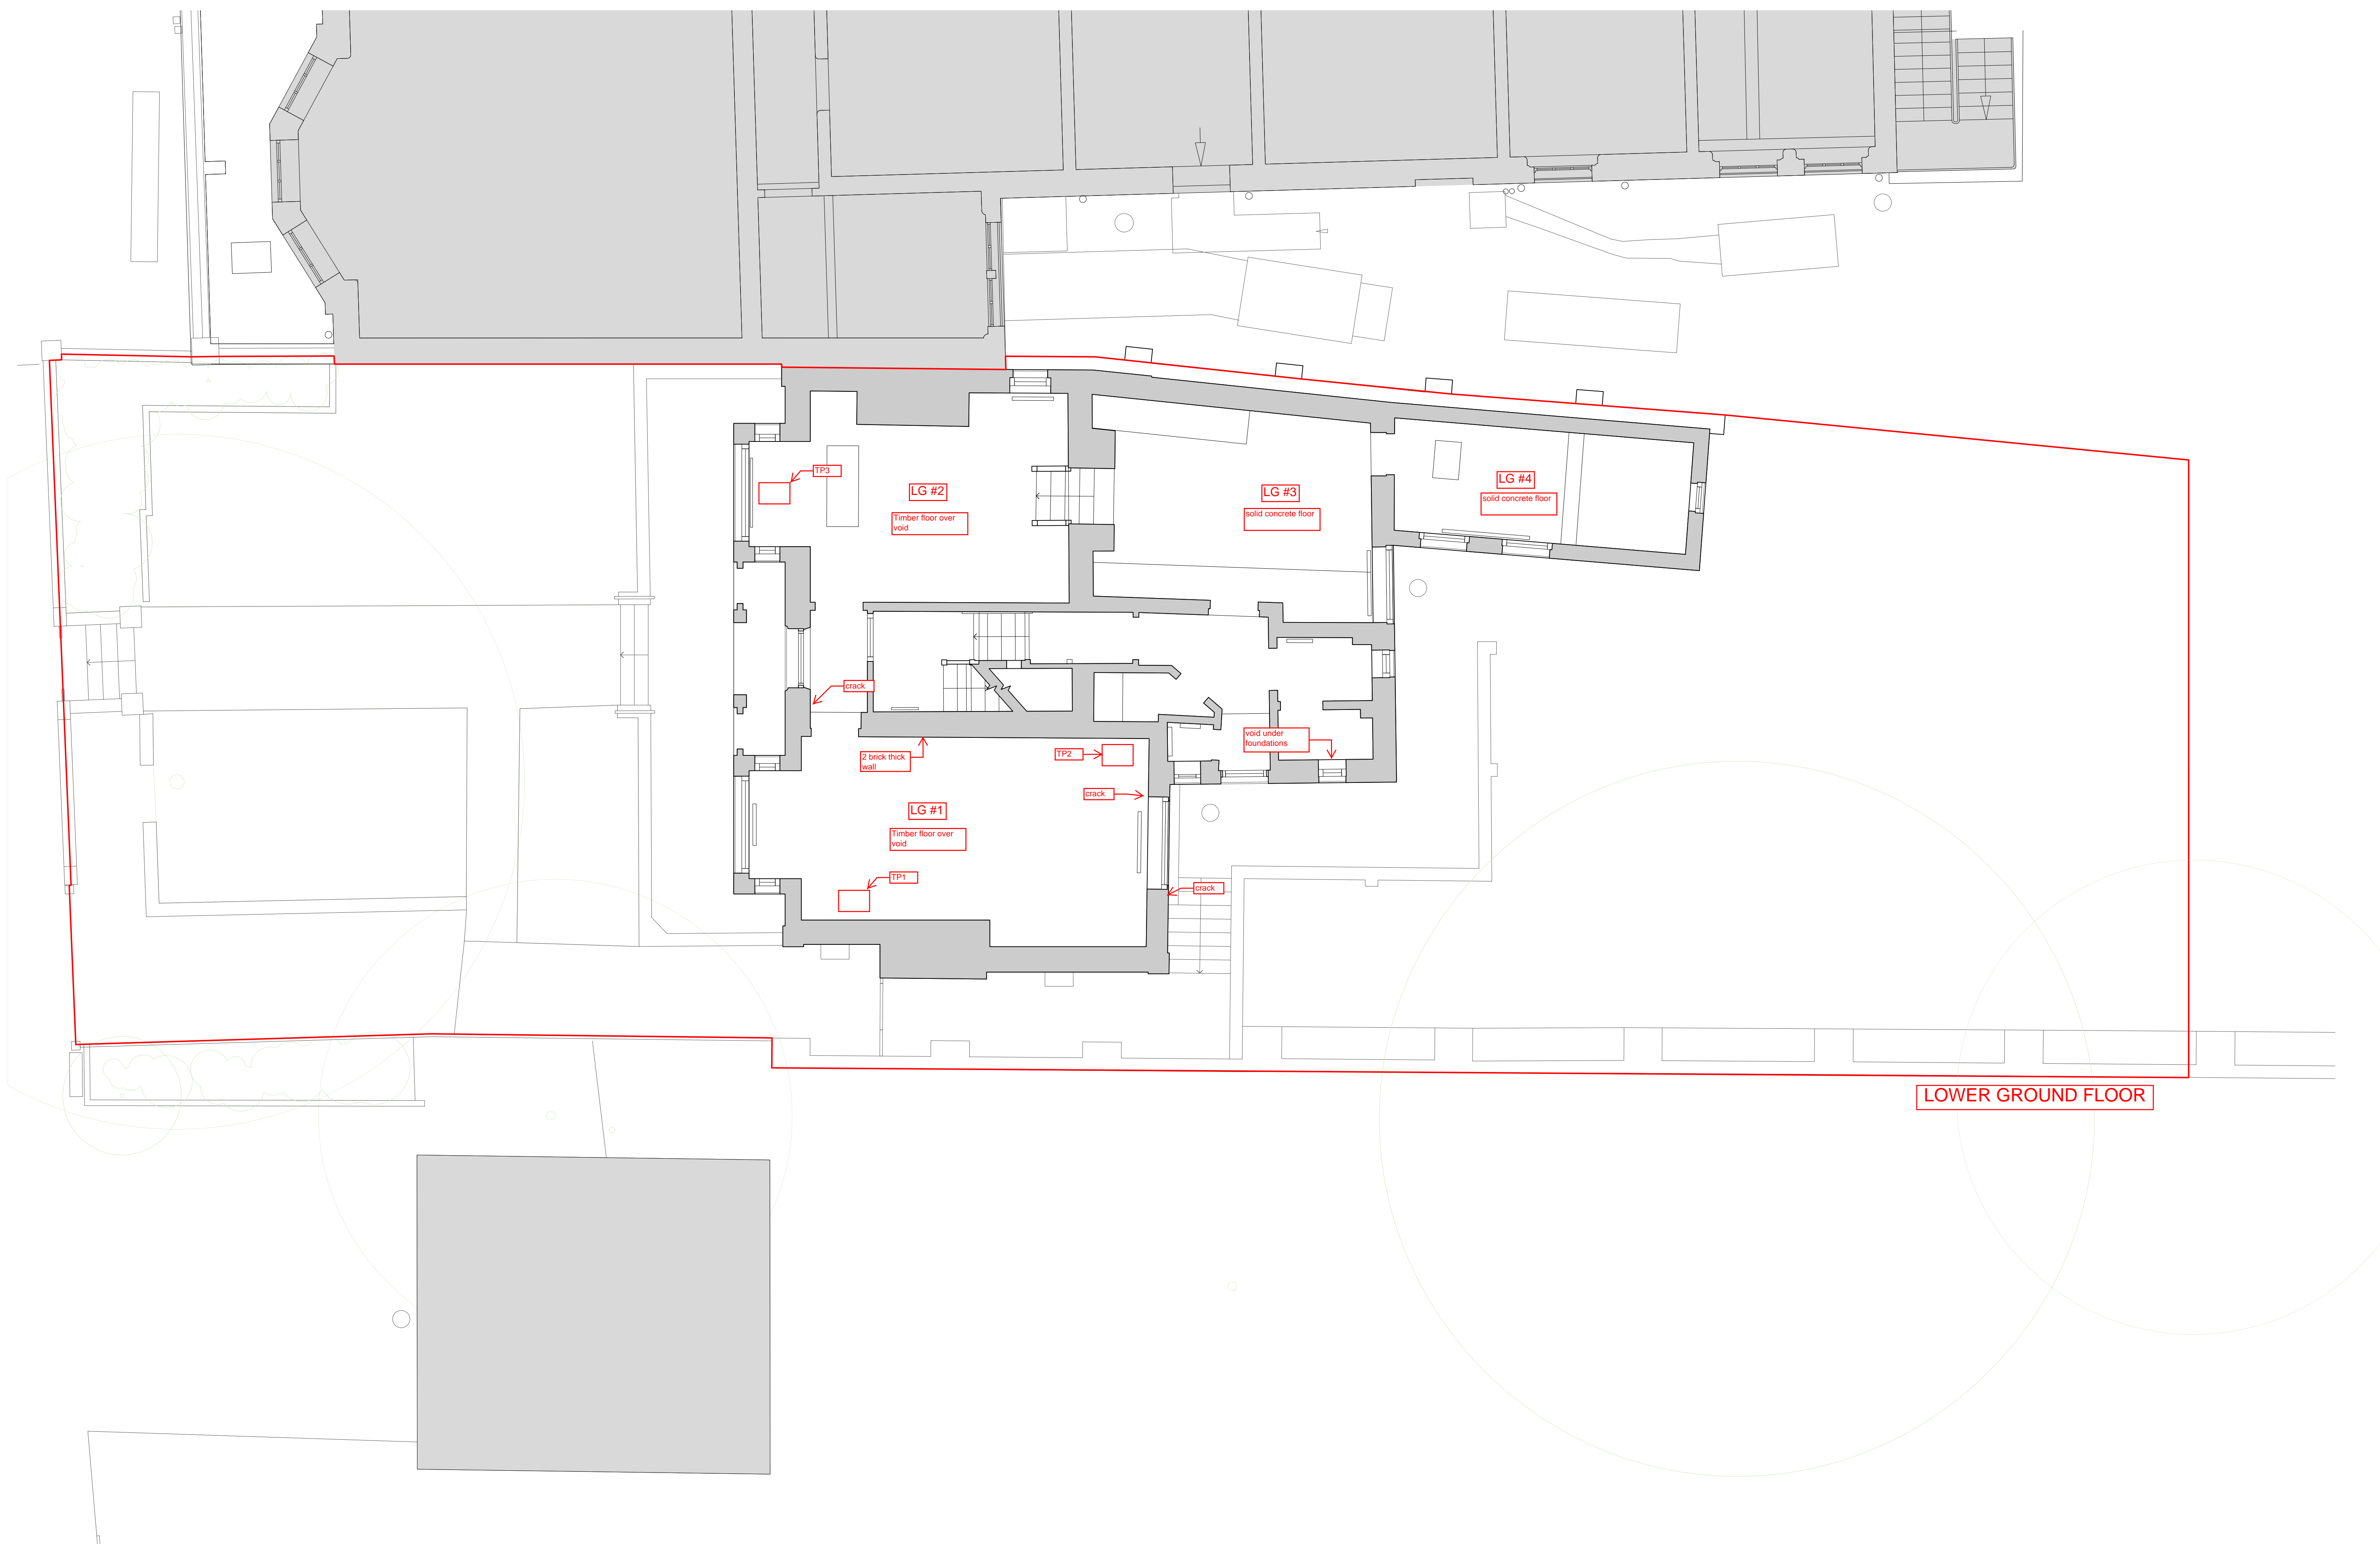
LOWER GROUND FLOOR

- Trial pits were dug prior to the survey in rooms LG #1 and LG #2 to ascertain the depth and profile of the foundations. The findings are described in Appendix 2 of this report.
- Water was present at the bottom of trial pit 1.
- The foundations typically consist of the brick wall sitting on a concrete footing bearing on a clay sub-strata.
- Foundations to the side external wall in room LG #1 are only 800 mm deep.
- To the rear of the property the external wall foundations in the toilet area consists of the brick wall bearing directly onto the sub-soil with no concrete footing at the depth of 0.5 m. At this location, locally, a 900 mm void under the wall was noted. This void could be an underground cistern, well or chamber. No lintels or concrete beams were installed, and the external wall was bearing directly above this void with no apparent support locally.

- The floors in the front of the property consists of a suspended timber floor with the floor joists spanning front to back.
- The void under the floor joists is inadequate as being too shallow and poorly vented.

- Some local staining and decayed of the timber subfloor and timber sole plates were noted.
- Notches have been cut in some joists to accommodate for services and pipes. These notches, sizes and locations are beyond the recommended minimum sizes, locations and limitations as per the Building Regulations Part A.

- As the property has been unoccupied and unheated for a long period of time there is a high level of dampness within the solid brick walls especially around the bay windows. Defective plaster finishes were noted throughout this floor.
- Cracks in the brick wall were noted internally in room LG #1 in the rear wall adjacent to the window. This crack is reflected externally at the same location and would indicate local movement in this area.
- Cracks in the hallway between rooms LG #1 and LG #2 adjacent to the window was noted. This crack appears at this location on the upper levels.

- Mould growth was noted to the ceiling of the rear toilets.
- Sign of dampness and water staining could be seen in the ceiling of room LG-#3.
- The mono pitch roof timber structure above room LG-#4 was locally exposed. Some timber rafters appeared to be stained and water ingress within the roof space was noted probably from failing flashings.

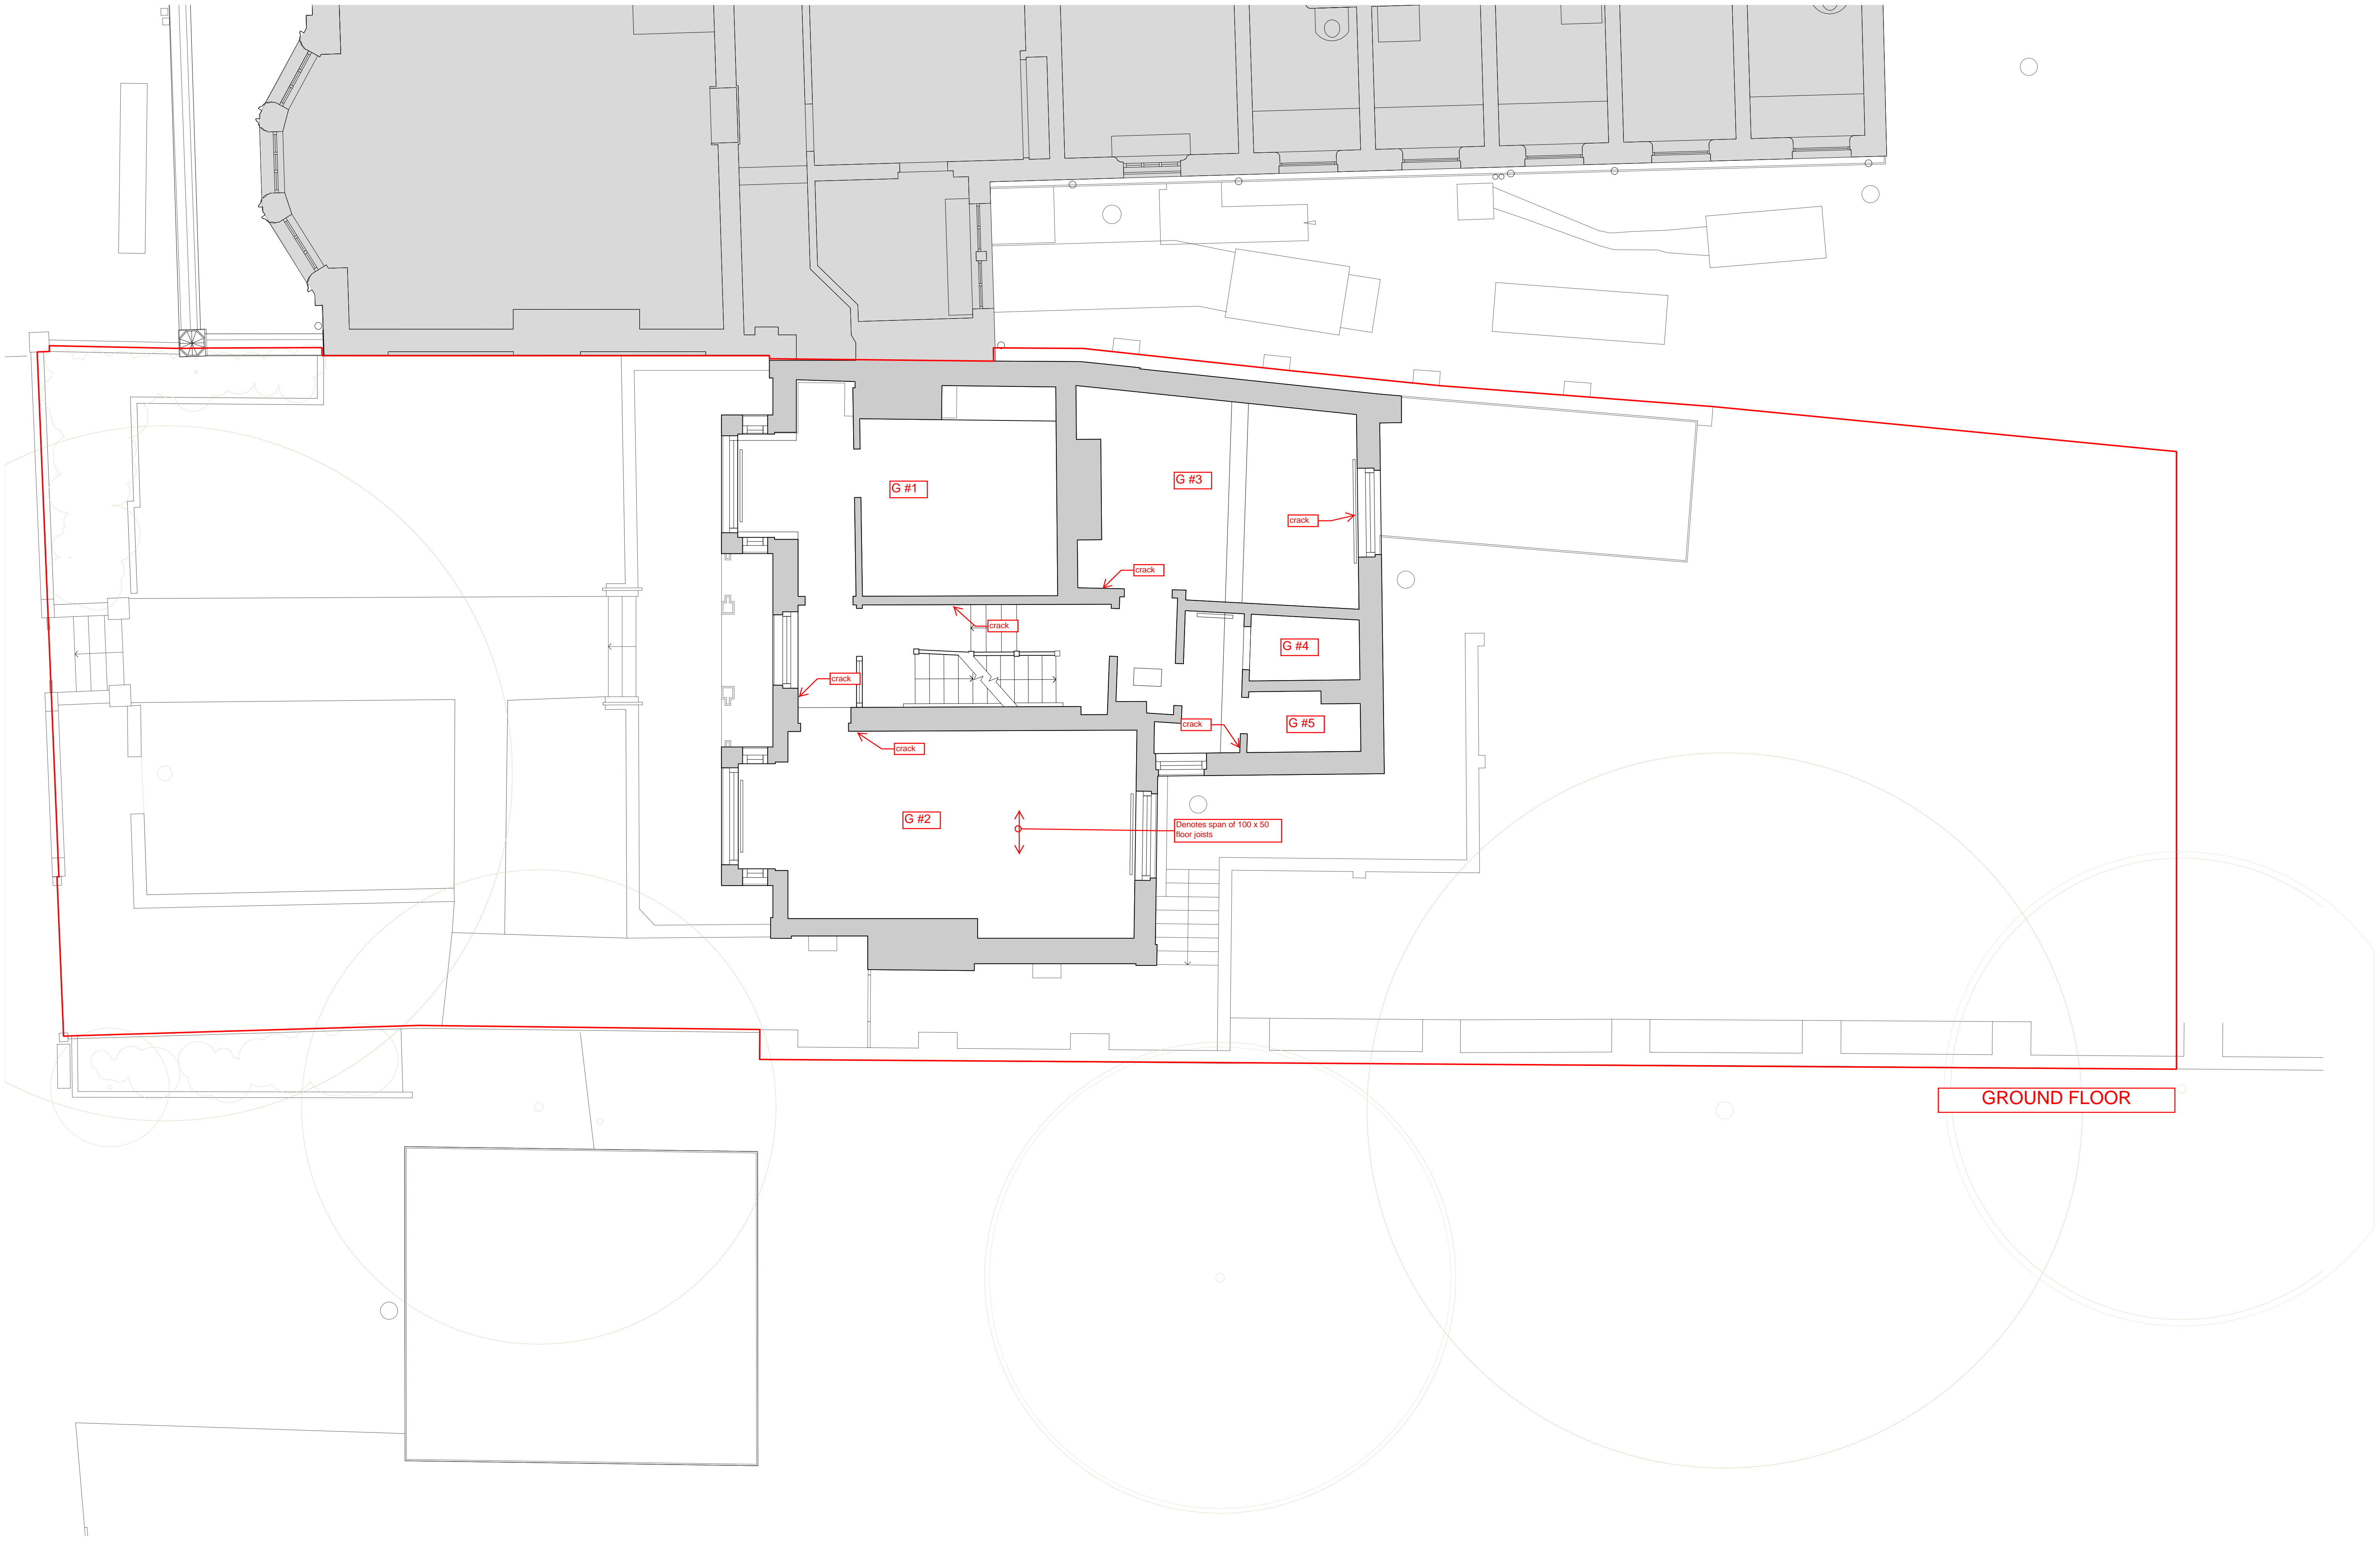
GROUND FLOOR

- The floors are typically suspended timber floor with floor joists at 400 mm c/c.
- In room G #2 the joists are spanning from the side wall to the internal wall adjacent to the stair and are only 100 deep by 50 at a closer centre. The floor is very lively when carrying out a drop heel test. These joists sizes are usually used for ceiling joists not floor joists.
- The rear of the property joists are deeper joists typically 225 x 50 and appears to be more recent construction.
- The original joists and timber joist plate are built in the wall.
- Fungal growth was noted on the joists with sign of local decay to some of them.
- Notching and drilling for services were noted in some joists exceeding the recommended maximum depth and locations.

- Damp walls with defective plaster finishes were noted throughout this floor.
- Cracks in the brick wall were noted internally in room G #2 adjacent to the door.
- Cracks in the hallway between rooms G #1 and G #2 adjacent to the window was noted. This crack appears at this location on the first floor.
- Cracks to the underside of the window in room G-#3 was noted. This crack appeared at the same location at first floor level above.

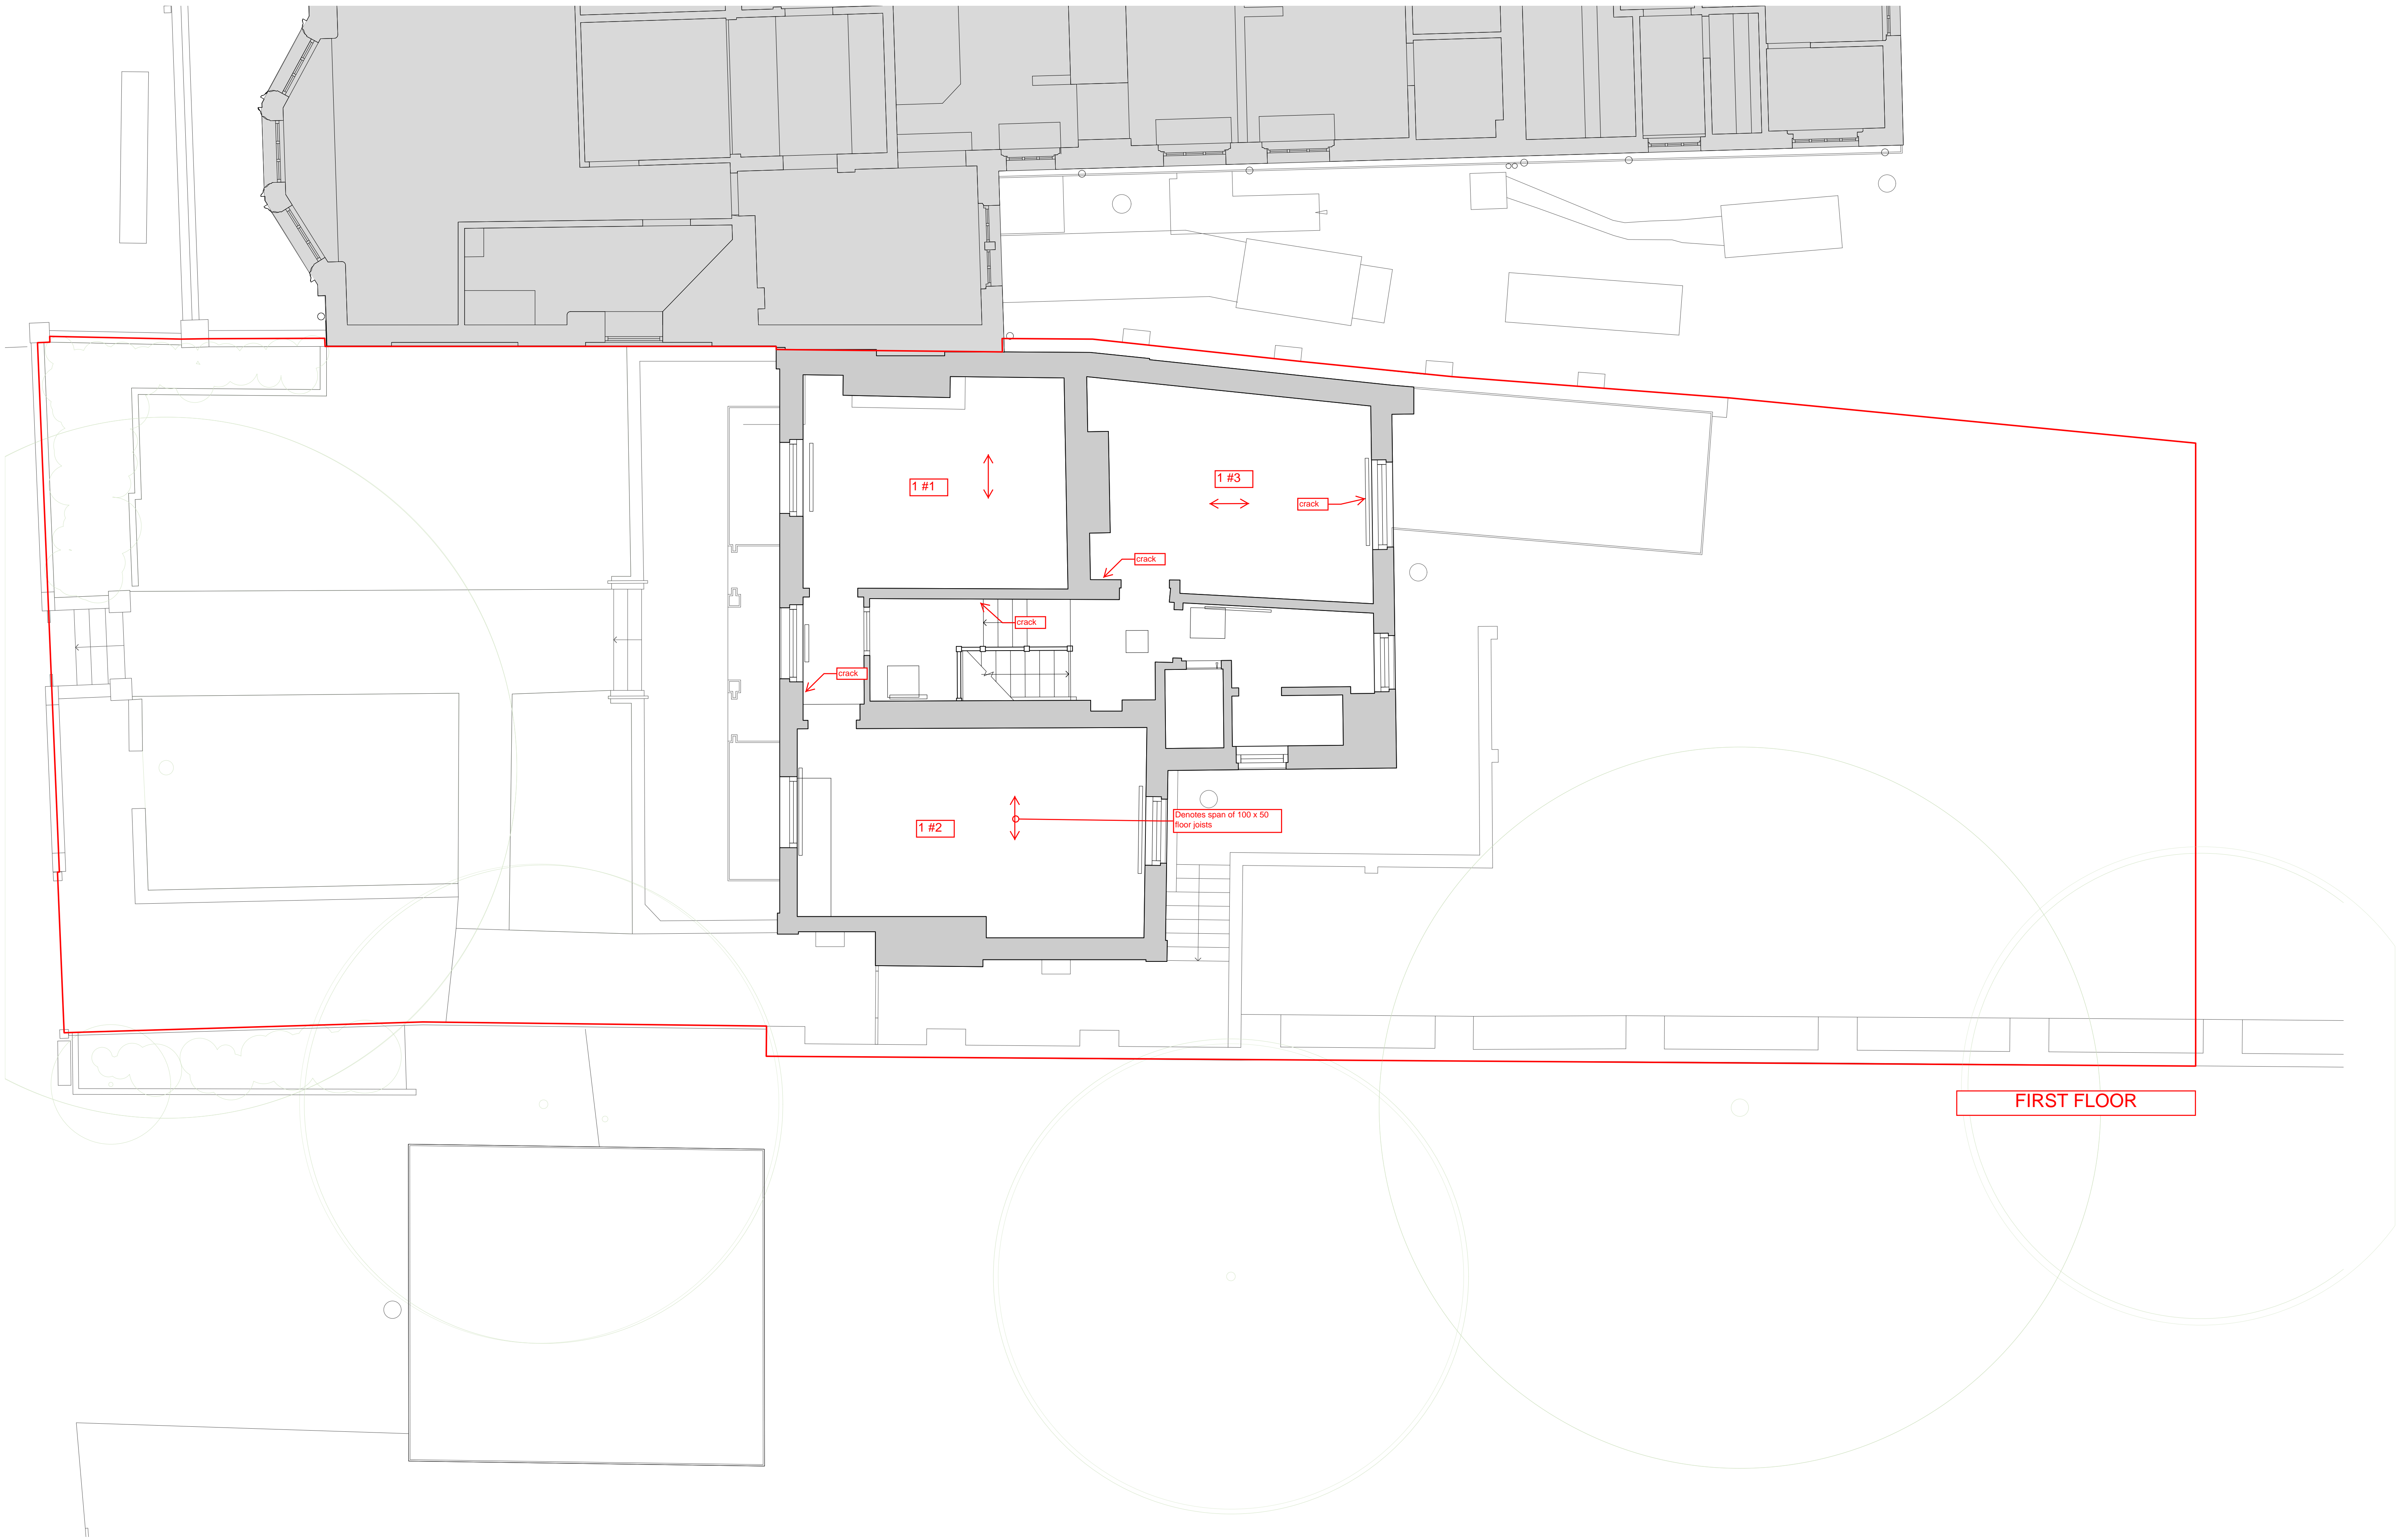
FIRST FLOOR

- In room 1-#2 the joists are spanning from the side wall to the internal wall adjacent to the stair and are only 100 deep by 50 at a closer centre. The floor is very lively when carrying out a drop heel test. These joists sizes are usually used for ceiling joists not floor joists.
- Extensive fungal growth observed from the ground floor ceiling was noted on the floor joists of the rear toilets and shower room.
- Notches have been cut in some joists to accommodate for services and pipes. These notches, sizes and locations are beyond the recommended minimum sizes, locations and limitations as per the Building Regulations Part A.
