26 Rosslyn Hill London – NW3

Structural Survey

Date:	04/02/2025	Prepared by:	TS	
Reference:	1031-rep-003	Checked by:		
Filename:	1031-rep-002-P1-visual survey.docx			
Revision:	P1	Status:	PRELIMINARY	
Revision Date:	04/02/2025			
Revision:				
Revision Date:				
Kiosque Ltd, 20-22 Wenlock Road, London, N1 7GU				
t. 020 3740 0745 – e: mail@kiosque.co.uk

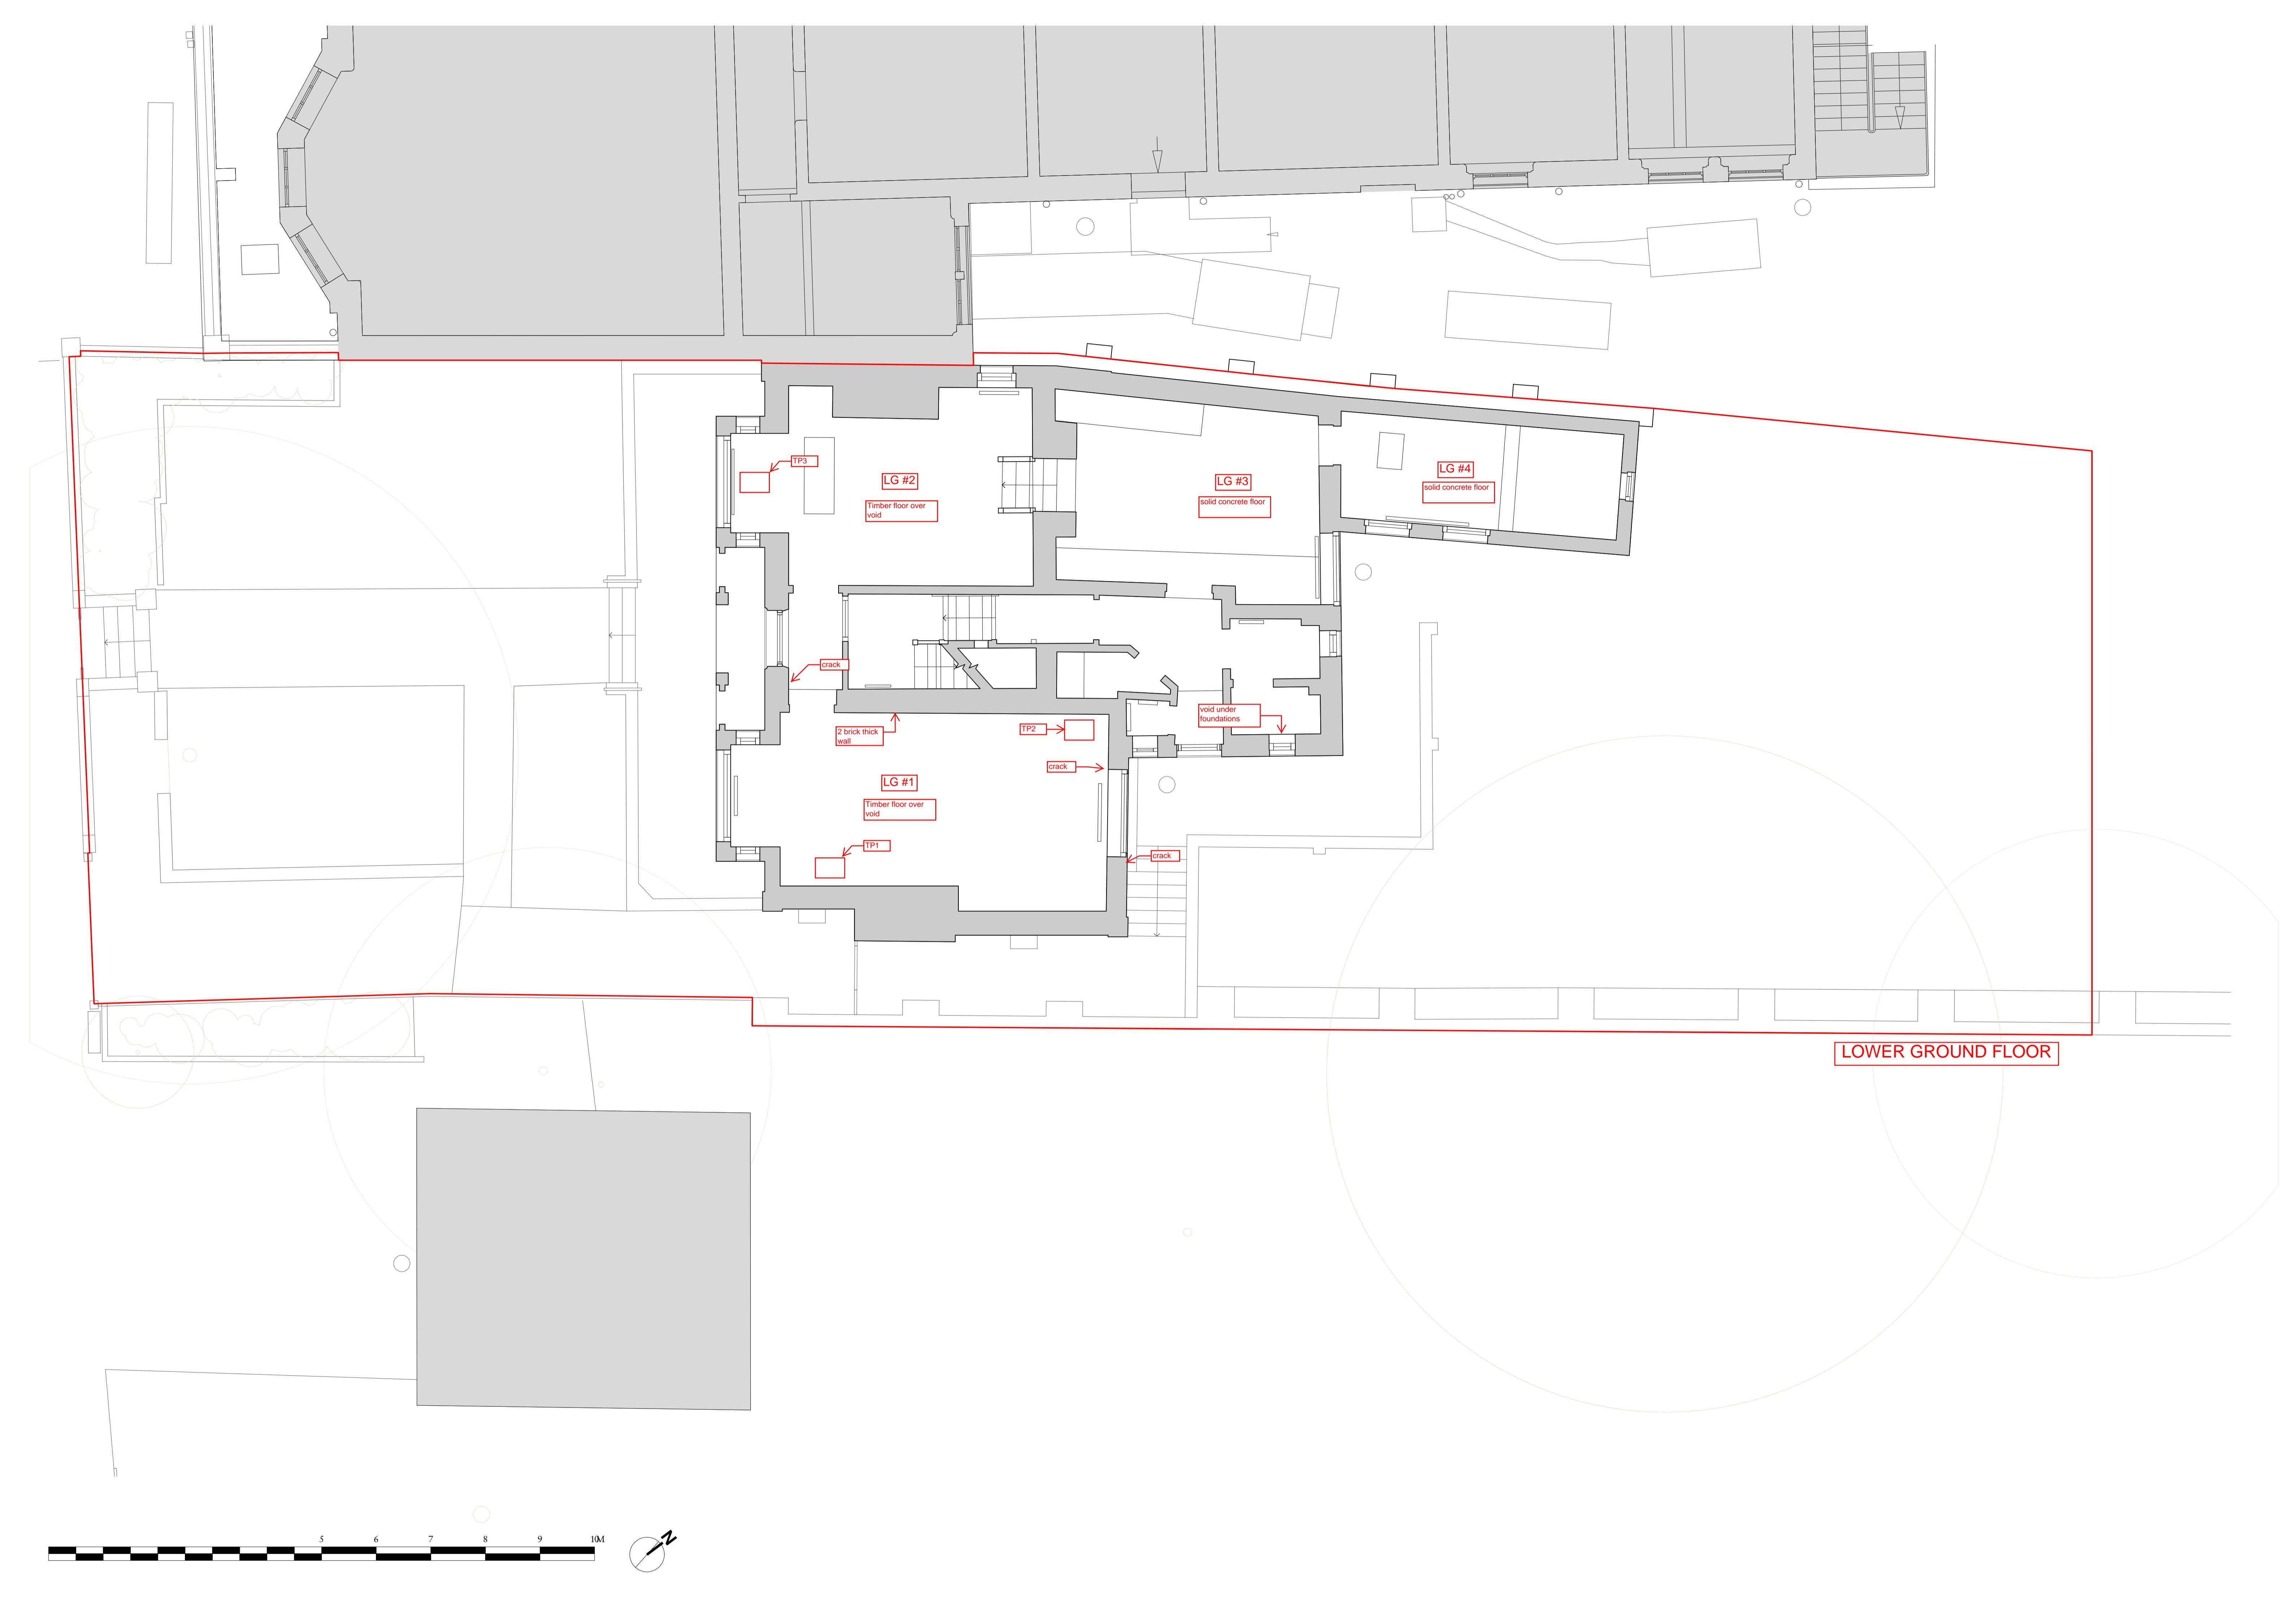
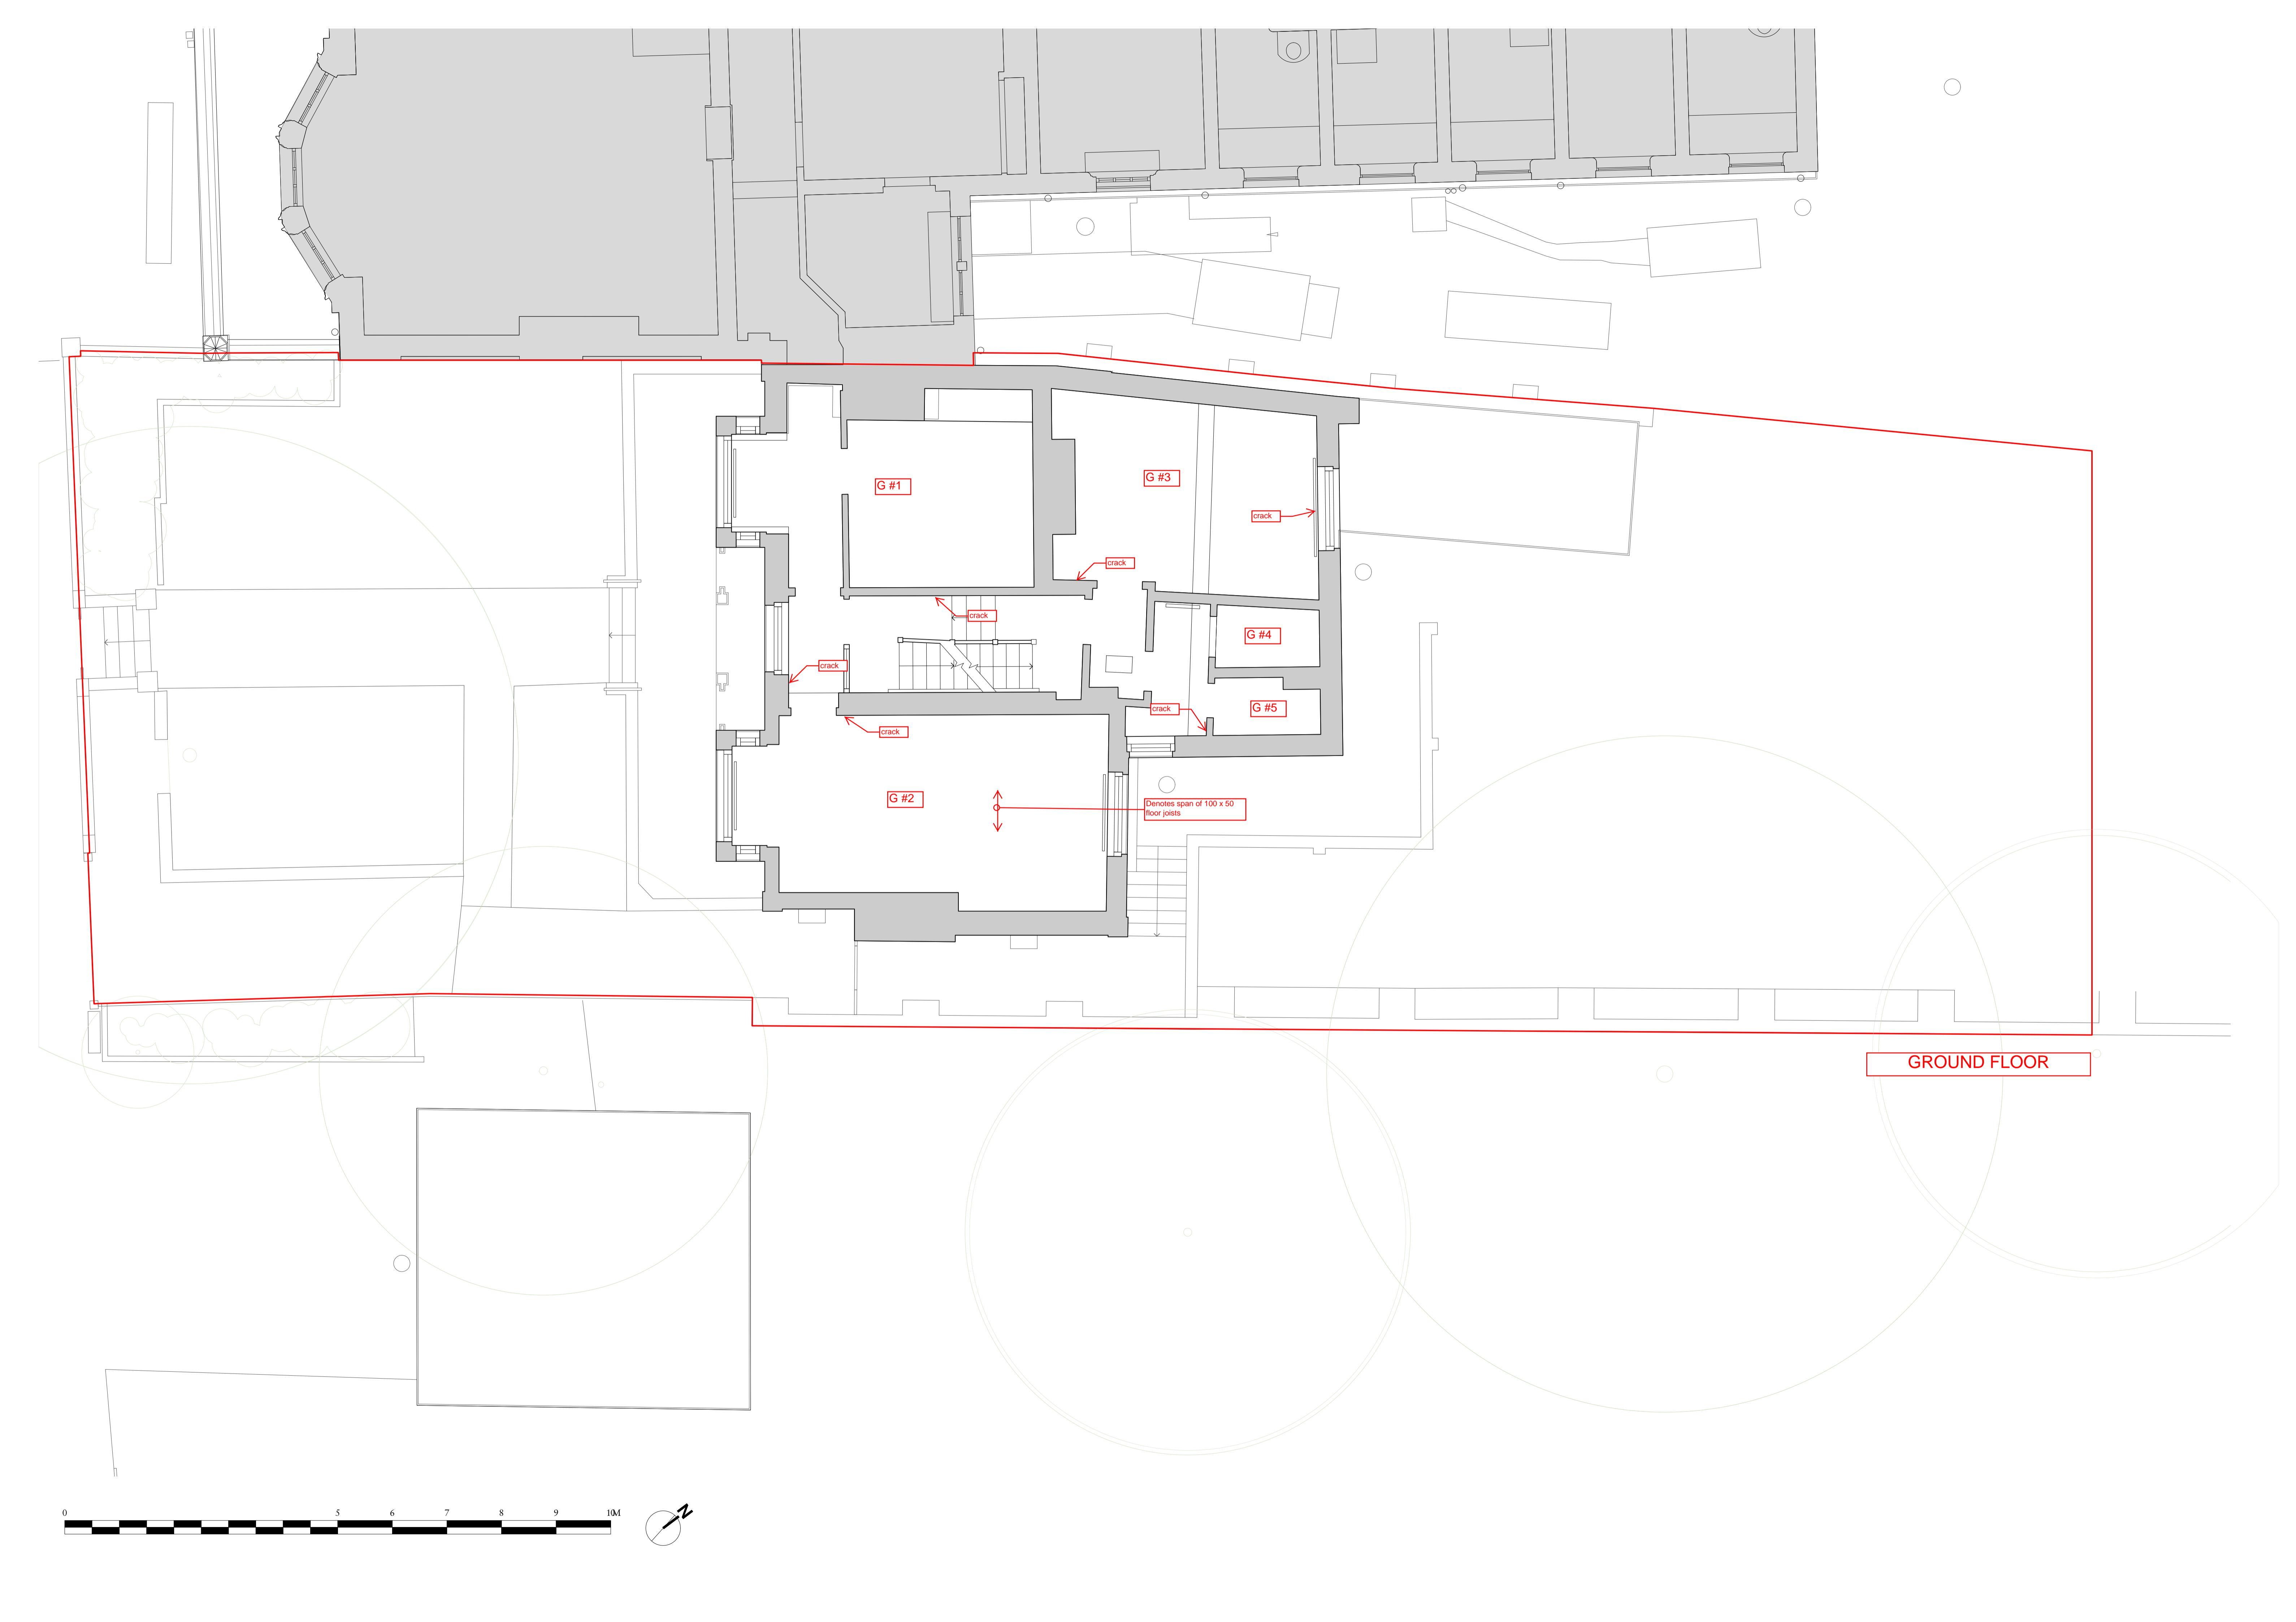
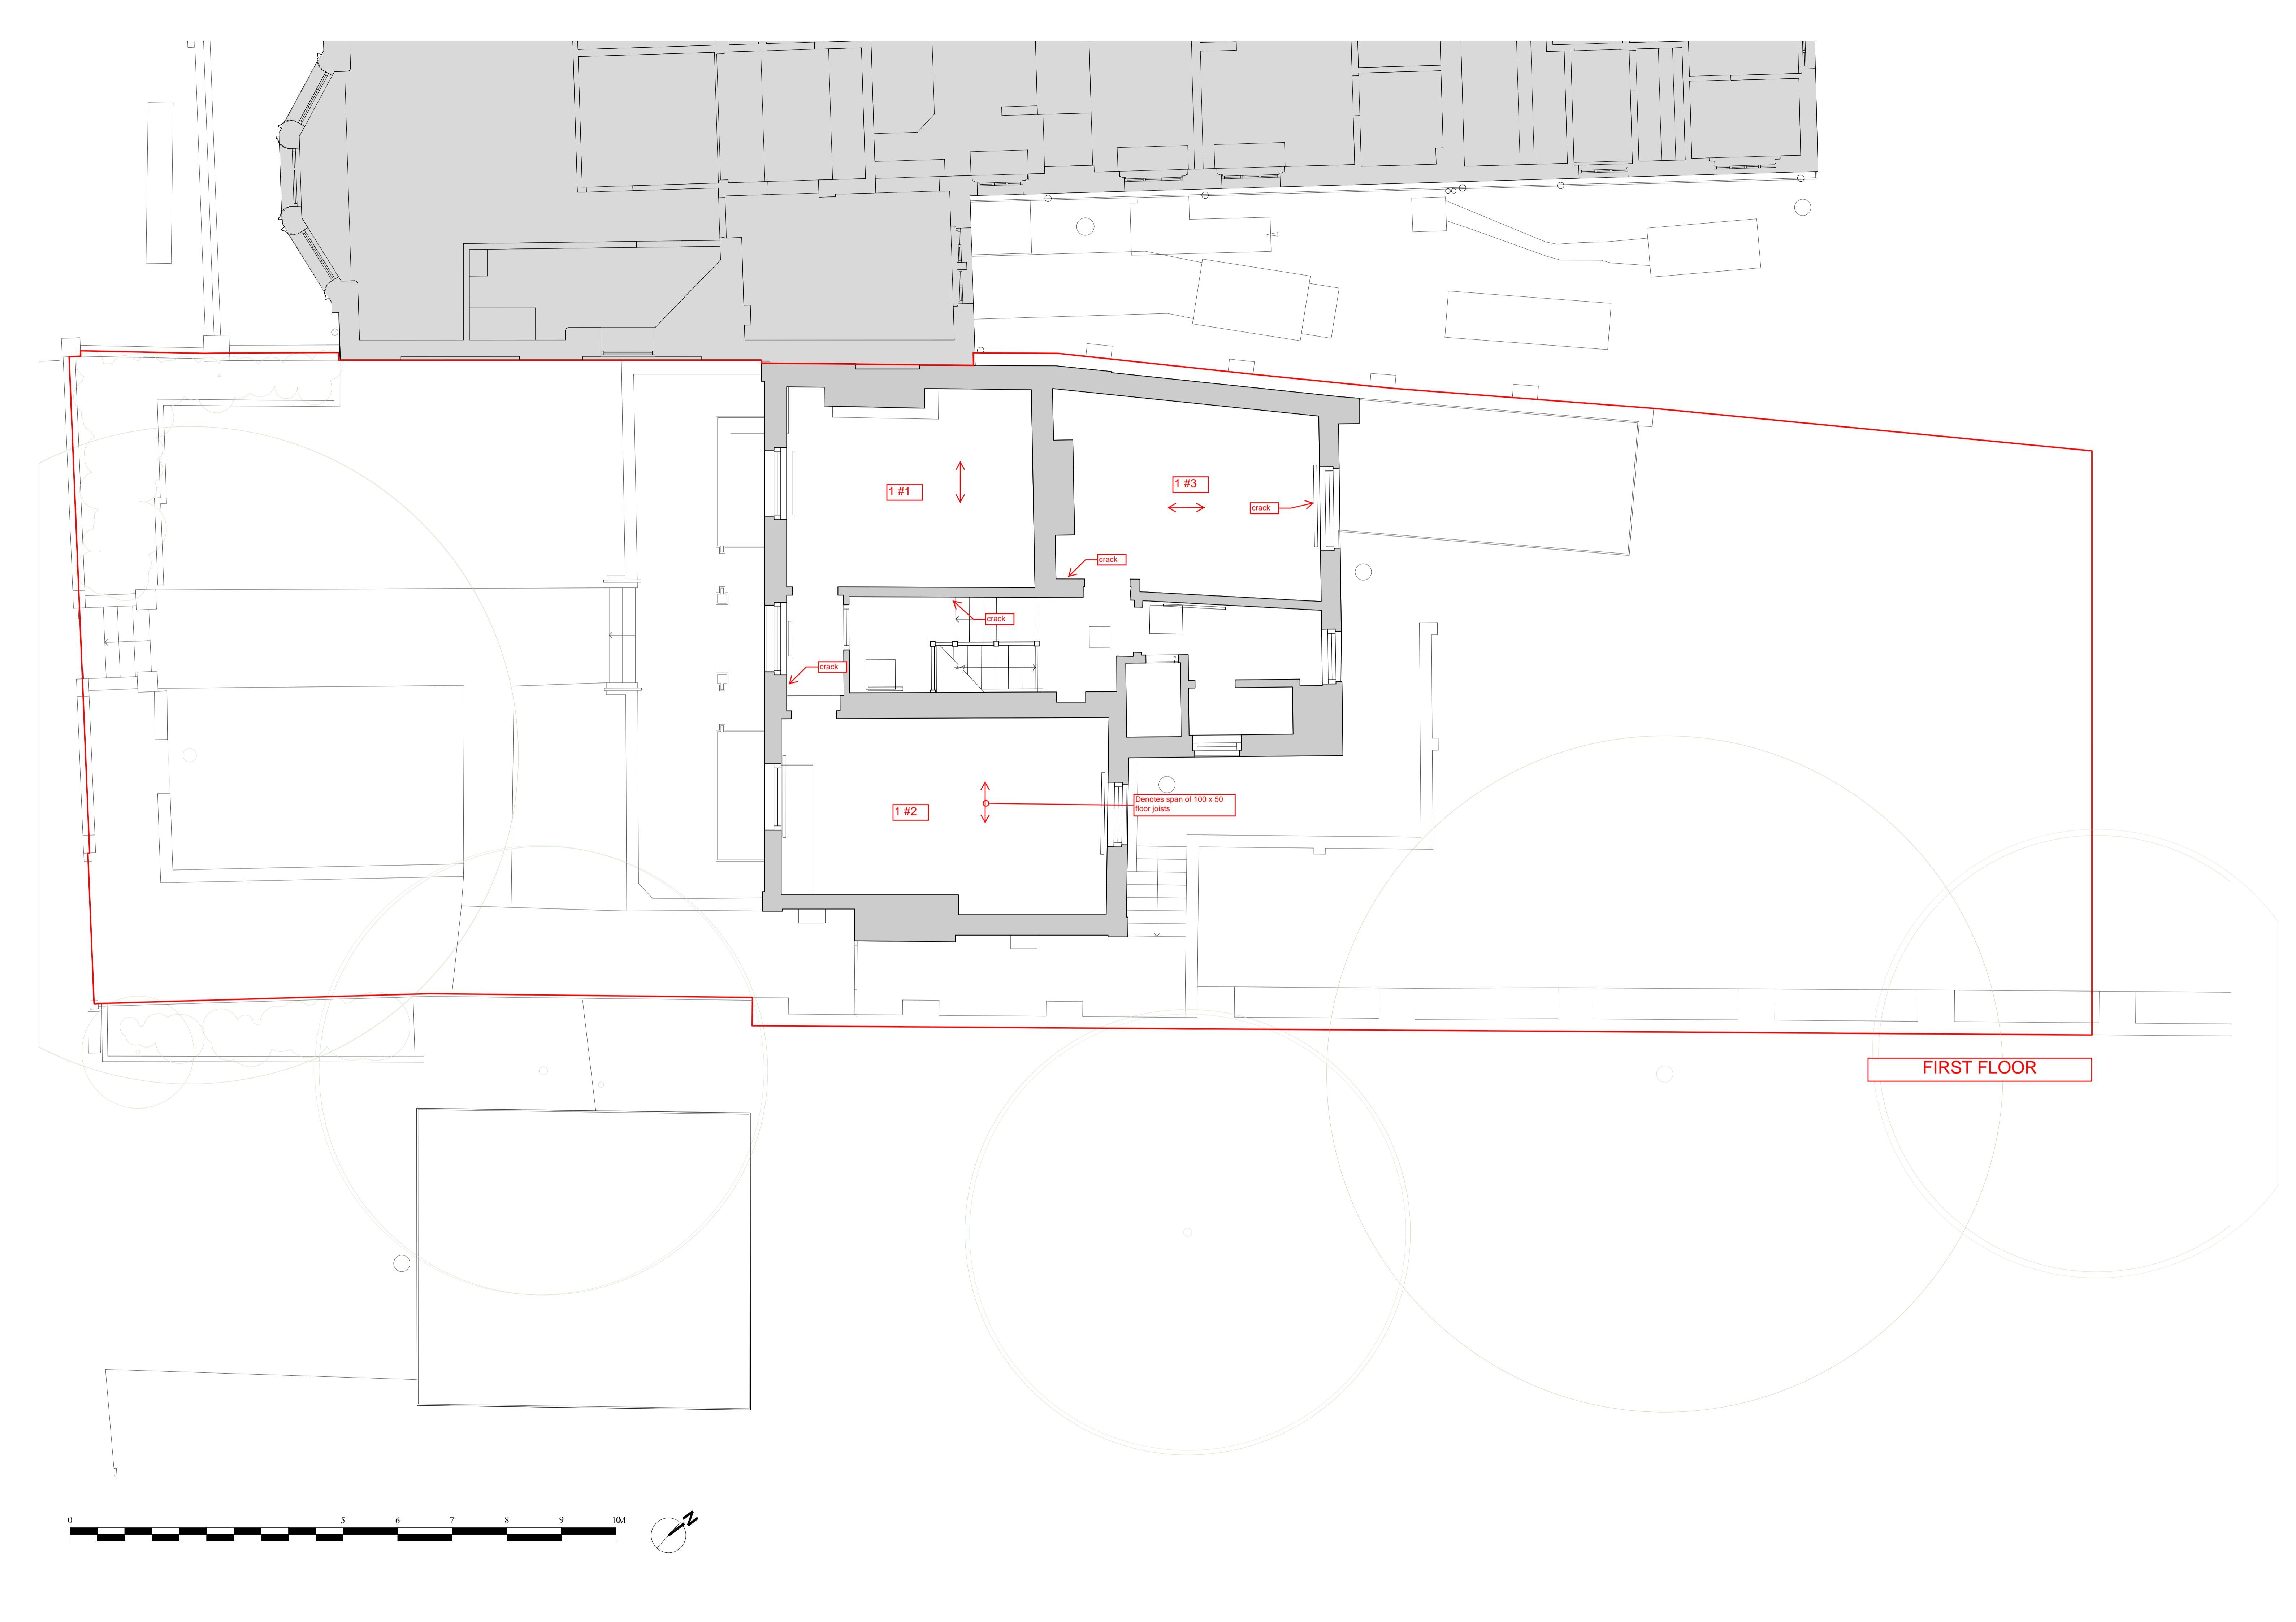
Appendix 1: Plans

All room notation, trial pits and locations of structural defects are shown on the plans in Appendix 1 of this report
