CFBL WINDOW REPAIRS PHASE 2

87 Holmes Road, Kentish Town, London NW5 3AX

WINDOW REPAIRS PHASE 2 REPORT REV. 03
Report Existing windows at CFBL & proposals for their
repair in 2025.

Francis Birch
Architect Dipl.Arch. RIBA

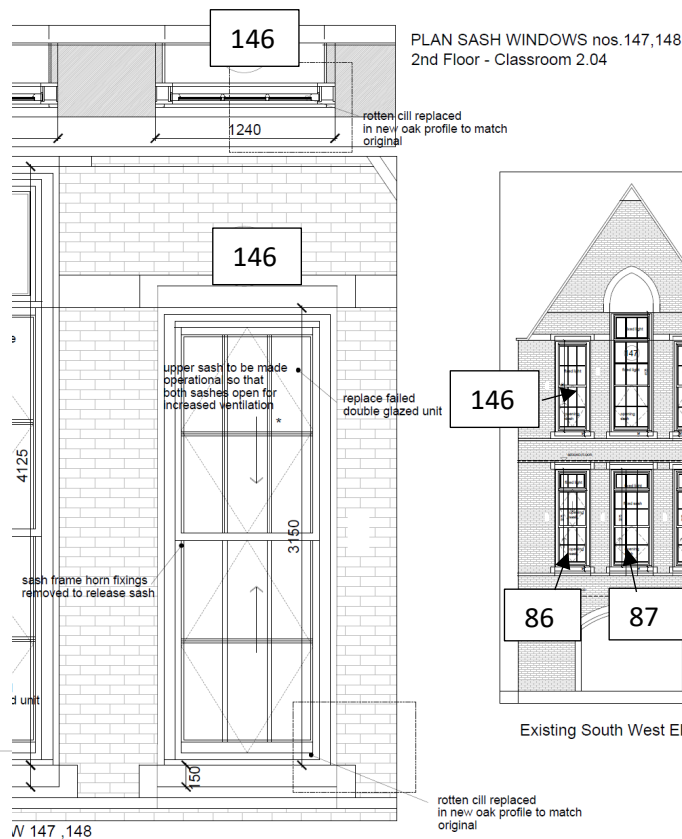
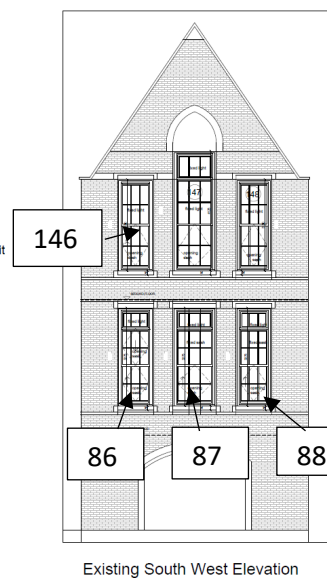
Project Information	
Client	CFBL French School
Location	Holmes Road, London NW5 3AX
Window Refurbishment	
Window Type	Type 2 Sash Window Repairs
Window Location	2nd Floor windows no. 147,148 Classroom 2.04
Project No.	FS2023 SK02-3 P2
Revision	1.2024A3 May 2023 FB
Francis Birch Architect	
Francis Birch Architect RIBA Architects	
11 North Hill Avenue, Haringey, London N4 4UJ	
T: 0208 442 8801	
M: 07958 555555	
E: f.birch@fba.co.uk
