# GEOTECHNICAL

**Garden Flat/Flat B, 7 Camden Terrace, London, NW1 9BP**

Client: SMS (AVI, PRE)  
Client Contact: [REDACTED]  
Client Ref: IFS-AVI-SUB-22-0102275  
Policy Holder: 7 Camden Terrace Freehold Ltd  
Report Date: 16 October 2024  
Our Ref: C79010G34782

## Drainage Investigation Report

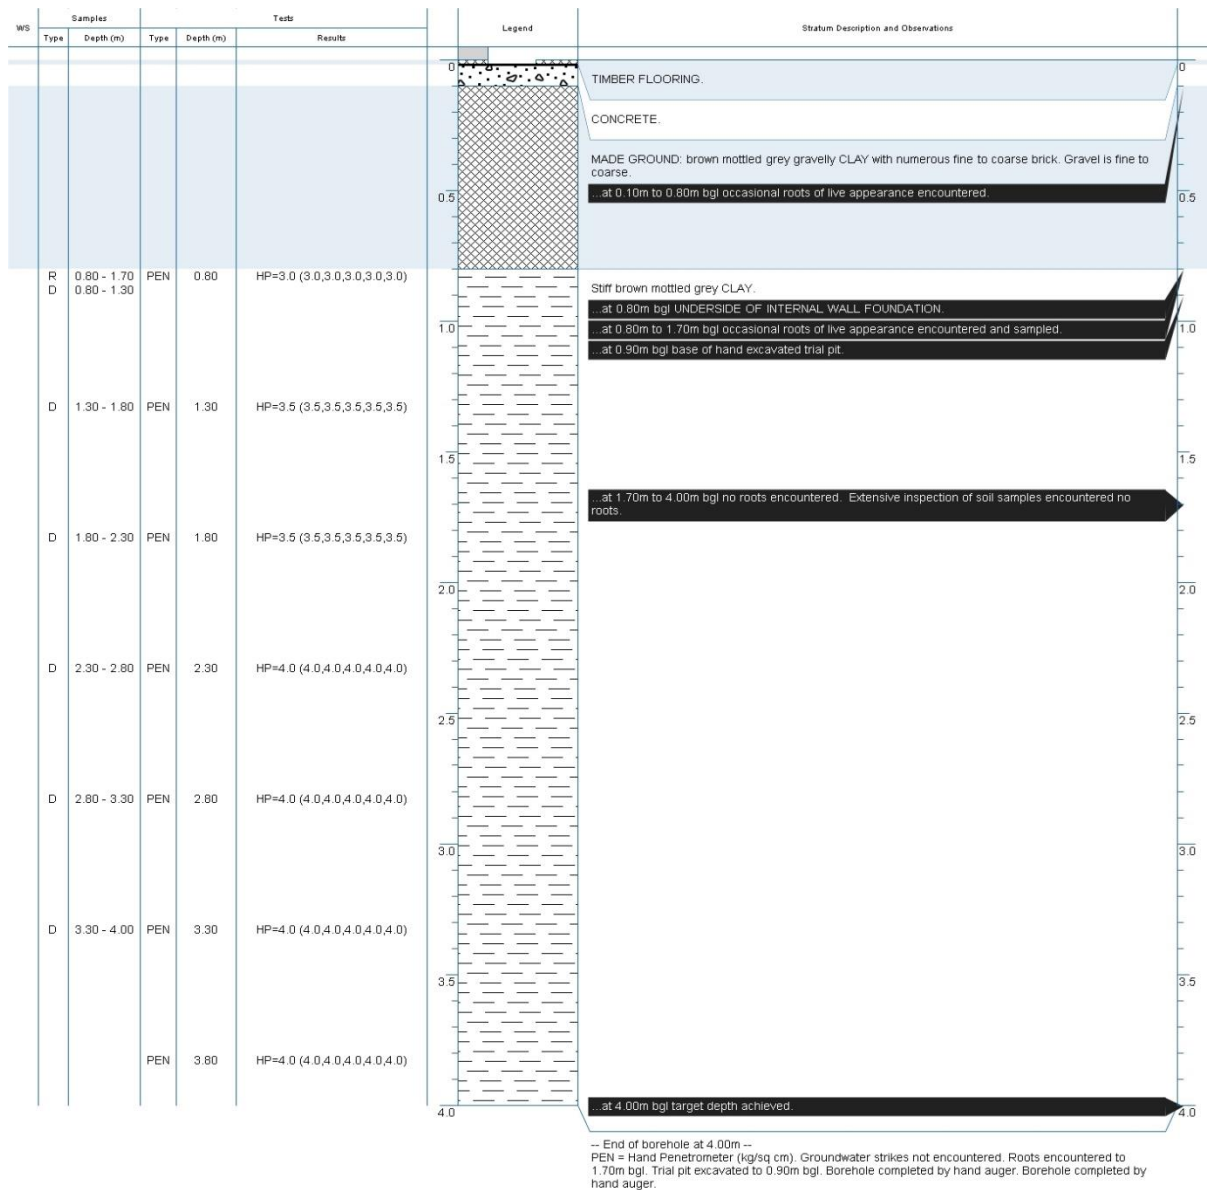
## ITP/BH2 Foundation Detail and Borehole Log

Internal wall foundation comprised of brick wall to 600mm bgl, bearing on concrete to 800mm bgl with no projection from the elevation. Underside of foundation (USF) was exposed to 100mm back from the face of the foundation and probed 400mm back from the face of the foundation.

At 0.80m bgl UNDERSIDE OF INTERNAL WALL FOUNDATION in ITP/BH2.

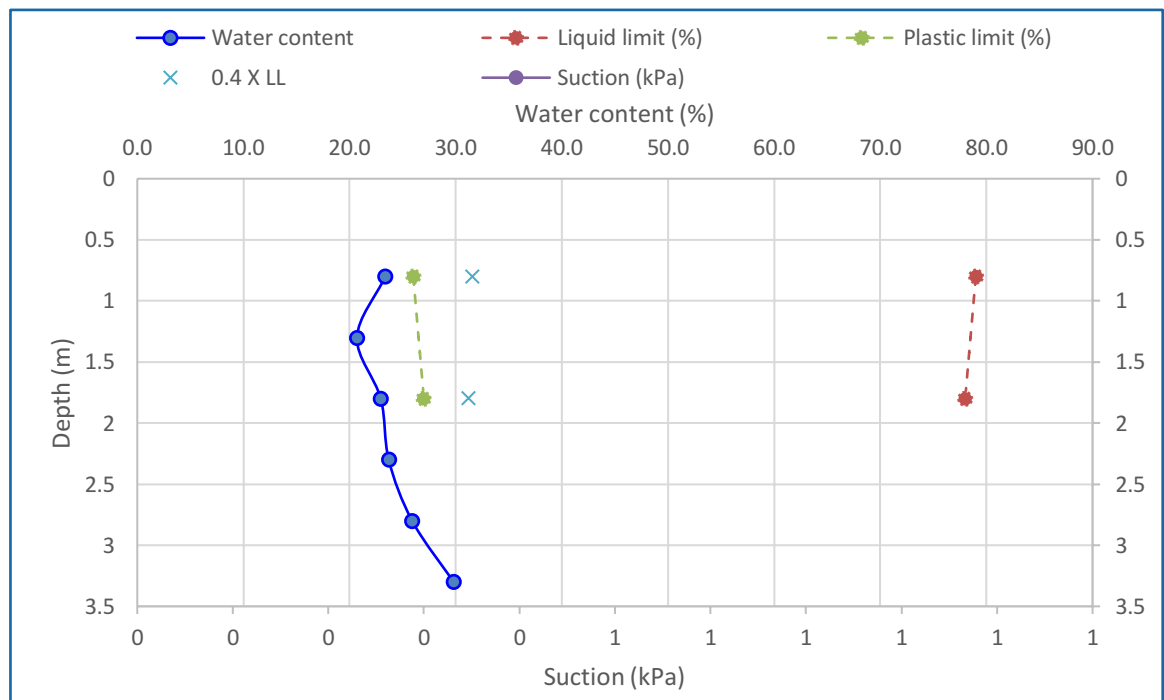
## Samples from BH1

Lab Ref	Depth (m)	WC (%)	LL (%)	PL (%)	PI (%)	.425 mm(%)	mod. PI (%)	Av. Suc. (kPa)	Description
1	0.8	23.4	79	26	53	91	48		Very stiff brown slightly gravelly CLAY with rare sand. Gravel is fine and medium.
2	1.3	20.7							Very stiff brown slightly gravelly CLAY with rare sand. Gravel is fine and medium.
3	1.8	22.9	78	27	51	99	50		Very stiff brown CLAY with rare gravel and sand. Gravel is fine
4	2.3	23.7							Very stiff brown CLAY with rare gravel and sand. Gravel is fine
5	2.8	25.9							Very stiff brown CLAY with rare gravel and sand. Gravel is fine
6	3.3	29.8							Very stiff brown CLAY with rare gravel and sand. Gravel is fine

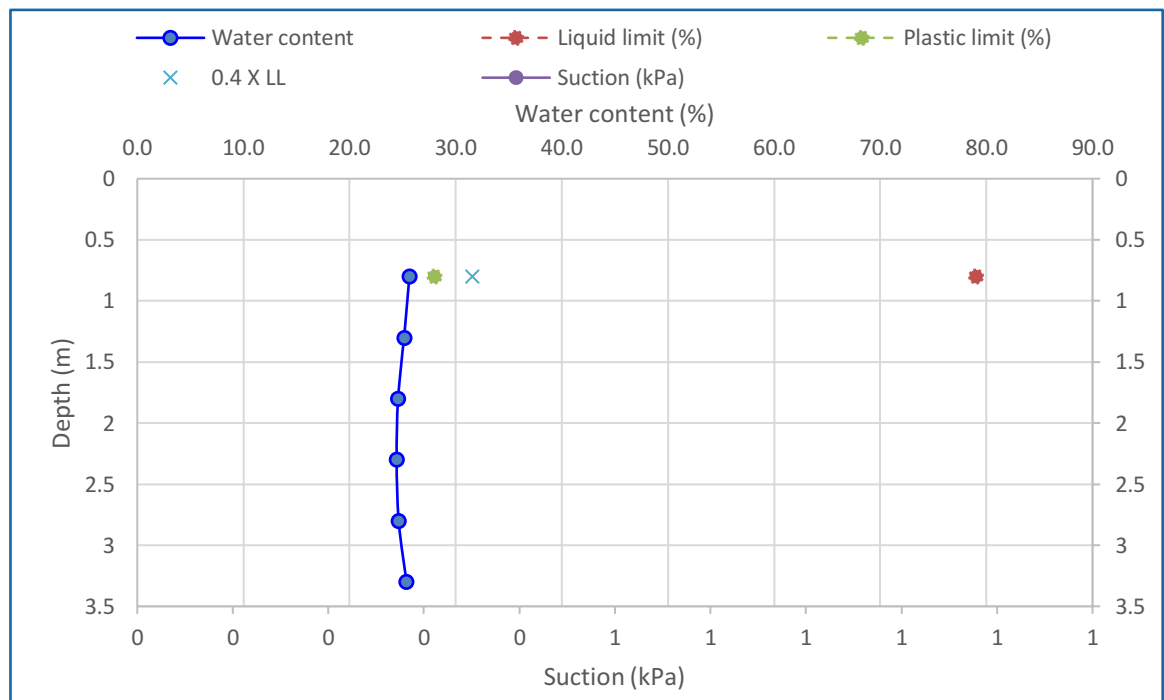
## Samples from BH2

Lab Ref	Depth (m)	WC (%)	LL (%)	PL (%)	PI (%)	.425 mm(%)	mod. PI (%)	Av. Suc. (kPa)	Description
7	0.8	25.6	79	28	51	100	51		Very stiff brown CLAY with rare gravel and sand. Gravel is fine
8	1.3	25.1							Very stiff brown CLAY with rare gravel and sand. Gravel is fine
9	1.8	24.6							Very stiff brown CLAY with rare gravel and sand. Gravel is fine
10	2.3	24.4							Very stiff brown CLAY with rare gravel and sand. Gravel is fine
11	2.8	24.6							Very stiff brown CLAY with rare gravel and sand. Gravel is fine
12	3.3	25.4							Very stiff brown CLAY with rare gravel and sand. Gravel is fine
