**8 HOLLY TERRACE, LONDON
N6 6LX**

**Heritage report, incorporating
design and access.**

**Application for remedial works to
strip and re-slate the roof, repairs to
brick vaults, renovation of
windows, repairs to render and
balcony and alterations to internal
lighting.**

April 2025

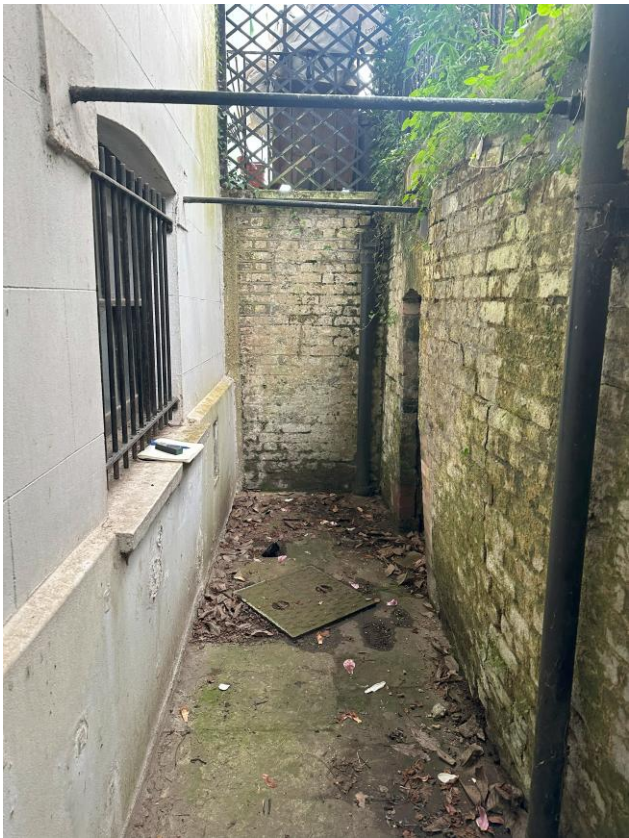
View D- view of lightwell

The existing vaults are structurally unsafe. Both arches have failed; the front wall has come away from the remainder of the vault, and the brickwork is bowing considerably. This movement and damage are caused by the close proximity of tree roots. Carefully take down bowing and unsafe brickwork and failing arches. Clean off bricks and set aside for re-use. Front of vaults to be re-built in existing and matching brickwork, and incorporate new lintels and Helibar steel bars to tie front wall into existing walls of vaults-as Engineer’s details

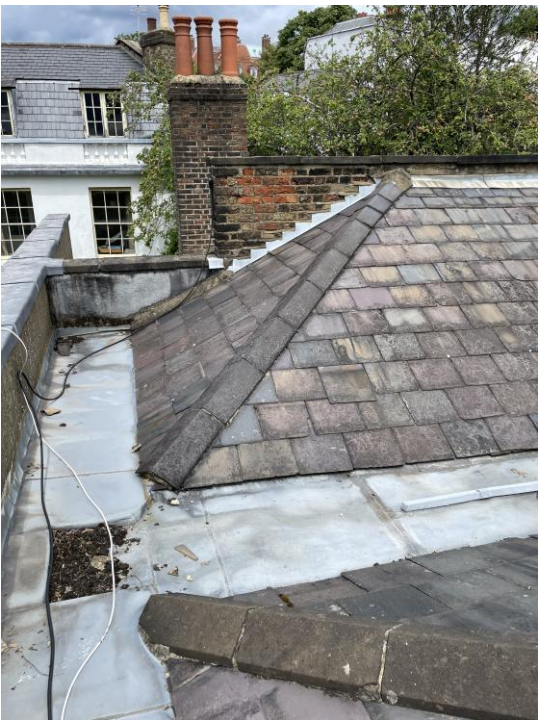
Damp coming through second-floor beam from leaking roof.
