19 Charterhouse Street

Project No. 23-52

Drainage Strategy Report DMAG-2352-DSR March 2025

Produced for Farrview Limited

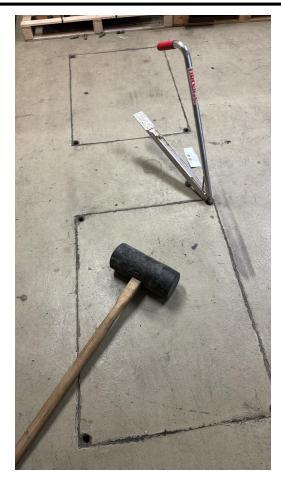
Unable to lift cover lids (2)

It is recommended that the seized covers are replaced for maintenance purposes and the remaining pipes are surveyed.

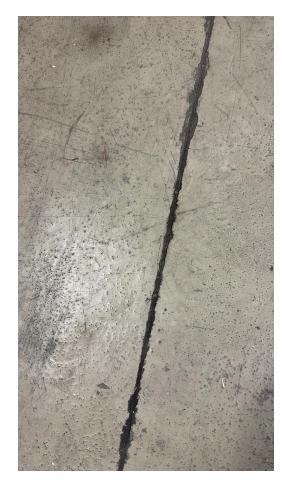
Unable to lift cover lids (4)

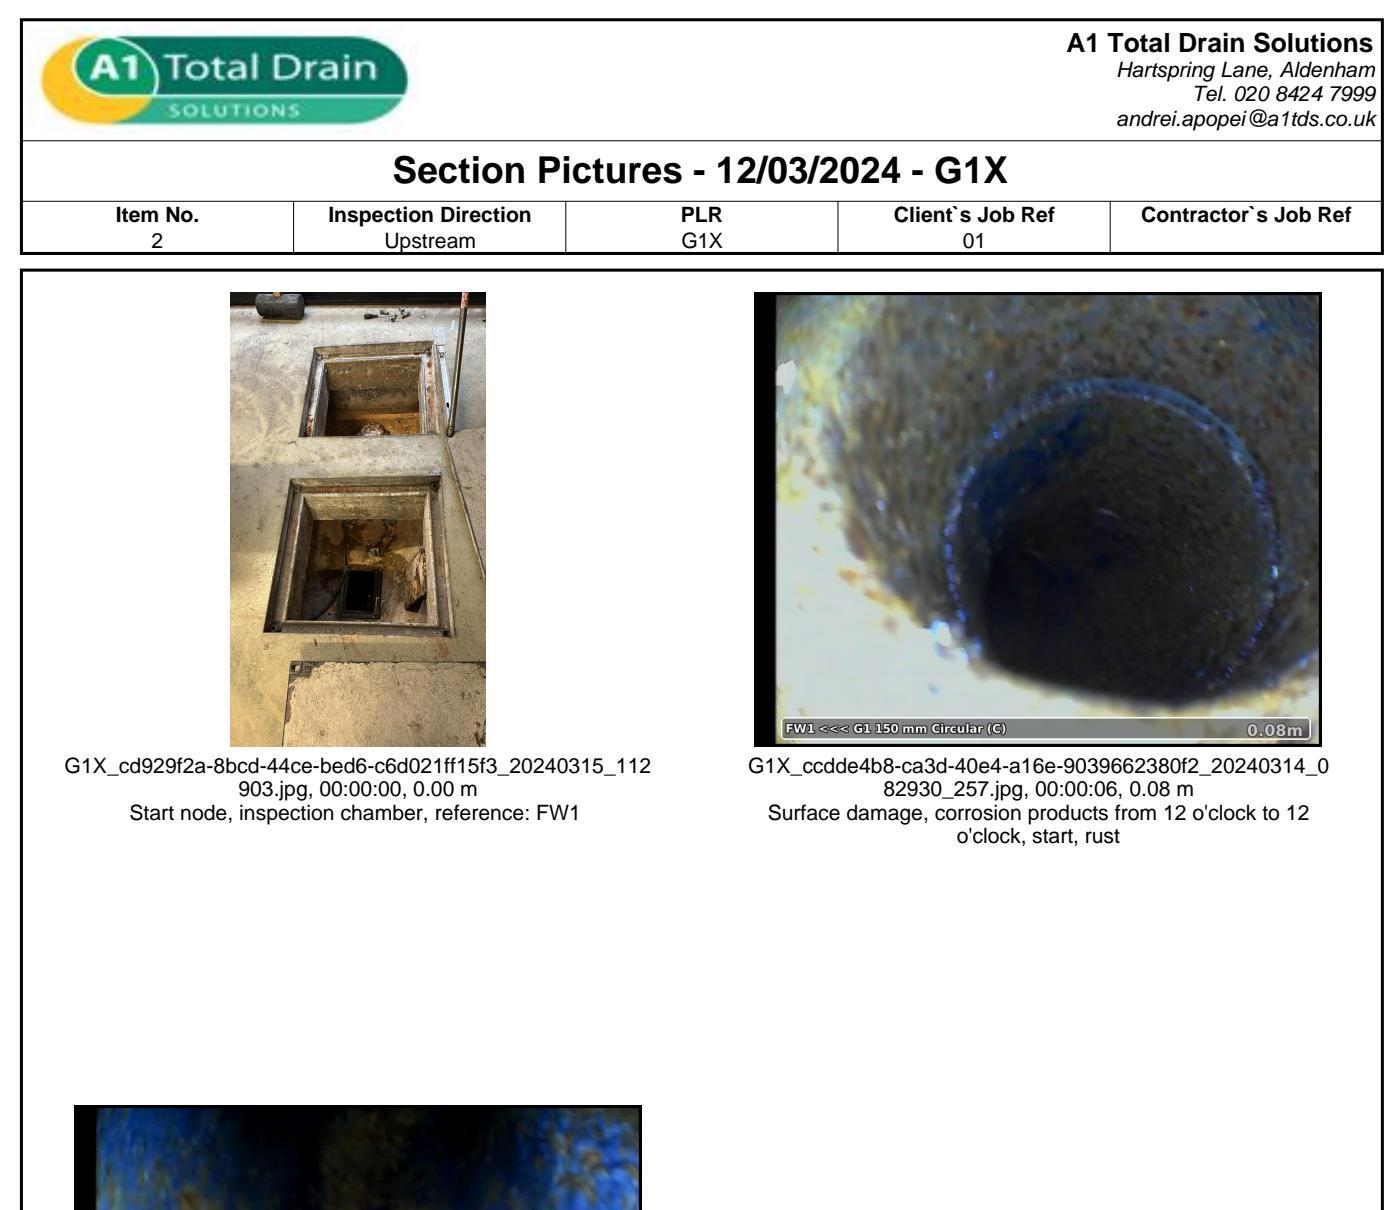
G1X_0d4d1348-9d12-48ac-9c04-da5c2d59dba1_20240314_0 83005_121.jpg, 00:00:25, 2.32 m Surface damage, corrosion products from 12 o'clock to 12 o'clock, finish, rust

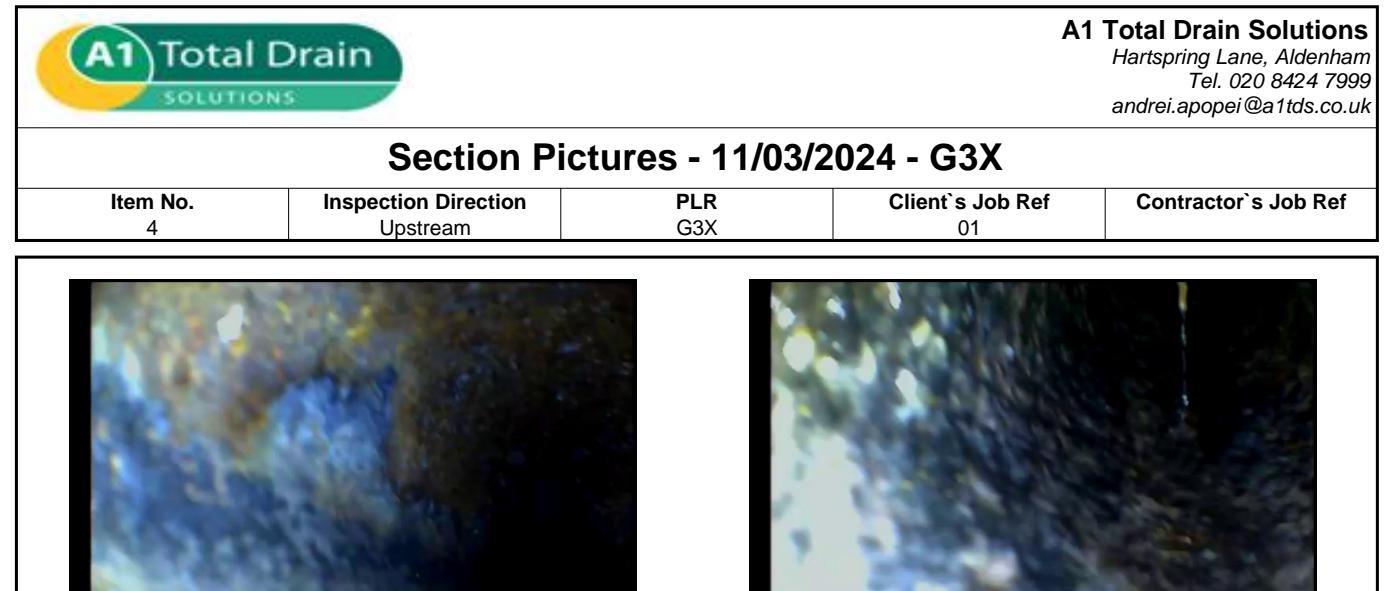
FW1 <<< G3 150 mm Circular (C) 0.49m

G3X_45320adb-739e-4579-869e-f48f43425c7d_20240314_08 3708_145.jpg, 00:00:09, 0.49 m Surface damage, corrosion products from 12 o'clock to 12 o'clock, start, rust

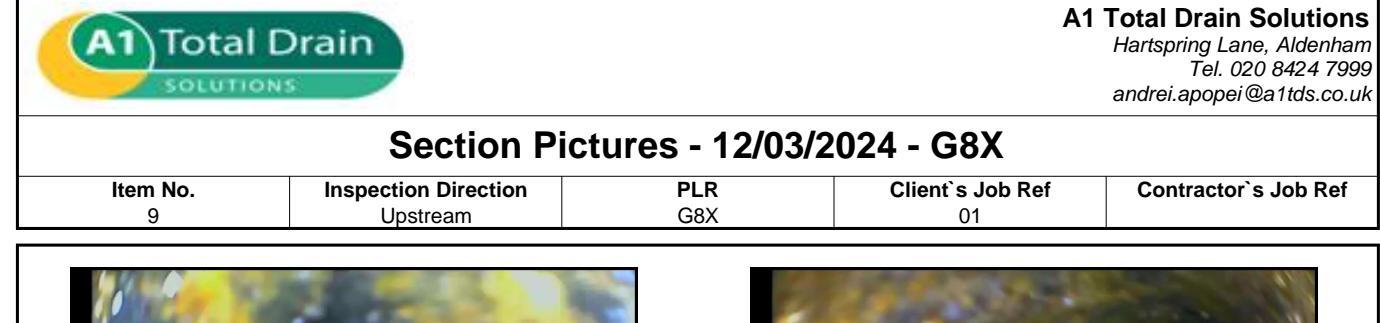
G8X_83a088b8-ce63-4d3a-b8c8-9b50ea16ae07_20240314_0 94508_379.jpg, 00:00:23, 2.24 m Surface damage, corrosion products from 12 o'clock to 12 o'clock, rust

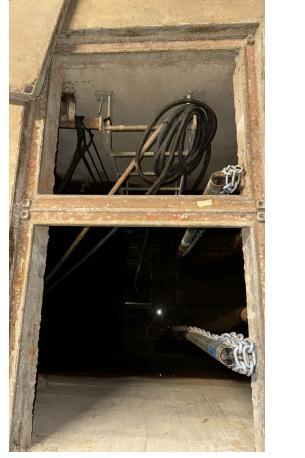
G9X_3ddb165c-6889-455c-bccc-03b02a745db1_20240315_1 22105.jpg, 00:00:02, 0.00 m Start node, other special chamber, reference: PS2, PUMPING STATION

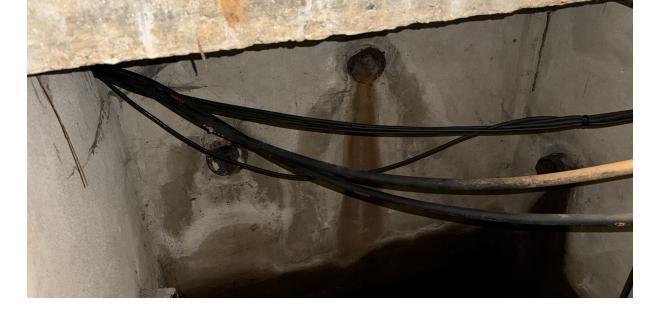
G9X_298c2a89-c7d5-4b55-a21e-bca4e45f0cc7_20240315_12 2112.jpg, 00:00:02, 0.00 m Start node, other special chamber, reference: PS2, PUMPING STATION

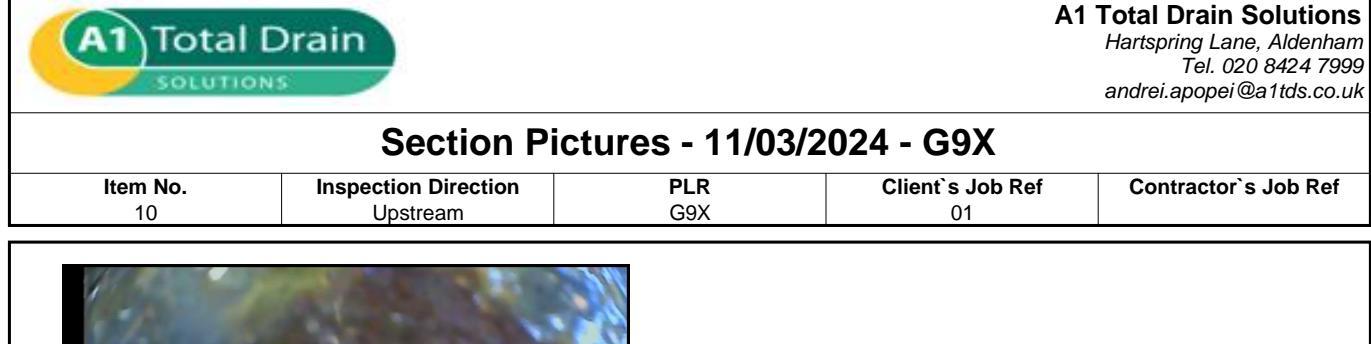
G9X_1836089f-fa55-4f23-86d8-3ead5427c59d_20240314_11 3444_049.jpg, 00:01:48, 14.82 m Attached deposits, other from 3 o'clock to 9 o'clock, 5% cross-sectional area loss, finish, rust

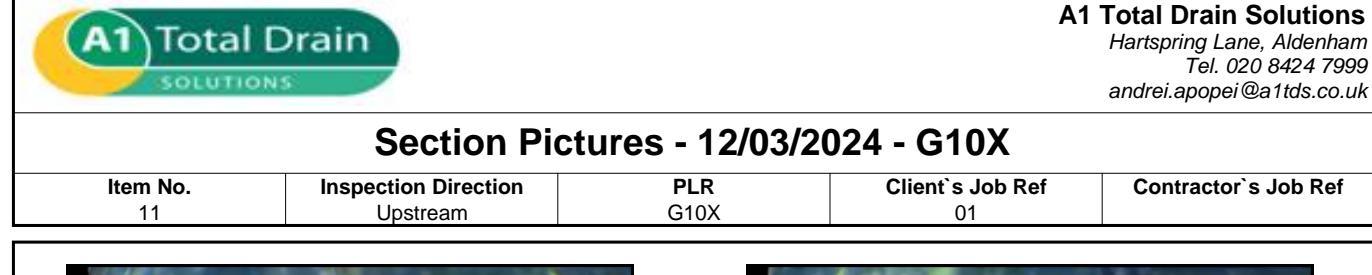
G10X_b4ab0cd9-77e9-4ed6-9eaa-721a4bf0d418_20240314_ 114651_698.jpg, 00:00:13, 0.04 m Surface damage, corrosion products from 12 o'clock to 12 o'clock, rust

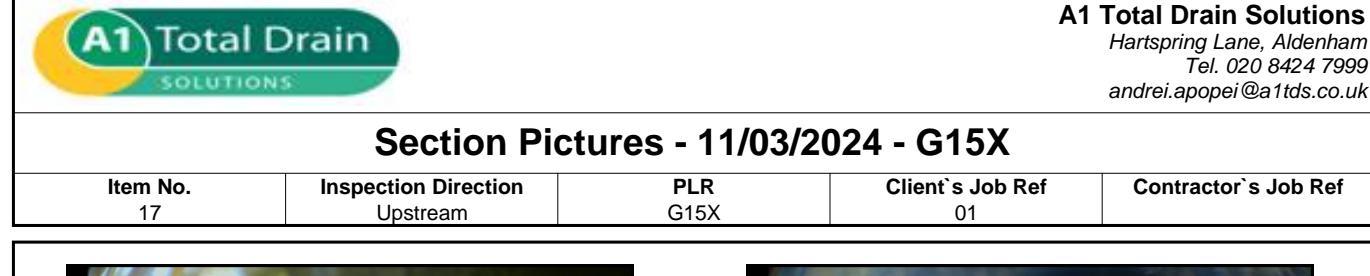
G15X_271d15ad-0d33-4f7f-805c-a734677c1be1_20240314_1 32510_254.jpg, 00:00:05, 0.00 m Surface damage, corrosion products from 12 o'clock to 12 o'clock, start, rust

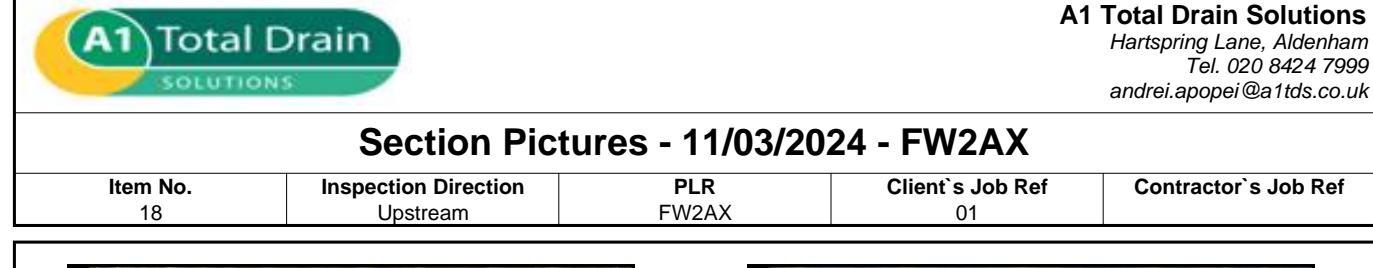
FW2AX_73906fd4-1a7b-4e96-89f6-7d1fb7850fde_20240314_ 132706_402.jpg, 00:00:05, 0.00 m Surface damage, corrosion products from 12 o'clock to 12 o'clock, start, rust

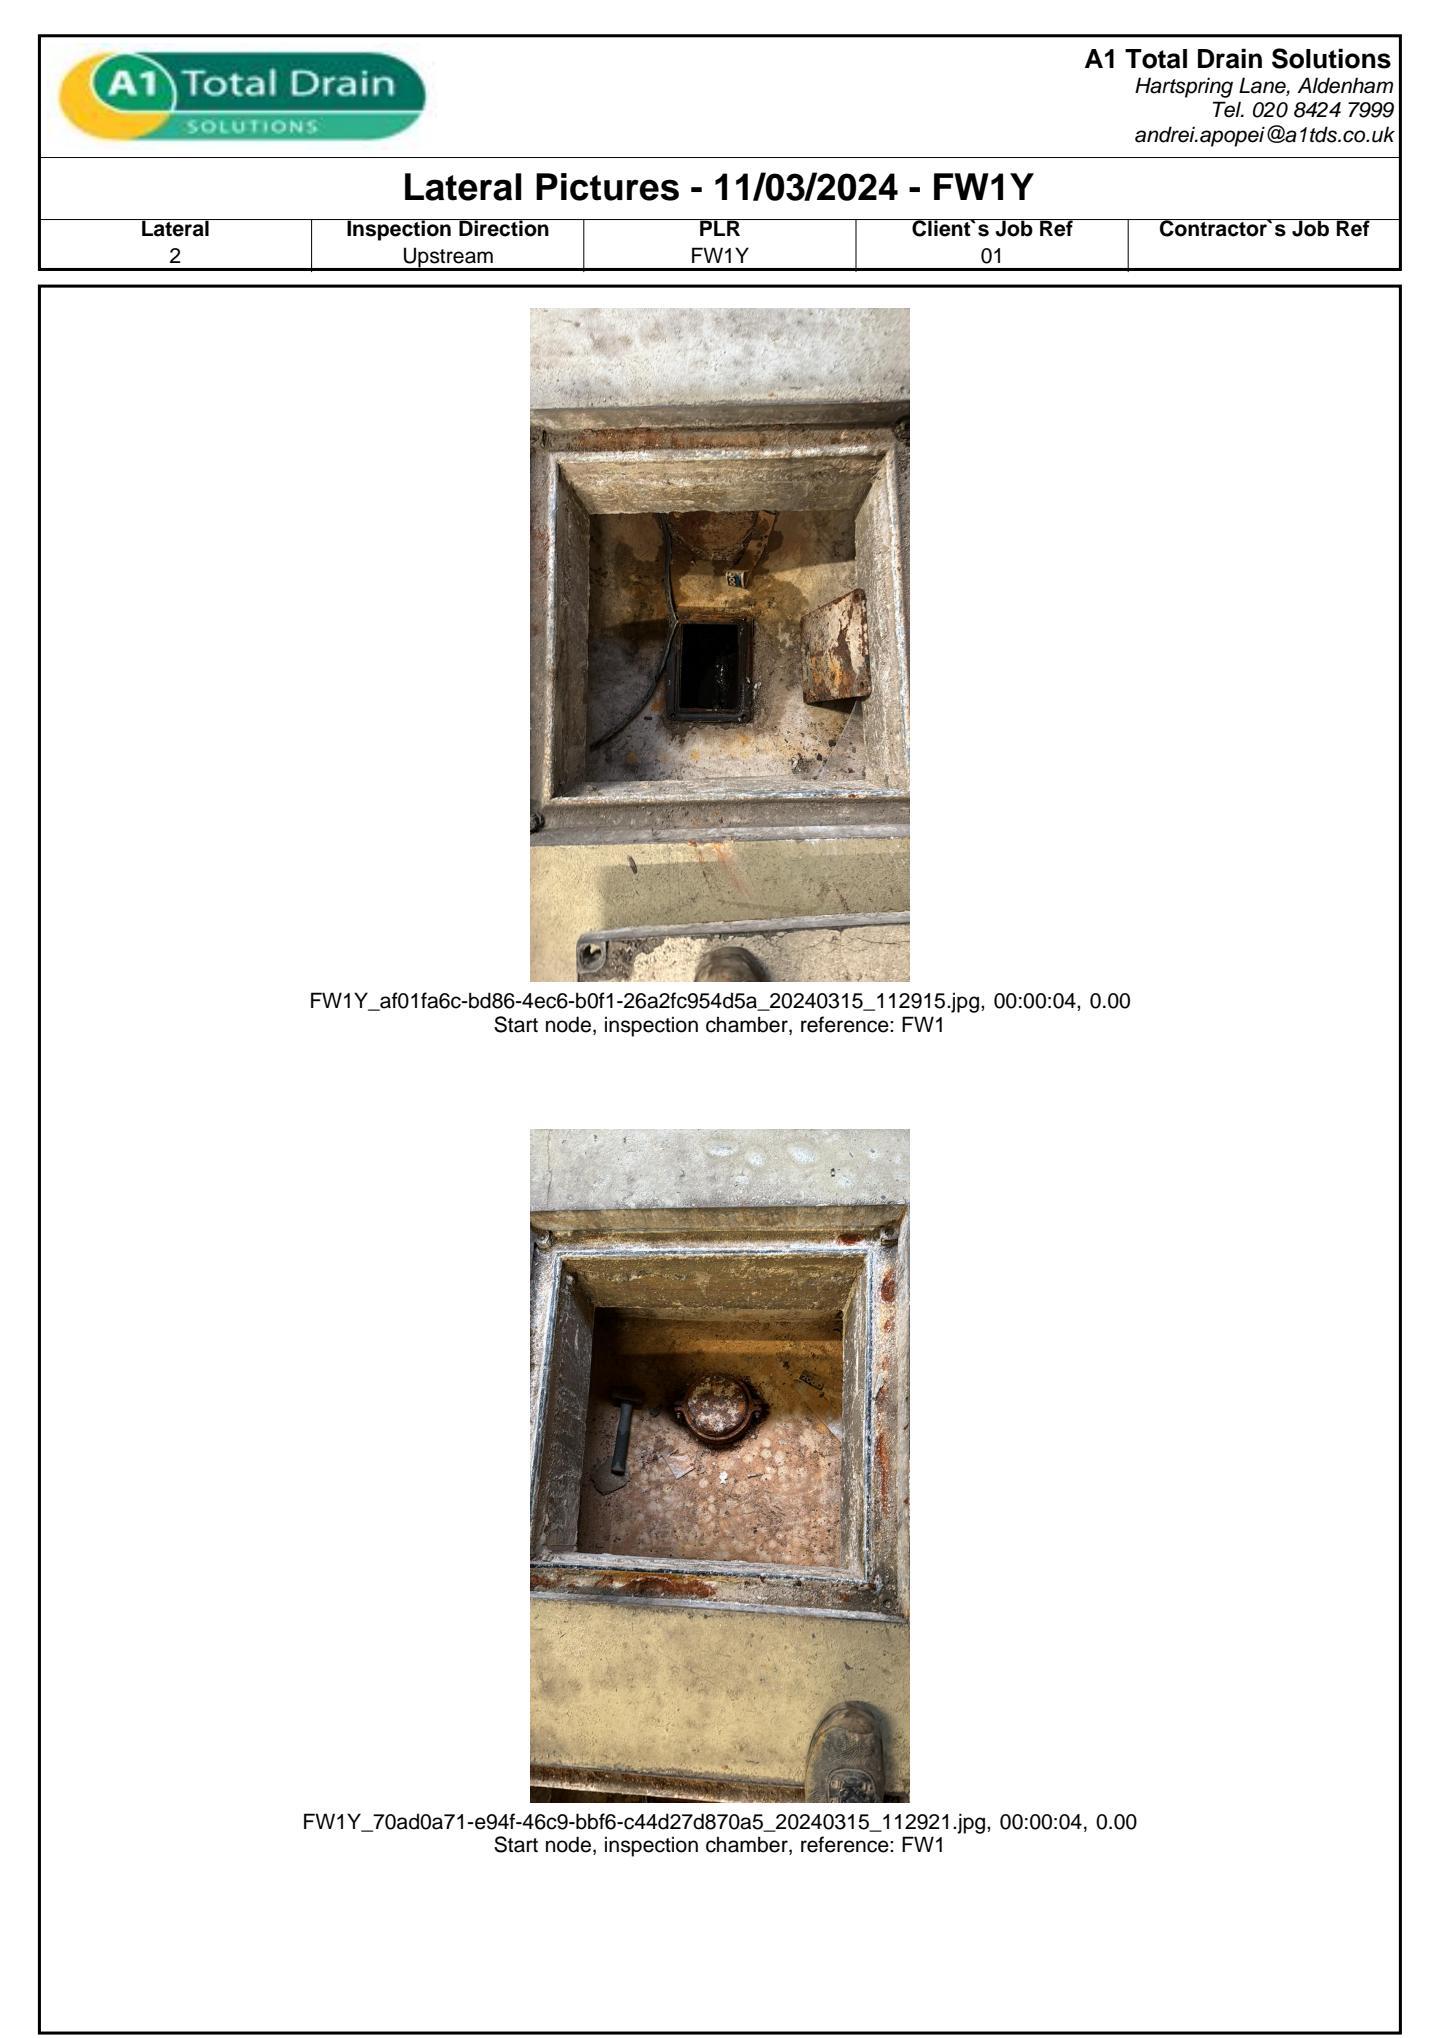
3.42	L	R	Line de	viates right				00:	00:25			
	6.92 MCVC					I changes to v	itrified clay			00:	00:38			
	7.00 FC				Fractur	e, circumferen	tial from 12 c	clock to 1	2 o'clo	ock 00:	00:39	FW2Y_	17	3
												e08ea7-	23	
		7 00	\٨/	т	Turbid	vater level 10	% of the vert	ical dimon	sion	00.0	00.46	54-4020	-0
