**Project Name:** HAPPY DRAINS Flat 1 18 Platts Lane NW3 7NS - C1013264  
**Project Description:** CCTV Survey  
**Project Status:** Issued  
**Project Date:** 23/10/2024  
**Inspection Standard:** MSCC5 Sewers & Drainage GB (SRM5 Scoring)

FLAT 1, PLATTS LANE  
HAMPSTEAD  
LONDON  
NW3 7NS

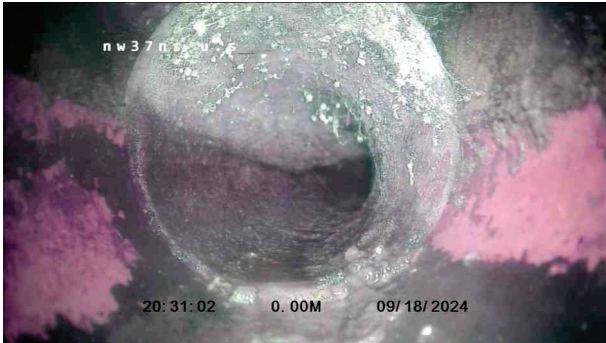
WCX\_6fc7e5e8-1425-47ef-9898-0138bef9f86b\_20240922\_124  
329\_312.jpg, 00:00:00, 0.00 m  
Start node, manhole, reference: FWMH1

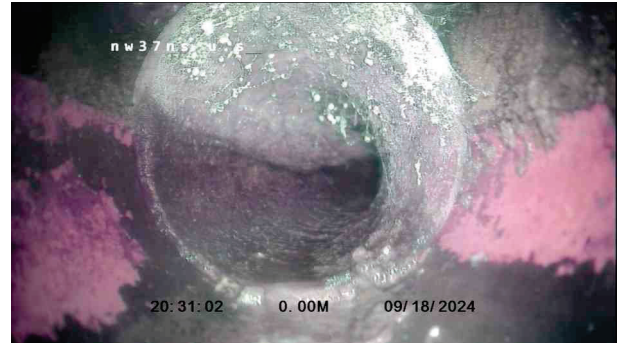
WCX\_39352e6f-2fab-4614-8250-97e7712343d3\_20240922\_1  
24336\_317.jpg, 00:00:00, 0.00 m  
Water level, 0% of the vertical dimension

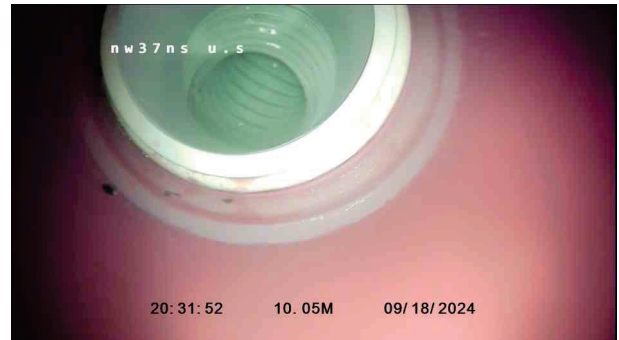
30e71dd8-0ac1-49ed-8709-9a35791bb8be.png, 00:00:51, 10.05 m  
Finish node, other special chamber, reference: WC, WC Outlet

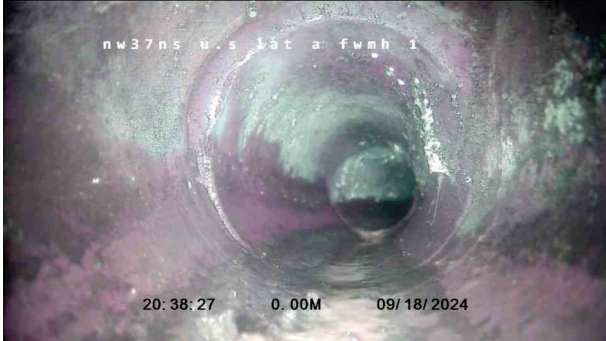
StackX\_8b9c0b4c-9d23-4312-810a-e2578a160066\_20240922\_124349\_381.jpg, 00:00:00, 0.00 m  
Start node, manhole, reference: FWMH1

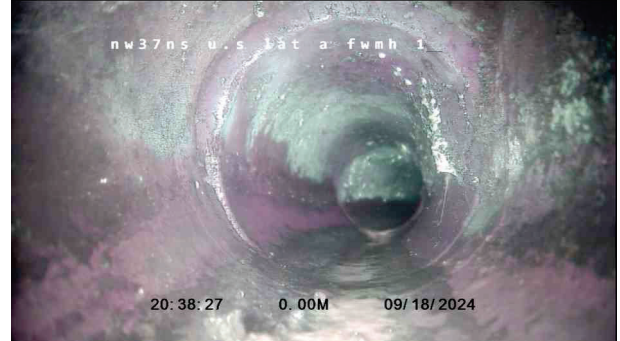
StackX\_cd691033-bd49-4663-9acf-ac5623cbe645\_20240922\_124355\_226.jpg, 00:00:00, 0.00 m  
Water level, 0% of the vertical dimension

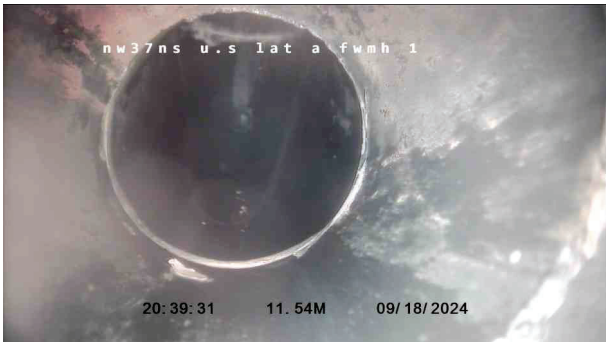
9595a0a6-322a-459c-9cde-2c20bc233e4d.png, 00:01:04, 11.54 m  
Finish node, other special chamber, reference: Stack, Downpipe

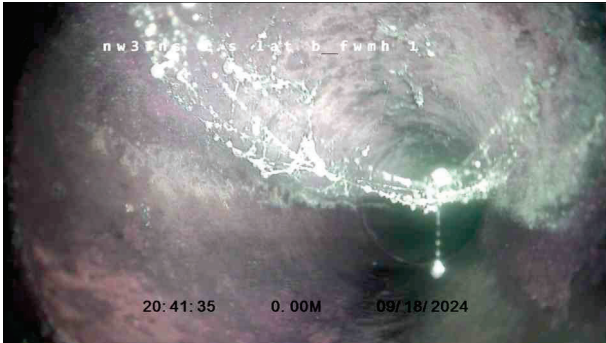
GullyX\_2fd6a9c8-f466-420b-a91e-420624c9f054\_20240922\_1  
24408\_623.jpg, 00:00:00, 0.00 m  
Start node, manhole, reference: FWMH1

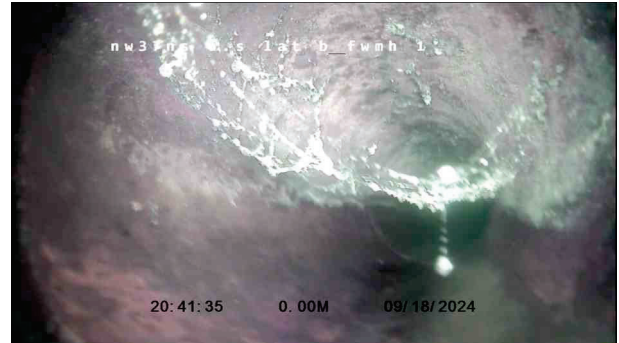
GullyX\_8e7b33be-abac-4371-b555-912a57c9bdfd\_20240922\_124412\_143.jpg, 00:00:00, 0.00 m  
Water level, 0% of the vertical dimension

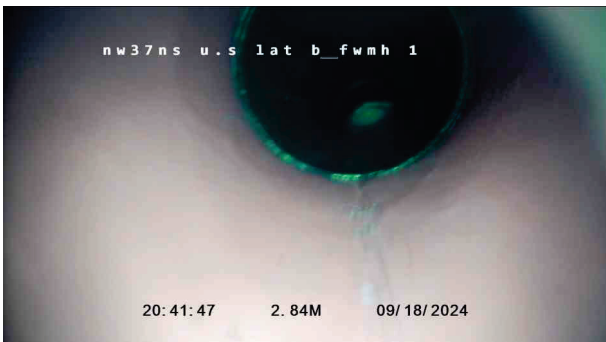
ea6b7b9f-6510-4b38-a6e8-01c8136cf193.png, 00:00:12, 2.84 m  
Finish node, gully, reference: Gully

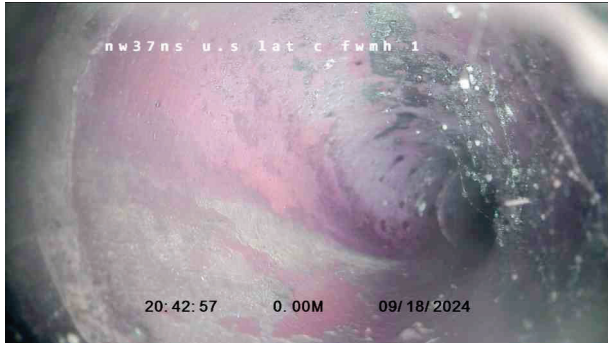
StackY\_258e7d10-5cd7-4268-8a6d-db3b72df8407\_20240922\_124424\_257.jpg, 00:00:00, 0.00 m  
Start node, manhole, reference: FWMH1

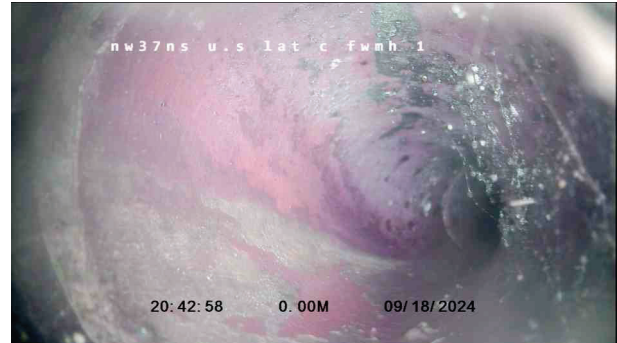
StackY\_6797472a-554f-4fad-aa6c-5ee8321ffe1b\_20240922\_124427\_948.jpg, 00:00:01, 0.00 m  
Water level, 0% of the vertical dimension

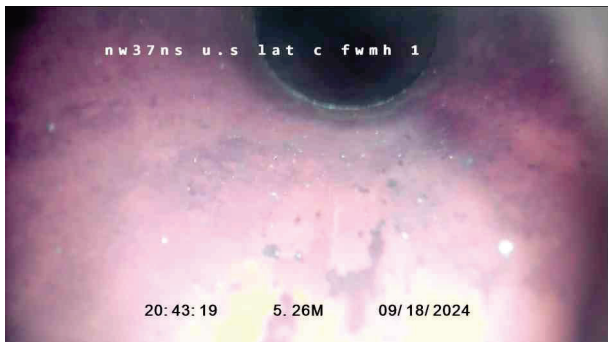
84ed1b34-c6c8-427d-a4b3-ca011fc27df4.png, 00:00:22, 5.26 m  
Finish node, other special chamber, reference: Stack, Downpipe

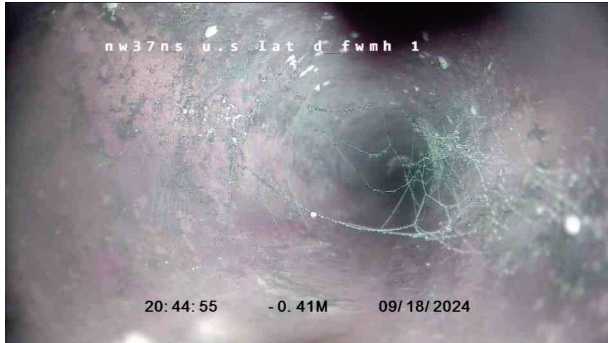
WCY\_1def0308-151b-4cf7-9529-d6fc00c39383\_20240922\_12  
4440\_568.jpg, 00:00:00, 0.00 m  
Start node, manhole, reference: FWMH1

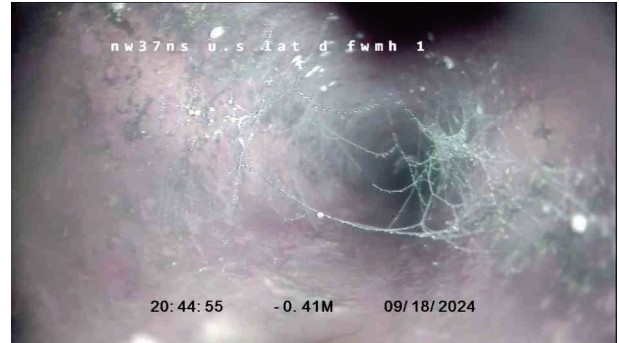
WCY\_dc5f5864-2216-4b03-a2c6-f1647335528a\_20240922\_12  
4445\_706.jpg, 00:00:01, 0.00 m  
Water level, 0% of the vertical dimension

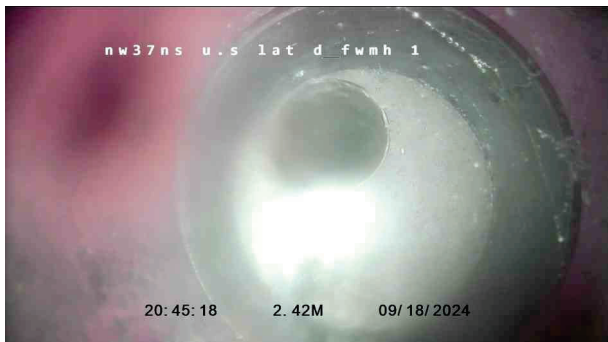
def27aae-c442-4bde-a74f-5681a032a4e3.png, 00:00:24, 2.42  
m  
Finish node, other special chamber, reference: WC, WC outlet

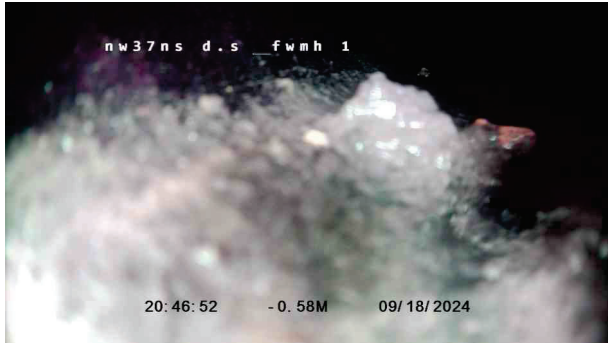
FWMH1X\_5deb5bc2-7c55-4057-90d4-8b2aef45b3f9\_2024092  
2\_124458\_447.jpg, 00:00:00, 0.00 m  
Start node, manhole, reference: FWMH1

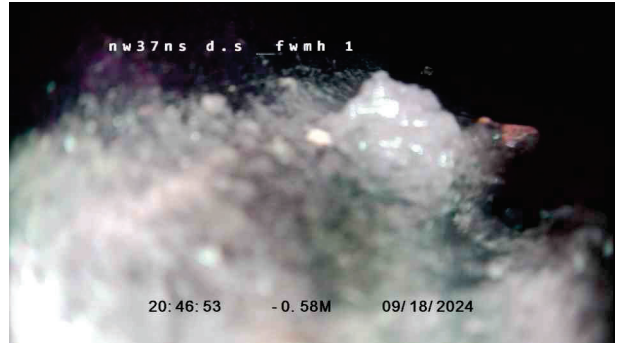
FWMH1X\_204676a4-f1ee-4a5b-8388-85c73dd93639\_202409  
22\_124503\_884.jpg, 00:00:01, 0.00 m  
Water level, 0% of the vertical dimension

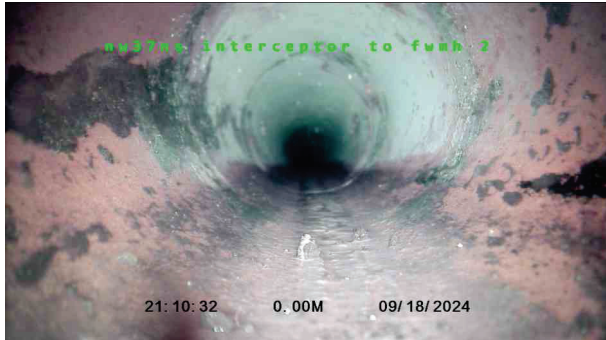
FWMH2X\_aa963c10-c128-4f11-905d-d98281da8b31\_20240922\_124517\_203.jpg, 00:00:00, 0.00 m  
Start node, manhole, reference: Interceptor

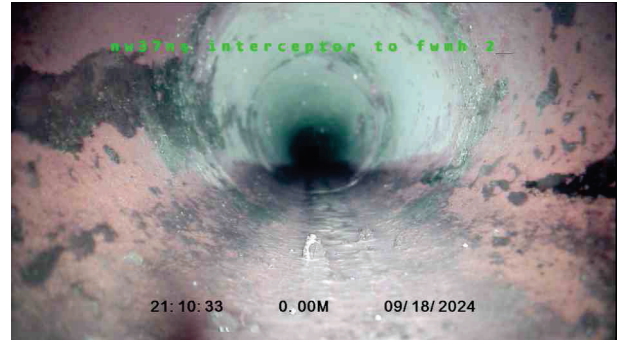
FWMH2X\_ec042548-a515-4205-bbdd-a3d21bd212fa\_20240922\_124520\_575.jpg, 00:00:01, 0.00 m  
Water level, 0% of the vertical dimension

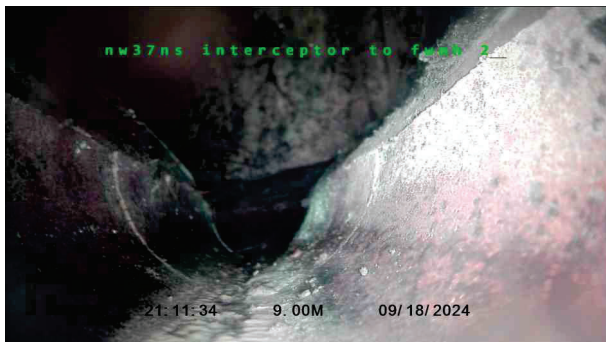
a9ad20ed-5963-477c-ada5-32f789414d7a.png, 00:01:02, 9.00 m  
Finish node, manhole, reference: FWMH2

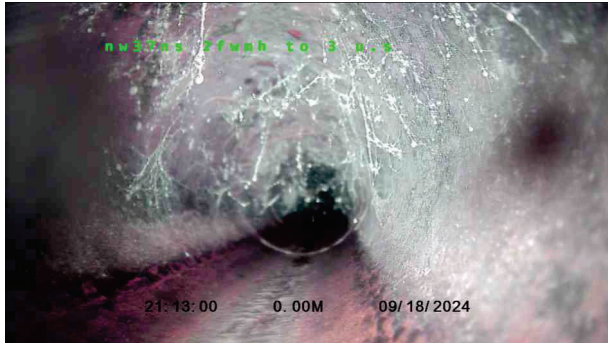
FWMH3X\_c4bc48de-c0dc-4c9c-9de3-39b2400c1c88\_2024092  
2\_124532\_142.jpg, 00:00:00, 0.00 m  
Start node, manhole, reference: FWMH2

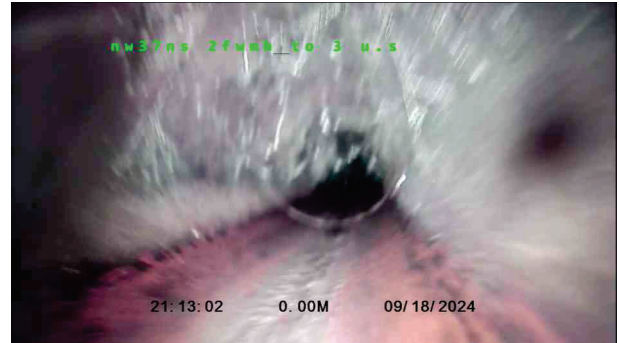
FWMH3X\_328538a0-1892-4cb2-a994-308f94411719\_202409  
22\_124544\_343.jpg, 00:00:02, 0.00 m  
Water level, 0% of the vertical dimension

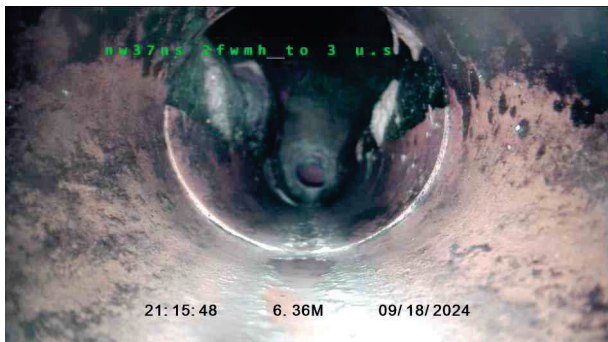
5aedf74f-88a5-4976-afdf-3cda24e694d6.png, 00:02:49, 6.36 m  
Finish node, manhole, reference: FWMH3

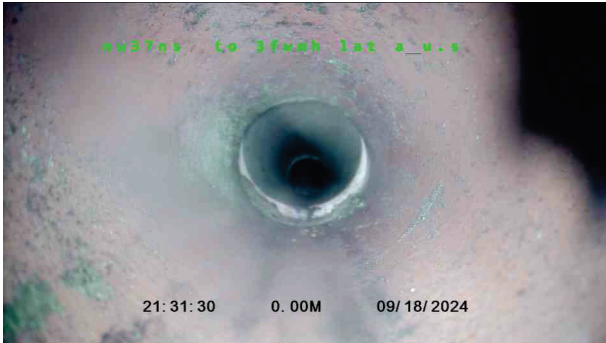
AX\_ac8cd9ed-97ea-4f14-bfe1-7682d8d4aac3\_20240922\_1248  
06\_879.jpg, 00:00:00, 0.00 m  
Start node, manhole, reference: FWMH3

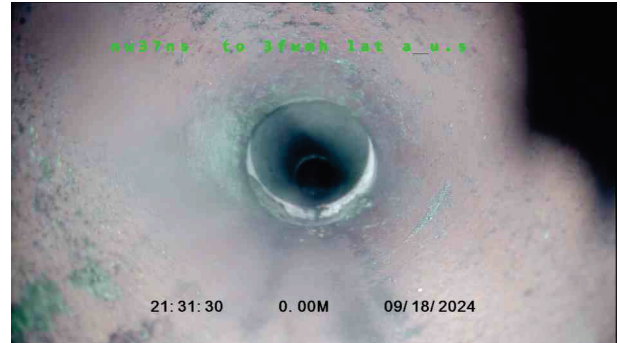
AX\_bea1b3f1-d0ba-47b6-8eb1-630b301e0136\_20240922\_124  
810\_536.jpg, 00:00:00, 0.00 m  
Water level, 0% of the vertical dimension

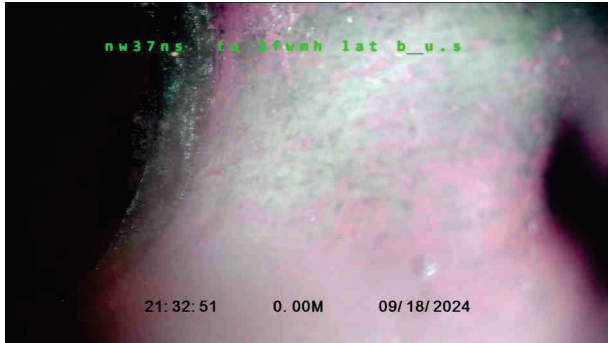
BX\_e3ceaddc-6c6a-42aa-8a74-01ea3157009c\_20240922\_124  
823\_491.jpg, 00:00:00, 0.00 m  
Start node, manhole, reference: FWMH3

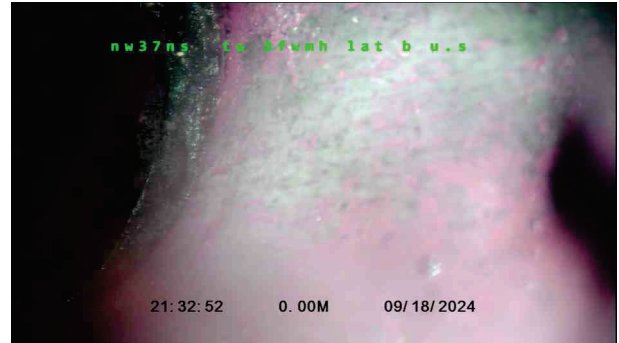
BX\_9bd0341b-d7c1-42d4-bef4-95c8c0eed3ce\_20240922\_124  
827\_174.jpg, 00:00:00, 0.00 m  
Water level, 0% of the vertical dimension

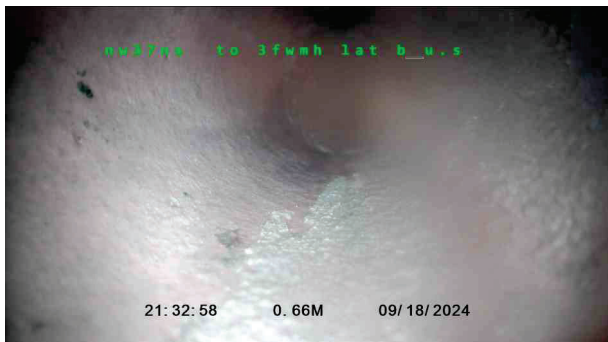
3209b333-d151-4a5f-9277-4b518c39258d.png, 00:00:07, 0.66  
m  
Finish node, other special chamber, reference: B, Downpipe

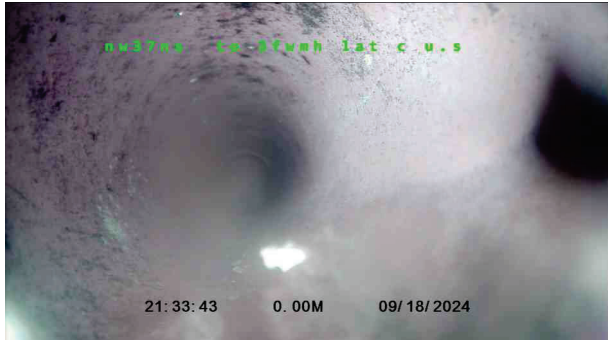
CX\_142534f0-107b-4de2-a719-1bf22820c6d7\_20240922\_124  
839\_530.jpg, 00:00:00, 0.00 m  
Start node, manhole, reference: FWMH3

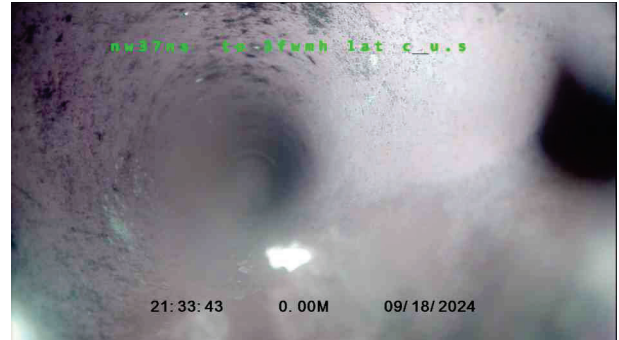
CX\_5077d3d9-44c0-4501-b08d-78f4bcd68e0f\_20240922\_124  
843\_143.jpg, 00:00:01, 0.00 m  
Water level, 0% of the vertical dimension

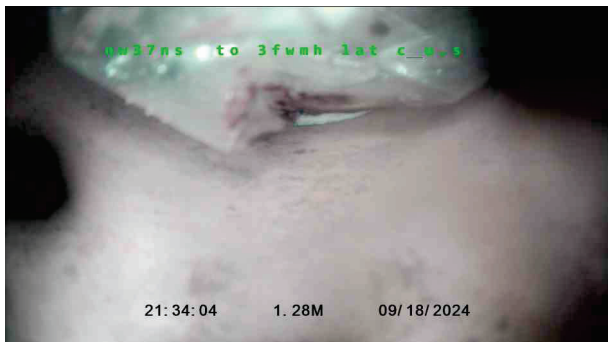
77f305b3-29ef-45f8-bfef-f0df4b8f19d9.png, 00:00:21, 1.28 m  
Finish node, other special chamber, reference: C, Downpipe

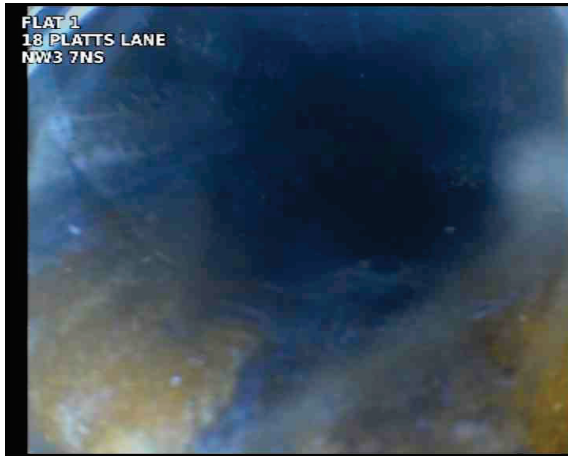
FWMH4X\_c8c40d6b-469b-4a22-bcc3-93ee2a049102\_20241007\_013123\_193.jpg, 00:00:00, 0.00 m  
Start node, manhole, reference: FWMH4

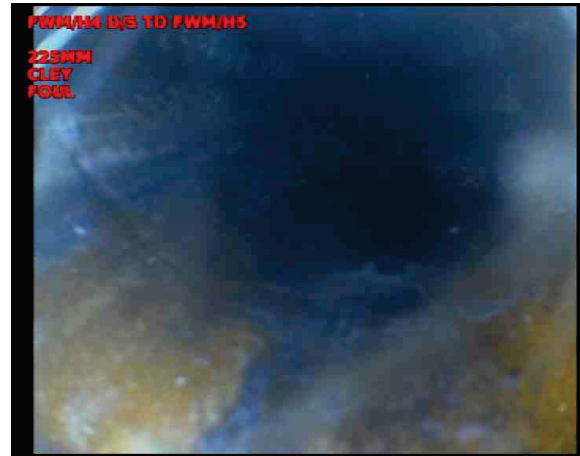
FWMH4X\_92b6c406-38bd-46ac-bc18-7620f114b33a\_20241007\_013144\_754.jpg, 00:00:00, 0.00 m  
Start node, manhole, reference: FWMH4

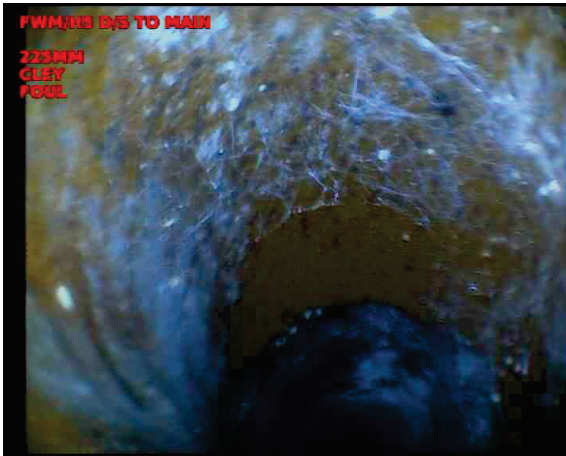
FWMH5X\_50f5f175-83b9-48ed-bd47-e08b24fca8d\_20241007\_013455\_553.jpg, 00:00:00, 0.00 m  
Start node, manhole, reference: FWMH5
