# Site Investigation Report

101134.1.BSI

Client	Crawford & Co
Client ref	SU1904991
Visit date	02/01/2020
Report date	06/01/2020

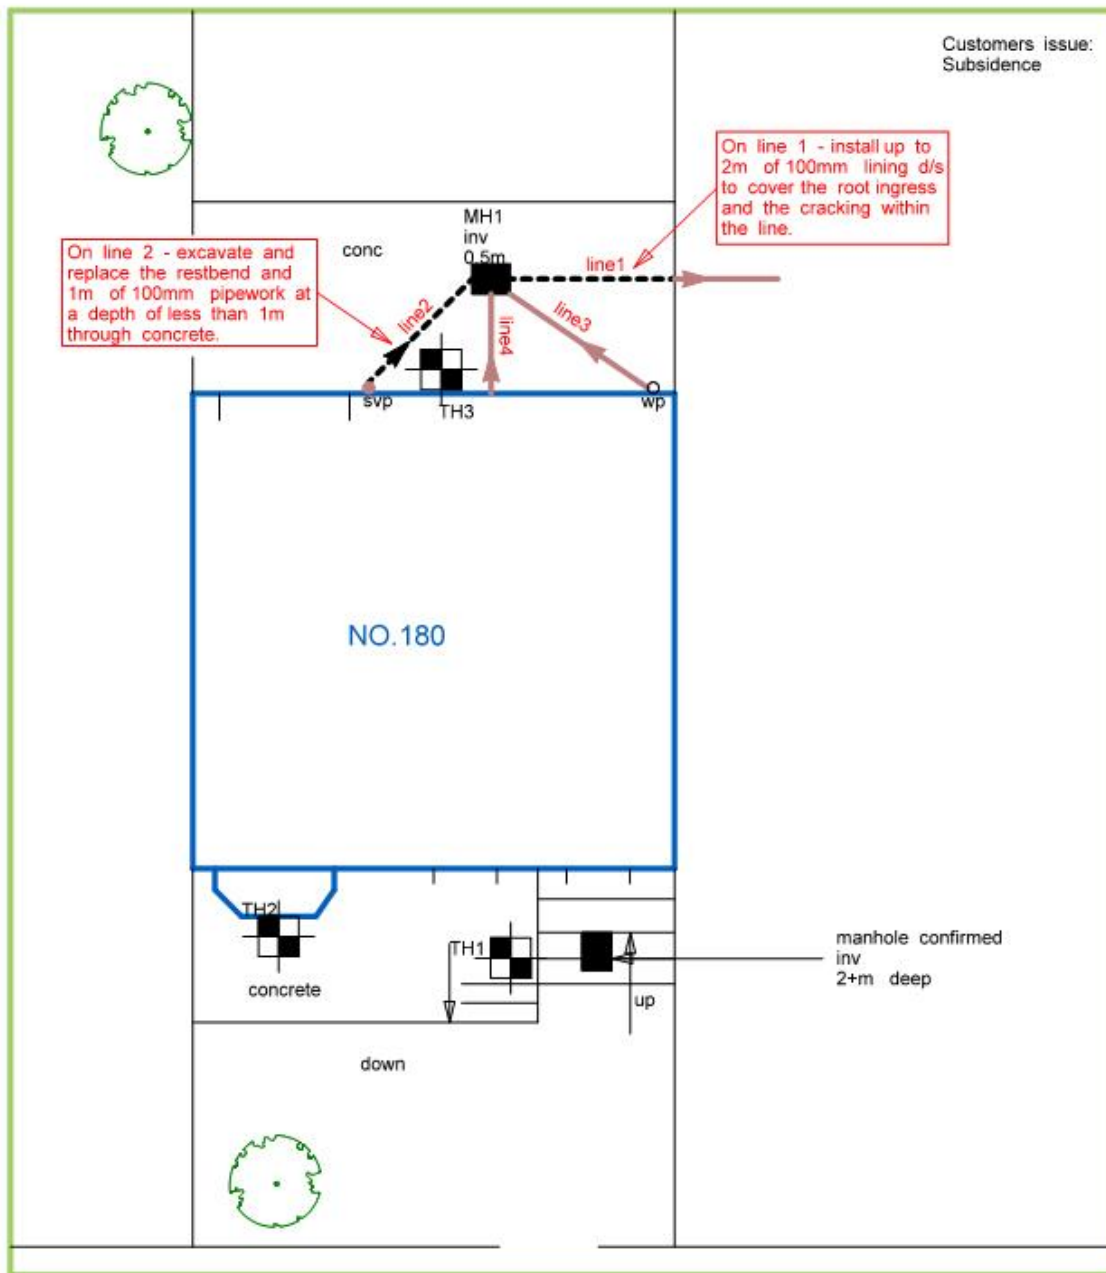
## FRONT OF PROPERTY

Our CCTV survey revealed cracking and root ingress for the first 2m of pipework.

Our CCTV survey revealed cracking directly u/s of mh1.

It should also be noted that there was a manhole located beneath the front set of stairs. This was over 2m deep and was a very tight manhole, due to this we could not survey any drainage lines entering it. If the LA wishes for this to be surveyed then 2 men will be required to attend site with confined space entry equipment which will come at a considerable cost. We believe that the drainage at the customers property is all accounted for and runs to the rear manhole.

On line 2, excavate and replace SVP and 1m of 100 mm pipework at a depth no greater than 1m through concrete.

On line 1, install 2m of 100 mm liner directly downstream of MH1.

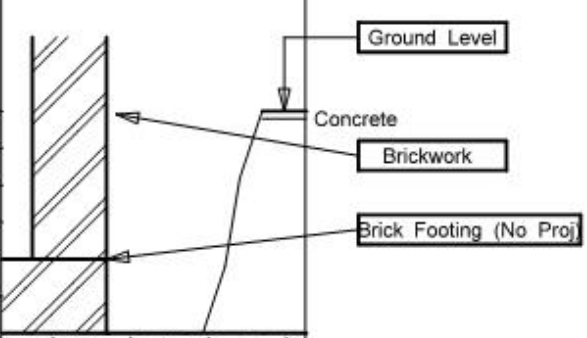
# Trial Hole Log No.1

Location: Front rhs

Ground Level Concrete Brickwork Brick Footing (No Proj)				
0.5						
1.0			54kpa		Soil @ 0.6m	
1.5			63kpa		Soil @ 1.1m	Root @ 1.1m
2.0			79kpa		Soil @ 1.6m	Root @ 1.6m
2.5
