**ADDENDUM ARBORICULTURAL REPORT**

**SUBSIDENCE CLAIM**

**180 Camden Road, London, NW1 9HG**

28 November 2024

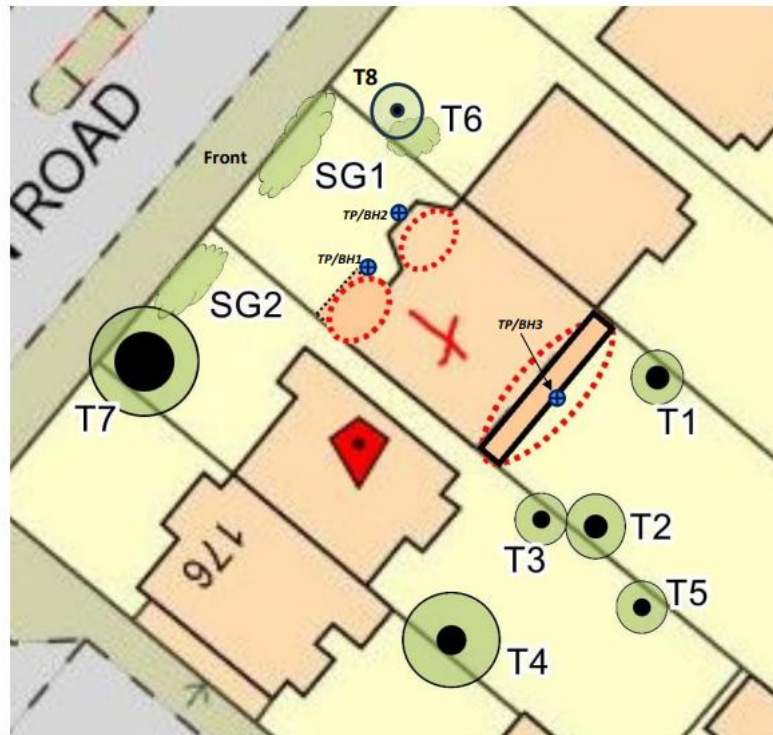
Approximate areas of damage

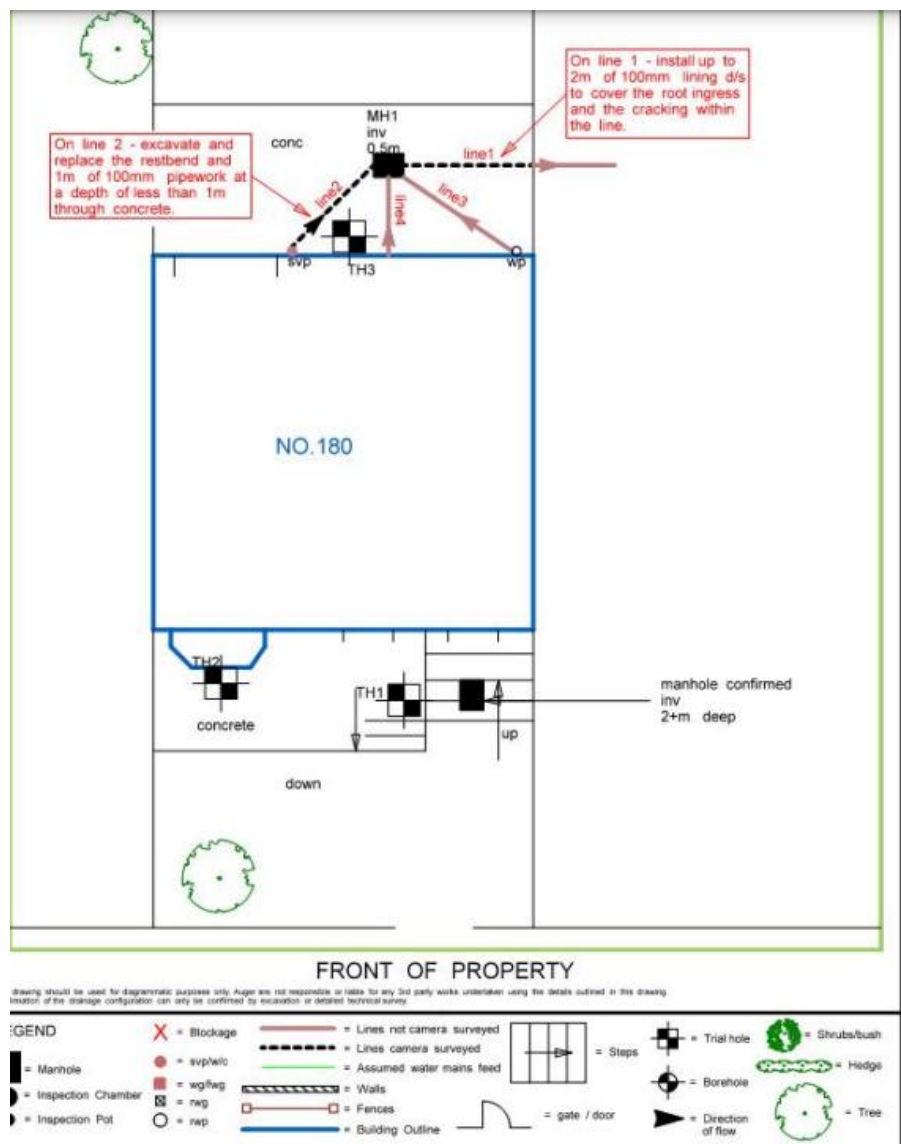
Foundation depths confirmed at 600mm (front) to 1000mm (rear) bearing onto clay soil that has high plasticity, meaning it can significantly shrink and seal seasonally due to fluctuations in moisture content.

Laboratory tests confirm (significant) desiccation has occurred where roots were observed, the moisture contents being at or significantly less than 0.5x the Liquid Limit, this indicates abnormal soil drying in the presence of tree roots.

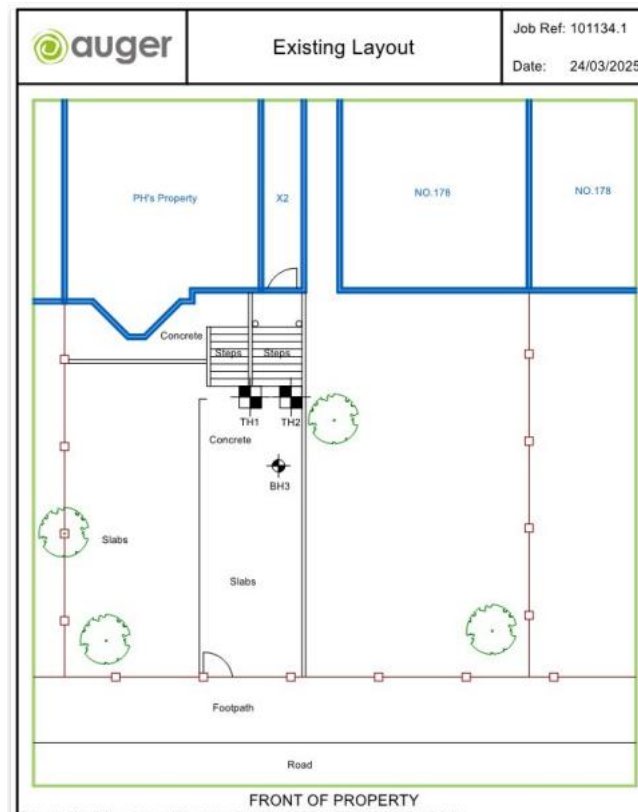
GSTL		LIQUID LIMIT, PLASTIC LIMIT AND PLASTICITY INDEX ( BS 1377:1990 - Part 2 : 4.4 & 5.3 )						auger	
environmental data right substance damage									
GSTL Contract Number		77896							
Report Date		31/03/2025							
Auger Reference		101134.3.2.R55							
Remarks		NP - (Non-Plastic), # - (Liquid Limit and Plastic Limit Wet Sieved)							
TH Trial Hole	Sample Type	Depth (m)	Moisture Content %	Liquid Limit %	Plastic Limit %	Plasticity Index %	Passing 425mm %	NHBC Chapter 4.2	Remarks
TH1	D	0.15	30	66	25	41	93	HIGH VCP	CH High Plasticity
TH1	D	0.65	29						
TH1	D	1.15	30	62	25	37	94	MEDIUM VCP	CH High Plasticity
TH1	D	1.65	30						
TH1	D	2.15	29	69	25	44	94	HIGH VCP	CH High Plasticity
TH1	D	2.65	24	62	17	45	95	HIGH VCP	CH High Plasticity
TH2	D	0.45	28	63	23	40	90	MEDIUM VCP	CH High Plasticity
TH2	D	0.95	28						
TH2	D	1.45	30	67	23	44	91	HIGH VCP	CH High Plasticity
TH2	D	1.95	29						
TH2	D	2.45	26	67	20	47	93	HIGH VCP	CH High Plasticity

TH2	D	2.95	21	58	18	40	94	MEDIUM VCP	CH High Plasticity
TH3	D	0.50	30	67	24	43	89	HIGH VCP	CH High Plasticity
TH3	D	1.00	27						
TH3	D	1.50	25	65	21	44	92	HIGH VCP	CH High Plasticity
TH3	D	2.00	29						
TH3	D	2.50	23	62	19	43	93	HIGH VCP	CH High Plasticity

There are indications of the onset of desiccation, despite sampling having occurred at a time of year when soil moisture deficits would be at their lowest and we would expect significantly drier soil during summer months when roots are active.

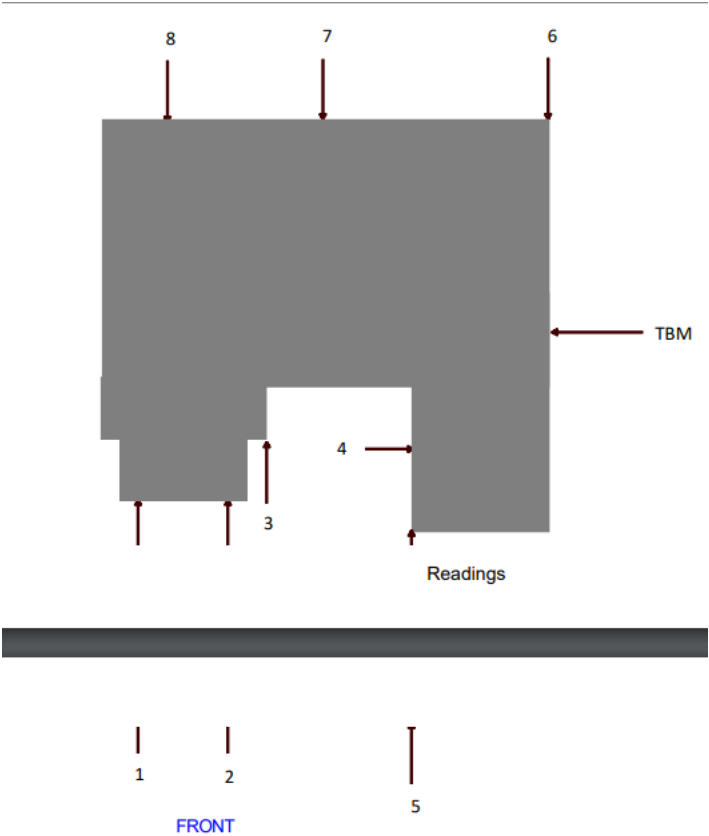
LEVEL MONITORING - RELATIVE SURVEY READINGS

The pattern of movement is not uniform around the property so 'nominal clay shrinkage' can be discounted as a cause.
