# **No.70 Great Russell Street** Results of Stair Opening Up Works

This report summarises the results of the opening up works to the existing staircase between ground and first floor level within No.70 Great Russell Street.

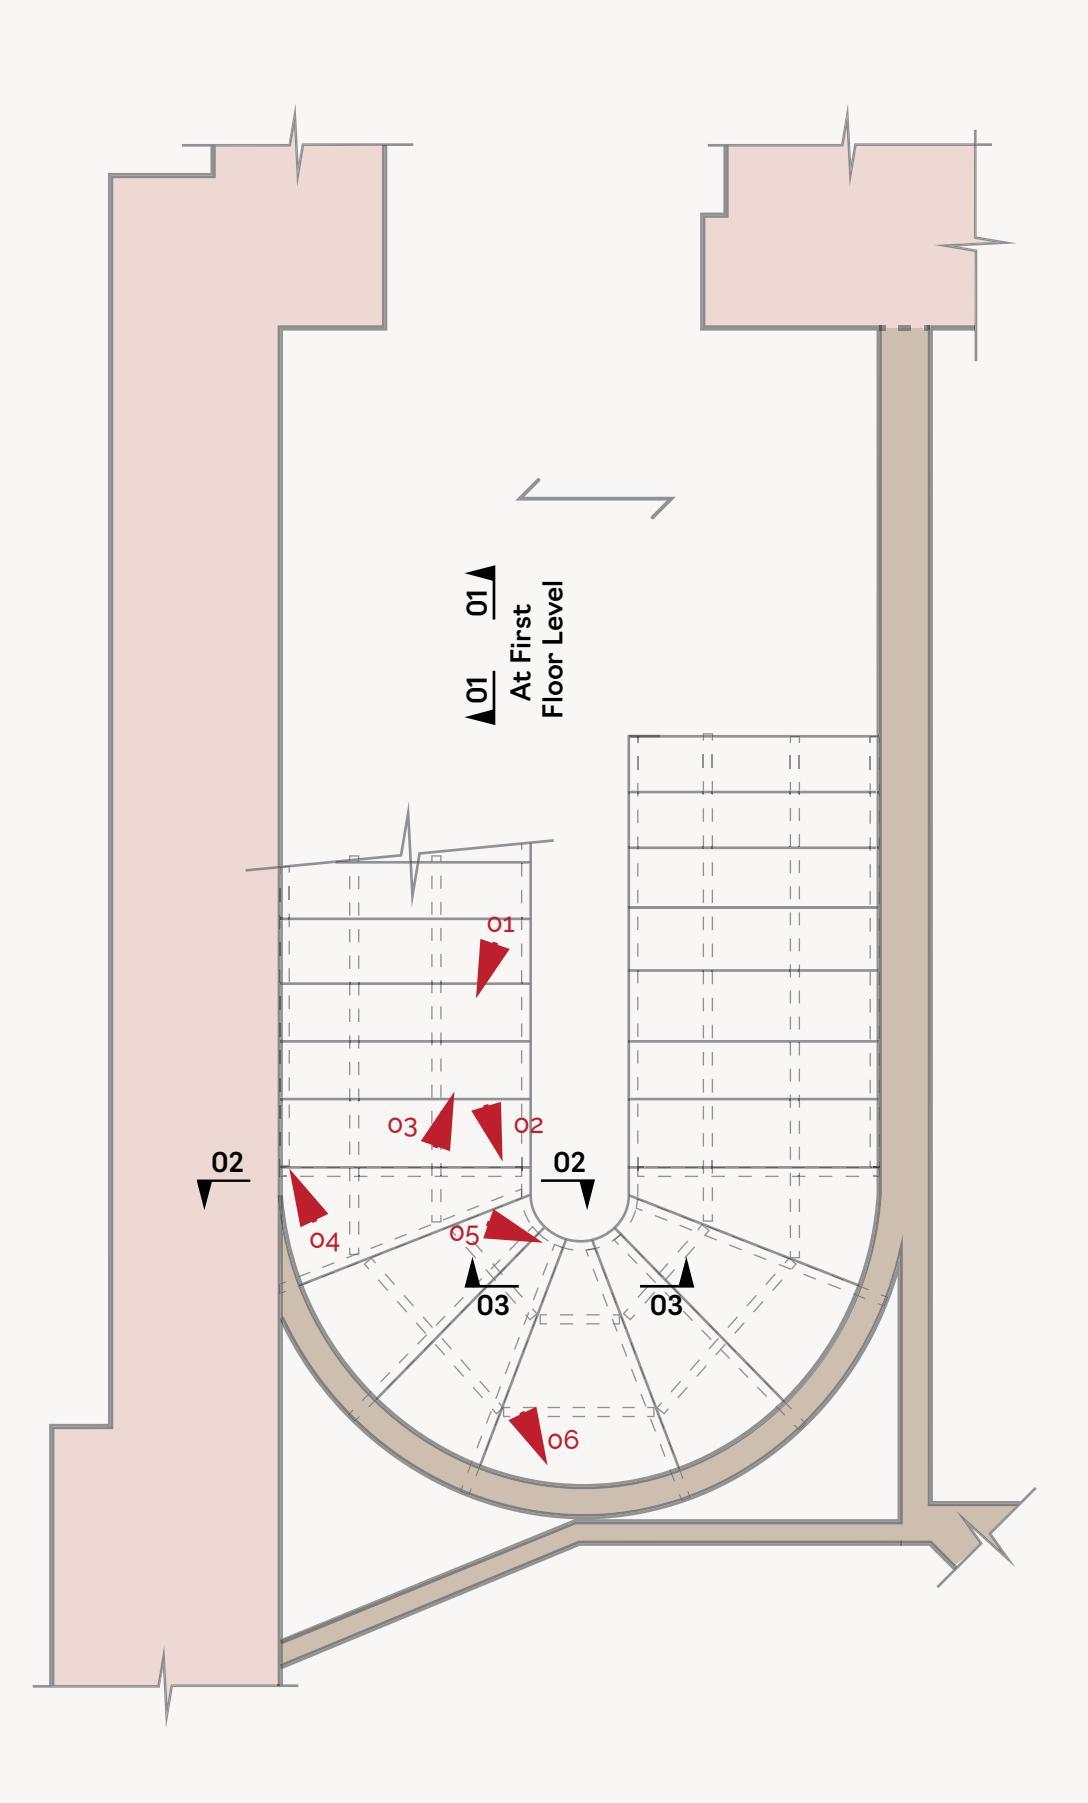
Figure 01 - Summary of Structural Opening Up Results - Plan

Refer to Structural Assembly's, Structural Engineering Report on Stairs for No.67 to 70 Great Russell Street, dated November 2024, for the location of the opening-up works and a summary of the structural form of the stair. The part plan shows the location of details which follow to summarise to summarise the results of the investigations, and location of photos included in the site visit report.

O1 Photo Locations and Orientations Indicated Thus.
