MORI

5 Hampstead High Street
London
NW3 1PR

Existing conditions survey plan, elevations/shopfront elevation

Drawing number
MORI005.06-01

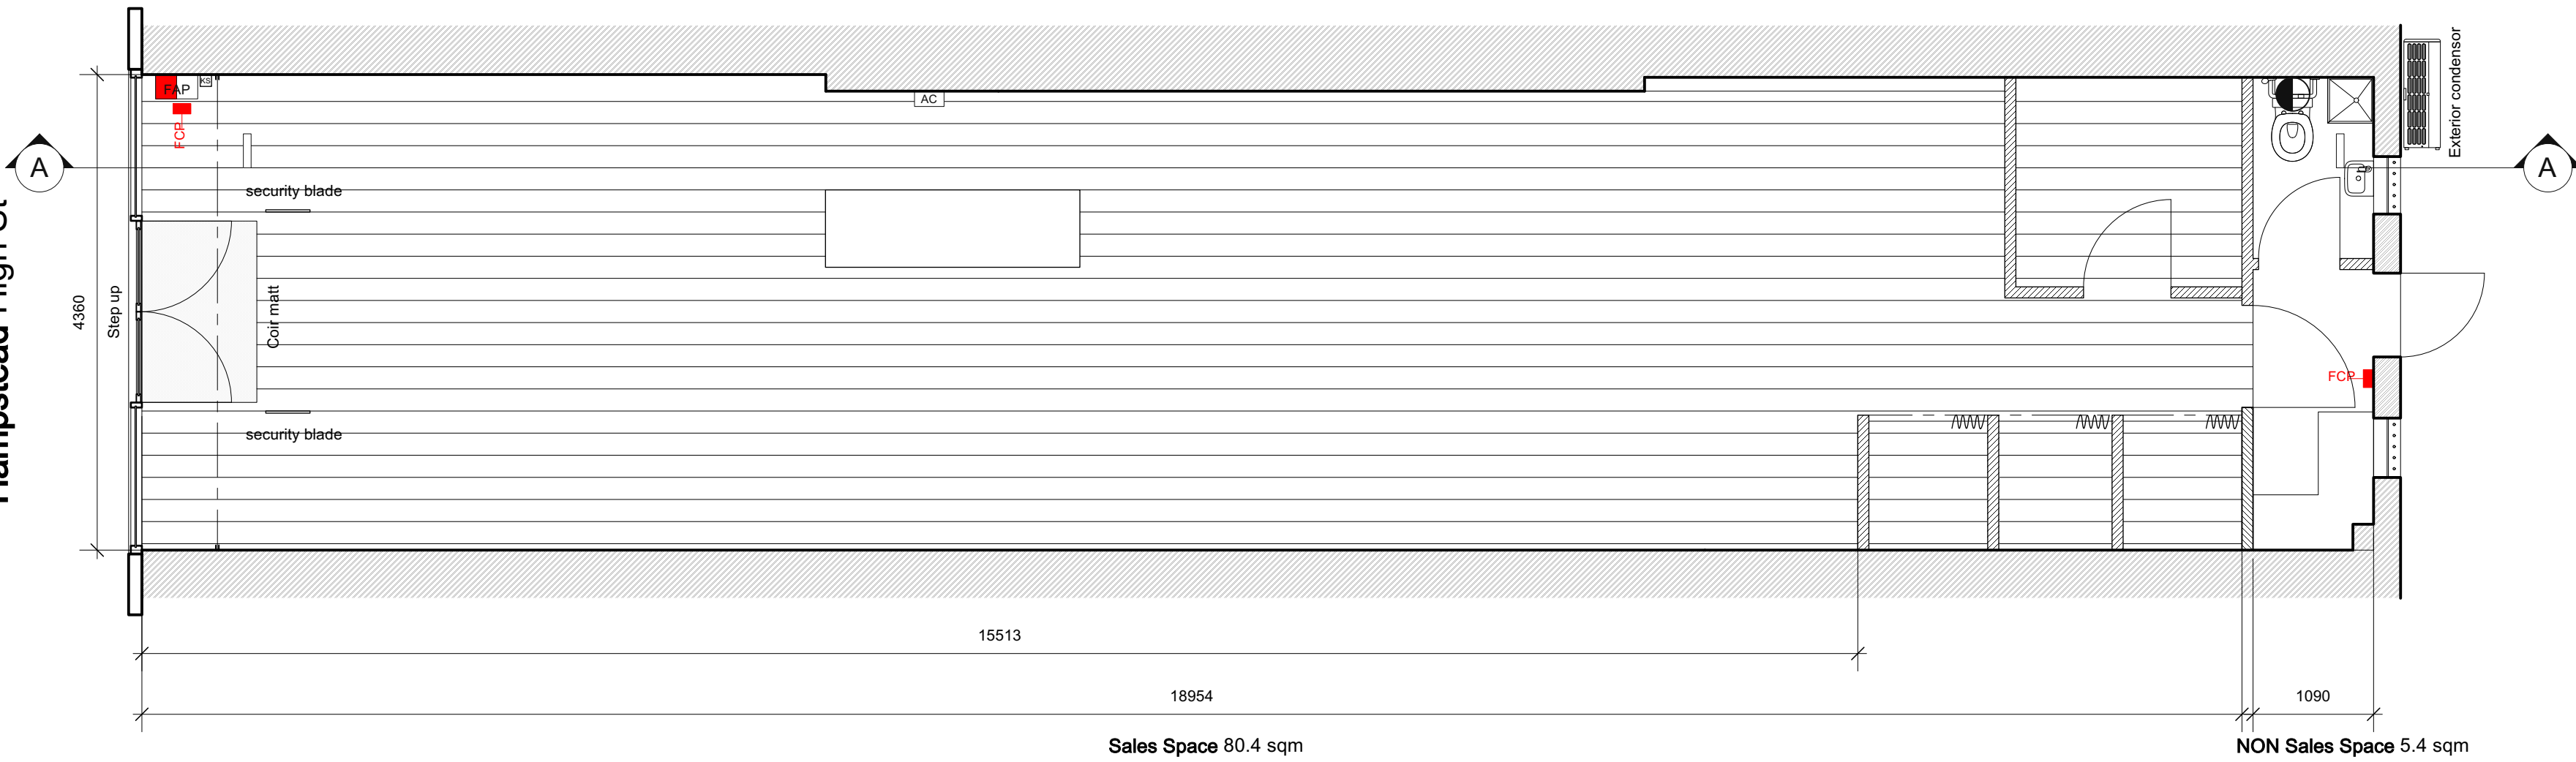
Existing conditions Masterplan

Storefront Frame is white UVPC.
Storefront Timber pillar to right hand side has wet rot to the lower part and shopfront. Fascia has wet rot to the right hand side. These will need to be made good when the storefront is re decorated.
Note existing step into store.
Existing internal shopfront shutter in working order.
New timber laminate floor in store in good condition.
Walls and ceilings in good condition.
Led track lights and track in good condition.
Speakers and smoke detectors in good condition.
AC controls and Burglar alarm controls will have to be re located.
Fire alarm panel and break glass points in good condition.
Air conditioning units x 2 in good condition.
Fuse board in the small office to the rear.
Existing WC and sink in good order.
Existing kitchenette in good order.
