# Site Investigation Report

Auger were commissioned by Crawford & Co to undertake a site investigation and CCTV inspection of the underground drainage within the area of concern (AOC) at the property.

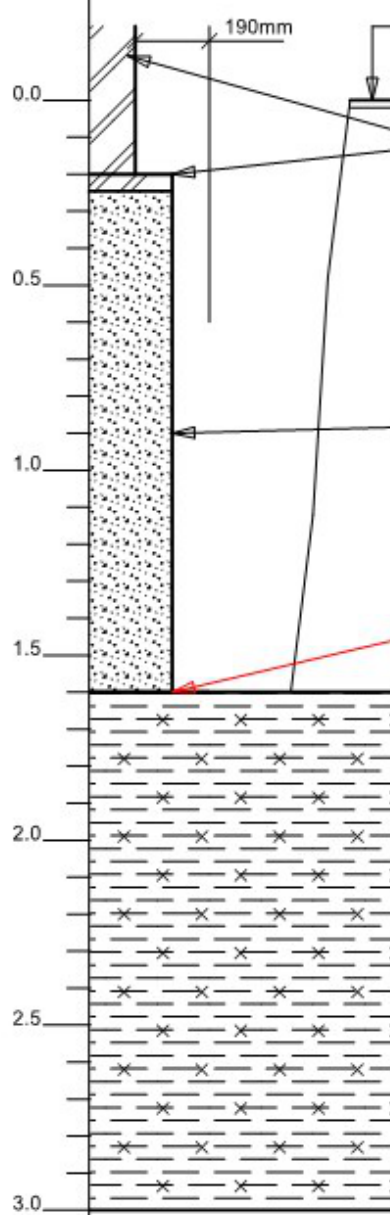
## Trial Hole Log No.2

Location: Rear middle of rear extension

Ground Level				
		Grass				
		Brickwork				
0.5						
1.0		Concrete				
1.5		Depth of footing cannot be confirmed				
2.0		Moist very stiff brown silty CLAY	140kpa		Soil @ 1.6m	Root @ 1.6m
2.5			140kpa		Soil @ 2.1m	
3.0		TRIAL HOLE TERMINATED	140kpa		Soil @ 2.6m
