# Site Investigation Report

Auger were commissioned by Crawford & Co to undertake a site investigation and CCTV inspection of the underground drainage within the area of concern (AOC) at the property.

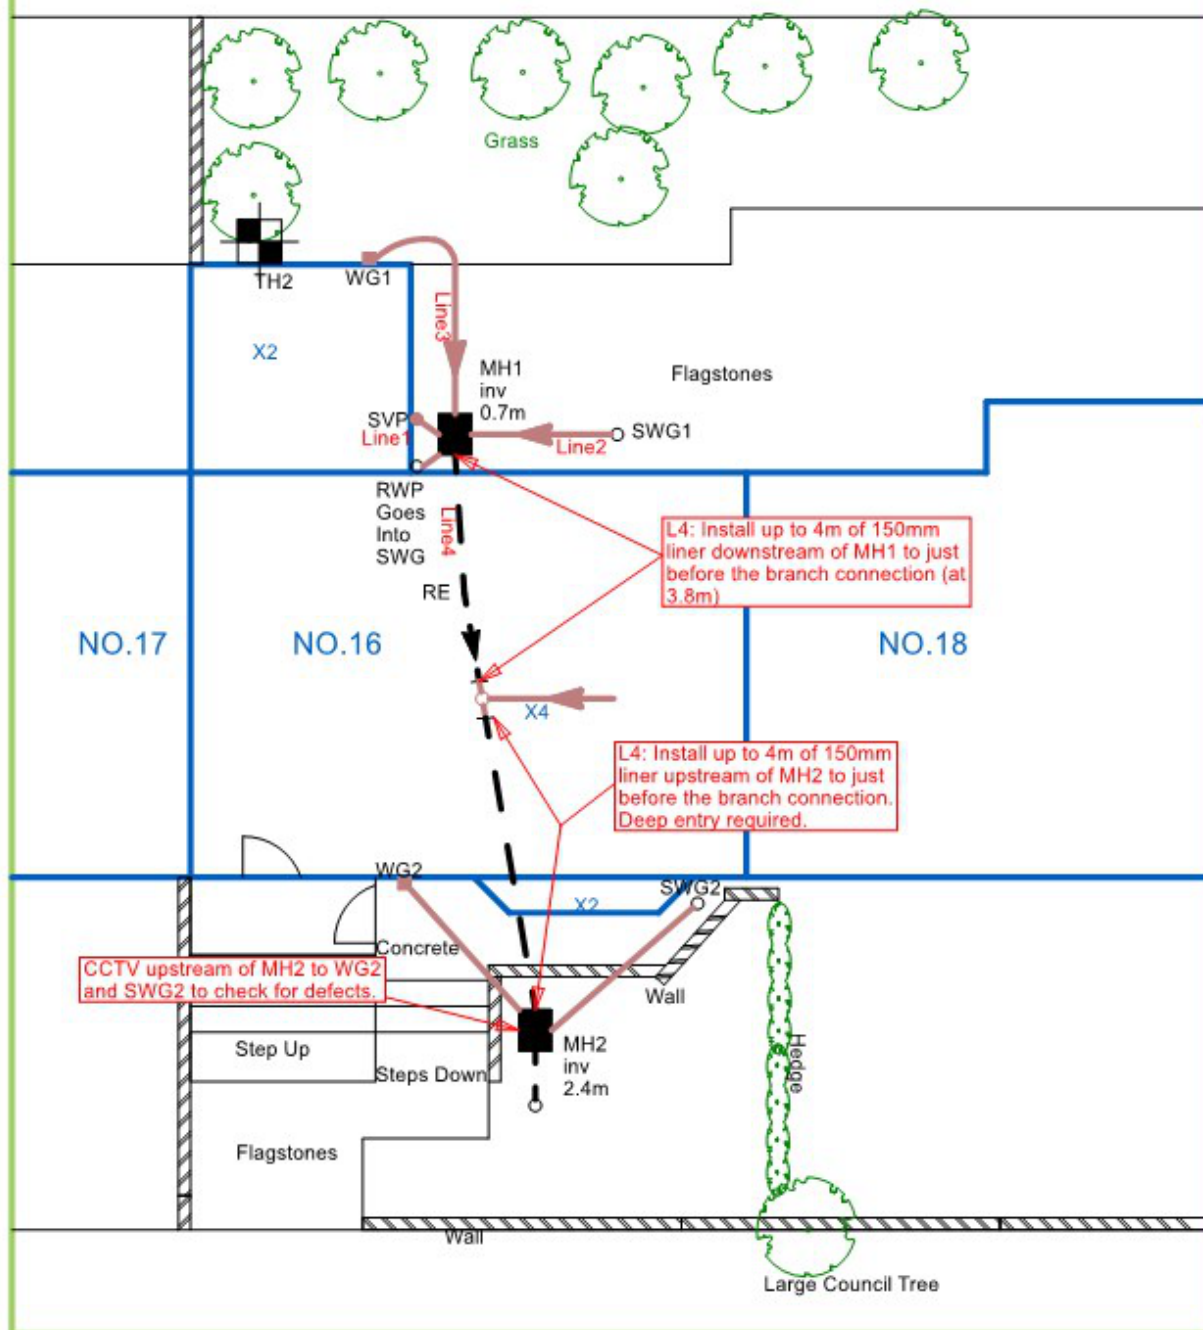
Our survey of line 4 revealed joint displacements and cracking throughout the line.

Due to the depth of MH2 our engineer was unable to survey the lines to WG2 and SWG2.

<b>Refer Back to Client</b>	<p>It is recommended that the following repairs are carried out to prevent an escape of water from the system:</p> <p><b>Line 4</b></p> <p>Install 4m of 150mm liner directly downstream of MH1 to just before the branch connection.</p> <p>Install 4m of 150mm liner directly upstream of MH2 to just before the branch connection.</p> <p>Deep manhole entry and an additional man will be required to install the liner.</p> <p>CCTV survey upstream from MH2 to check for further defects on the WG2 and SWG2 lines.</p> <p>We will now refer the claim back to the client in order to progress the claim.</p>
<b>Repair Caveats</b>	<p><i>Once repairs have been undertaken the customer should ensure the drainage system is periodically inspected in the future for any deterioration and kept free flowing / free of blockages. Any damage noted during future inspections should be repaired immediately in accordance with current Building Regulations.</i></p> <p><i>With any repair process, complications and unforeseen circumstances can arise. These scenarios will be reported whilst on-site and could potentially cause an increase in repair costs and inconvenience.</i></p> <p><i>If any of the above lining recommendations fail then excavation and replacement of the pipework would be required. This would severely increase the cost of repairs and would provide greater inconvenience to the residents. The relining of a severe joint displacement is normally unadvised due to the potential for complications in the future. If any issues arise in the future regarding this pipework, then excavation within the property would be required to replace the defective area of pipework. This in turn would result in major inconvenience to the occupier and a potentially large repair bill.</i></p> <p><i>Recommendations have been made to reline or patch reline sections of the drainage system at the property. This process combines a number of chemicals in a resin, which then harden in a fibreglass matting to create a new section of drain within the original. The reaction creates <b>a strong smell which can linger for up to 72 hours</b> once works are completed - this is not harmful. It is recommended that any areas where smells are experienced are kept well ventilated until the odour subsides.</i></p>
