Arboricultural Appraisal Report

Subsidence Damage Investigation at:

222 Finchley Road London NW3 6DH

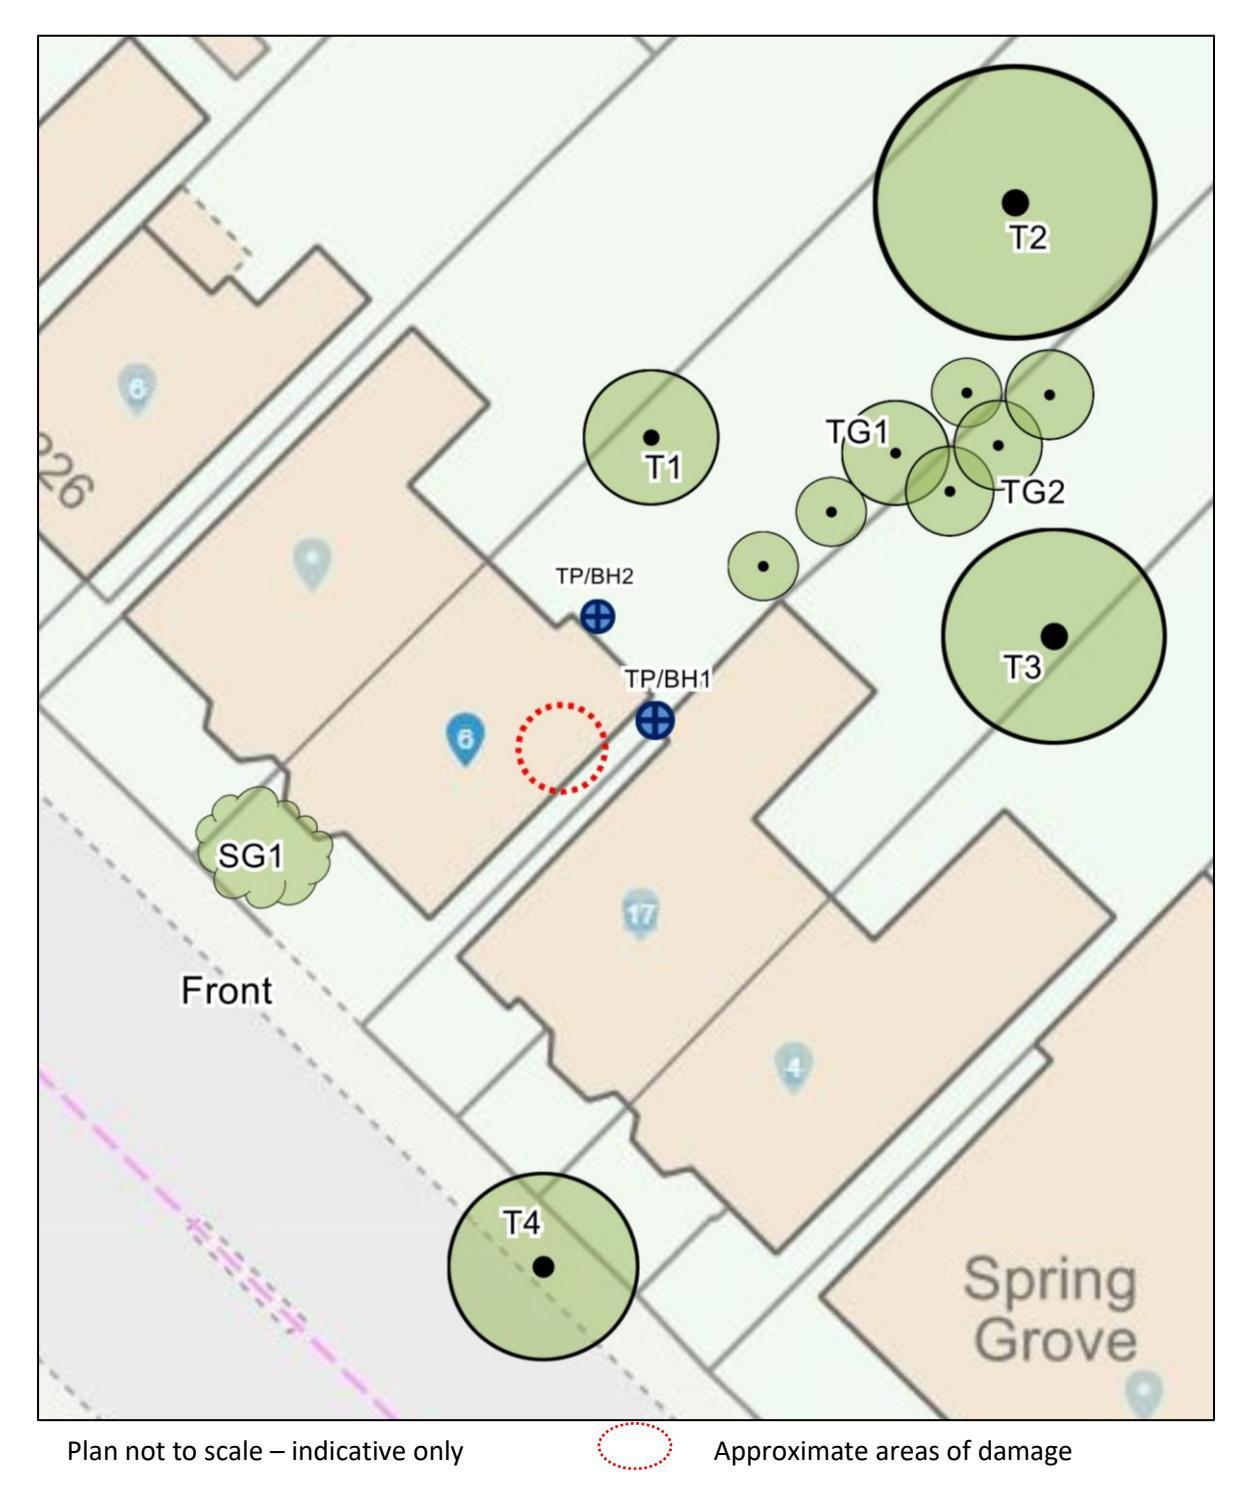
Site Plan

Of the roots recovered, the most significant are the Salicaceae spp. roots. These will emanate from T3 Poplar, confirming its influence on the soils below the foundations.

Based on the information currently available, engineering opinion and our own site assessment we conclude there is damage consistent with shrinkage of the clay subsoil exacerbated by the soil drying effects of vegetation. Having considered the information currently available, it is our opinion that T3 Poplar is the principal cause of the current building movement and damage.

If an arboricultural solution is to be implemented to mitigate the influence of the trees/vegetation considered to be responsible for the movement/damage, we recommend that T3 Poplar is removed. (see Table 1).
