Crack and Level Monitoring

Job Reference: QG1S1287571

Address: 222 Finchley Road, London, NW3 6DH

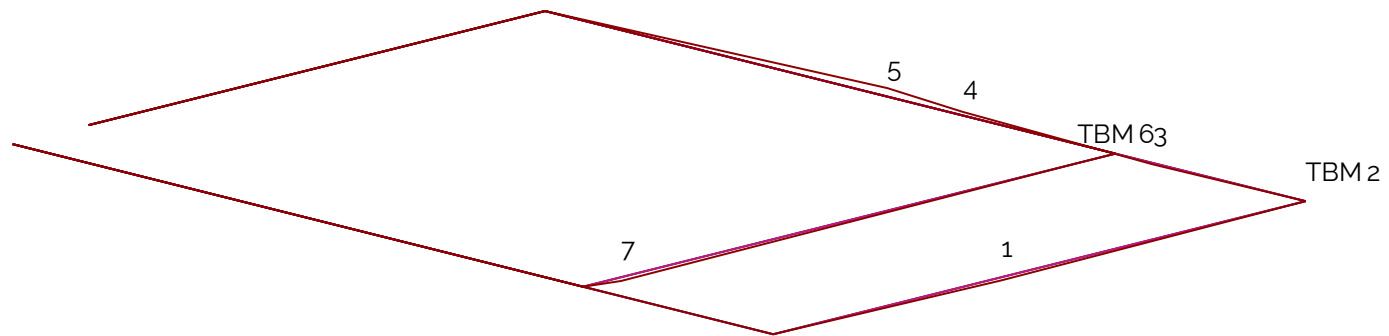
Relative Movement (Relative Survey, for illustration purposes only)

Visit 1	Visit 2	Visit 3	Visit 4	Visit 5	Visit 6	Visit 7	Visit 8
	29/10/24	10/03/25						
TBM 2	0	0						
1	0	-1.6						
3	0	-0.7						
4	0	+1.8						
5	0	+4.3						
TBM 6	0	0						
7	0	-1.9

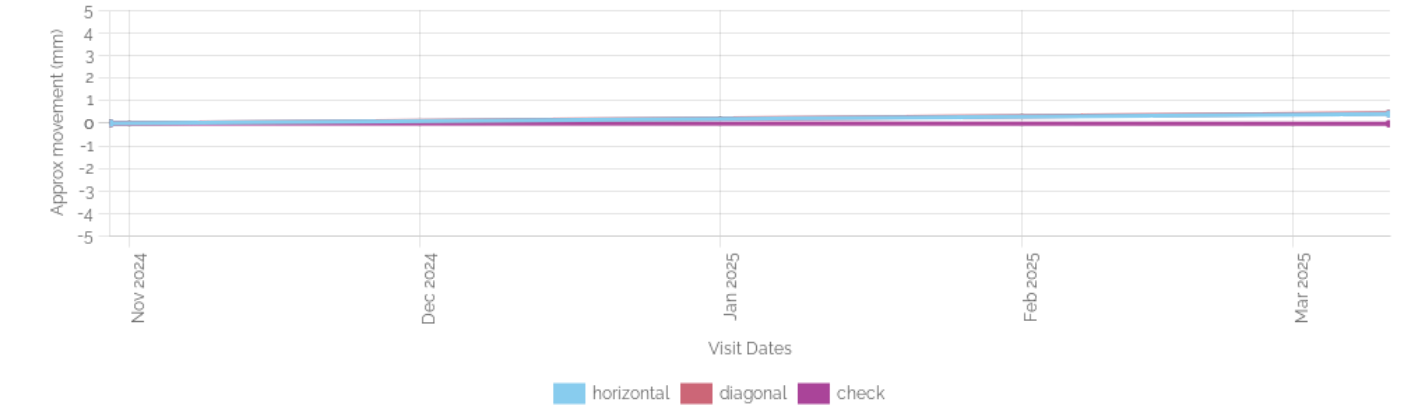
Right of wall after gate before stairs

Visit 1	Visit 2	Visit 3	Visit 4	Visit 5	Visit 6	Visit 7	Visit 8
	29/10/24	10/03/25						
H	0	0.41						
D	0	0.44						
C	0	-0.02
