Site Investigation Report

176136.1.2.BSI

Client	Structural Surveys Ltd
Client ref	QG1S1287571
Visit date	07/11/2024
Report date	29/11/2024

Auger were commissioned by Structural Surveys Ltd to undertake a site investigation and CCTV inspection of the underground drainage within the area of concern (AOC) at the property.

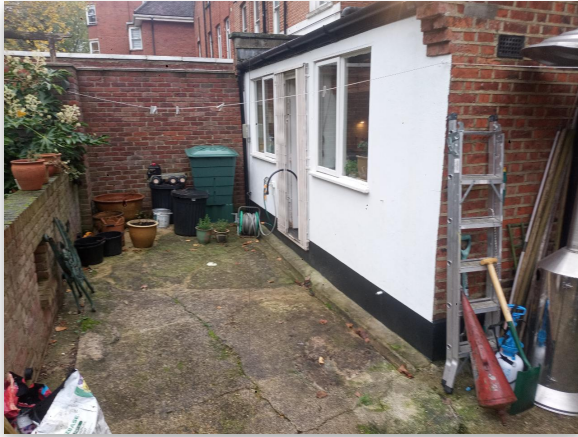
Fig 4.1: Rear of the property

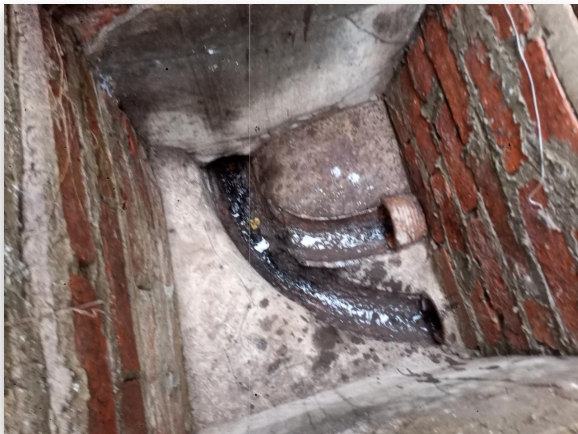
Fig 4.5: MH1

Our survey of line 2 revealed root ingress to the cast iron pipework 5m upstream to the gully. The survey also revealed broken pipework directly upstream of MH1

<p>Refer Back to Client</p>	<p>It is recommended that the following repairs are carried out to prevent an escape of water from the system:</p> <p>Line 1 Excavate and replace WG1 and 1m of 100mm pipework including a branch connection at a depth no greater than 1.0m through concrete.</p> <p>Install a 100mm patch directly upstream of MH1 to the branch.</p> <p>We will then need to conduct a further CCTV investigation upstream on this line.</p> <p>Line 2 Excavate and replace RWG1 and 3m of 100mm pipework at a depth no greater than 1.0m through concrete.</p> <p>Install a 100mm patch liner directly upstream of MH1 to seal the pipework into the cast iron.</p> <p>MH2 Deep MH entry required to survey the connection.</p> <p>Please note that the further CCTV investigation may reveal additional defects to the drainage system. This will be reported whilst on-site and could potentially cause an increase in repair costs and provide further inconvenience to the customer/occupants.</p> <p>Auger have not allowed or will not be held responsible for any alteration or modification to the above ground drainage following the removal of the existing gully and reinstatement of a new gully. The customer must ensure that the above ground drainage correctly expels into the gully pot and avoids overcrowding the gully with numerous downpipes which could lead to the gully overflowing.</p> <p>During the clean-up/reinstatement process we will endeavour to leave the area we are working in clean and tidy and as close to how we found it as possible. There will always be an element of general debris/mud/waste that will build up in the area which cannot be prevented. There may however be elements of this process that are outside our remit i.e., Repainting or cleaning. If this is the case, then we will need to speak to the customer's insurers to help in this regard.</p> <p>We will now refer the claim back to the client in order to progress the claim.</p>

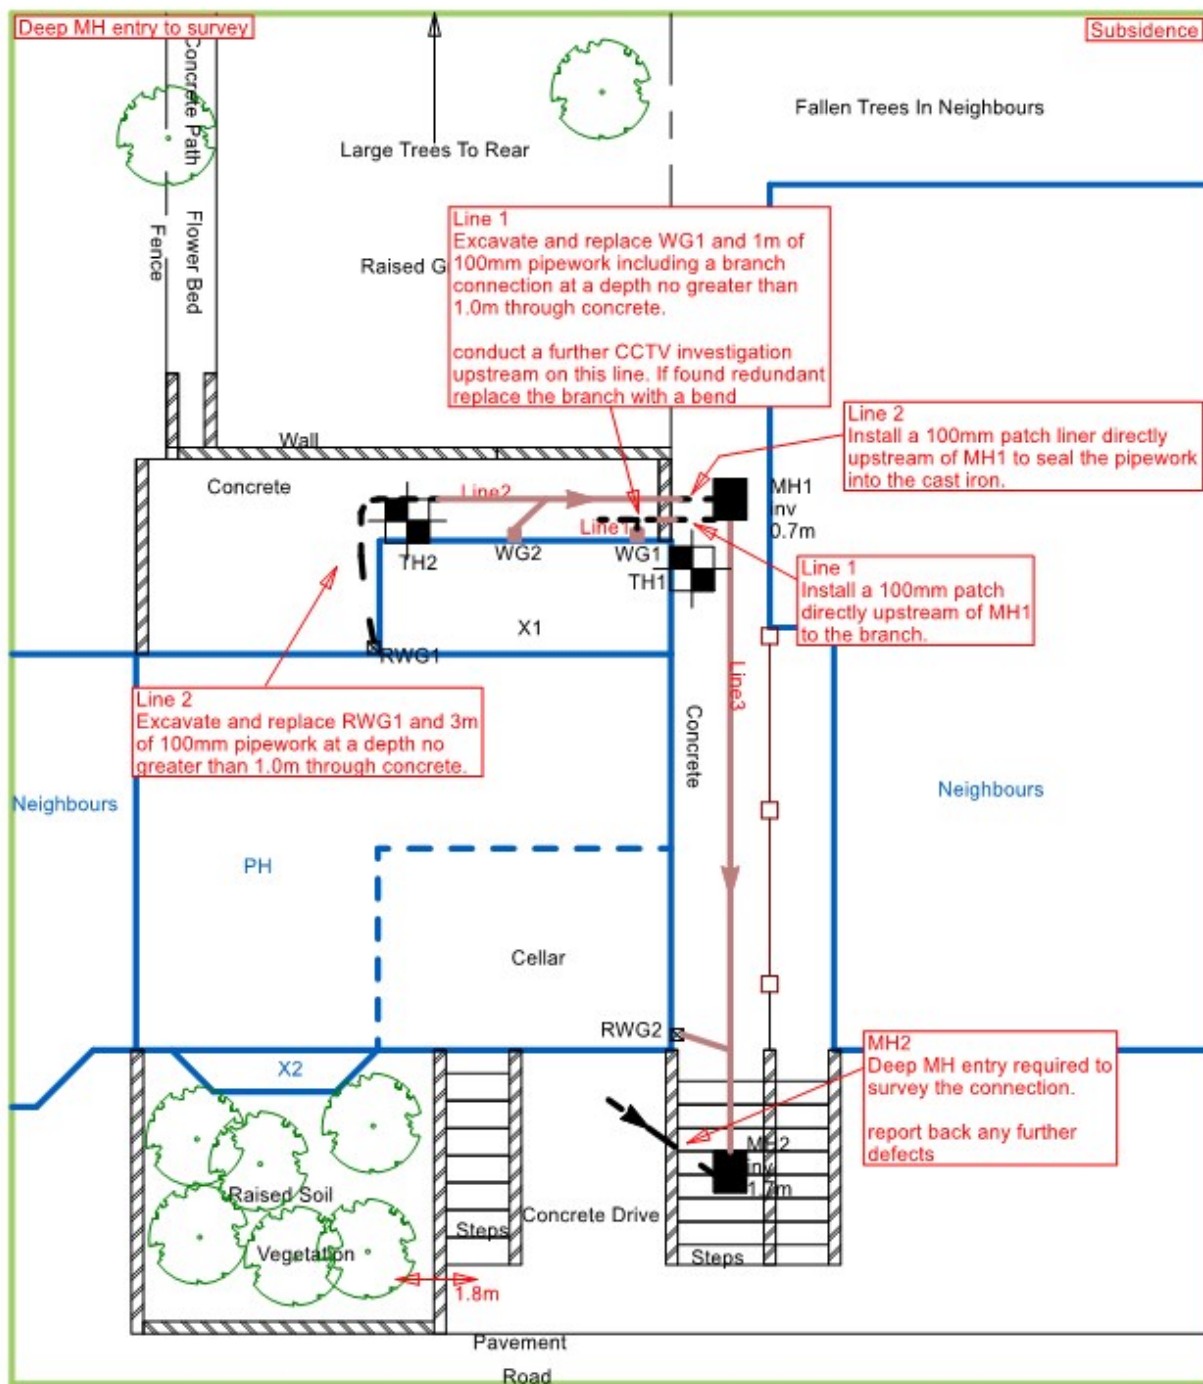
Line 1 - From MH1 upstream to WG1

Our survey of line 1 revealed root ingress and the WG connection bossed into the main line restricting flow and allowing an escape of water, we have therefore been unable to survey upstream on the main line.

Line 2 - From MH1 upstream to RWG1

Line 3 - From MH1 downstream to MH2

Our survey of line 3 revealed no significant defects to the pipework on this line which could be allowing an escape of water. This pipework has previously been lined.
