INSURANCE INCIDENT REPORT

222 Finchley Road
London
NW3 6DH

QG1U1287632

13th September 2024

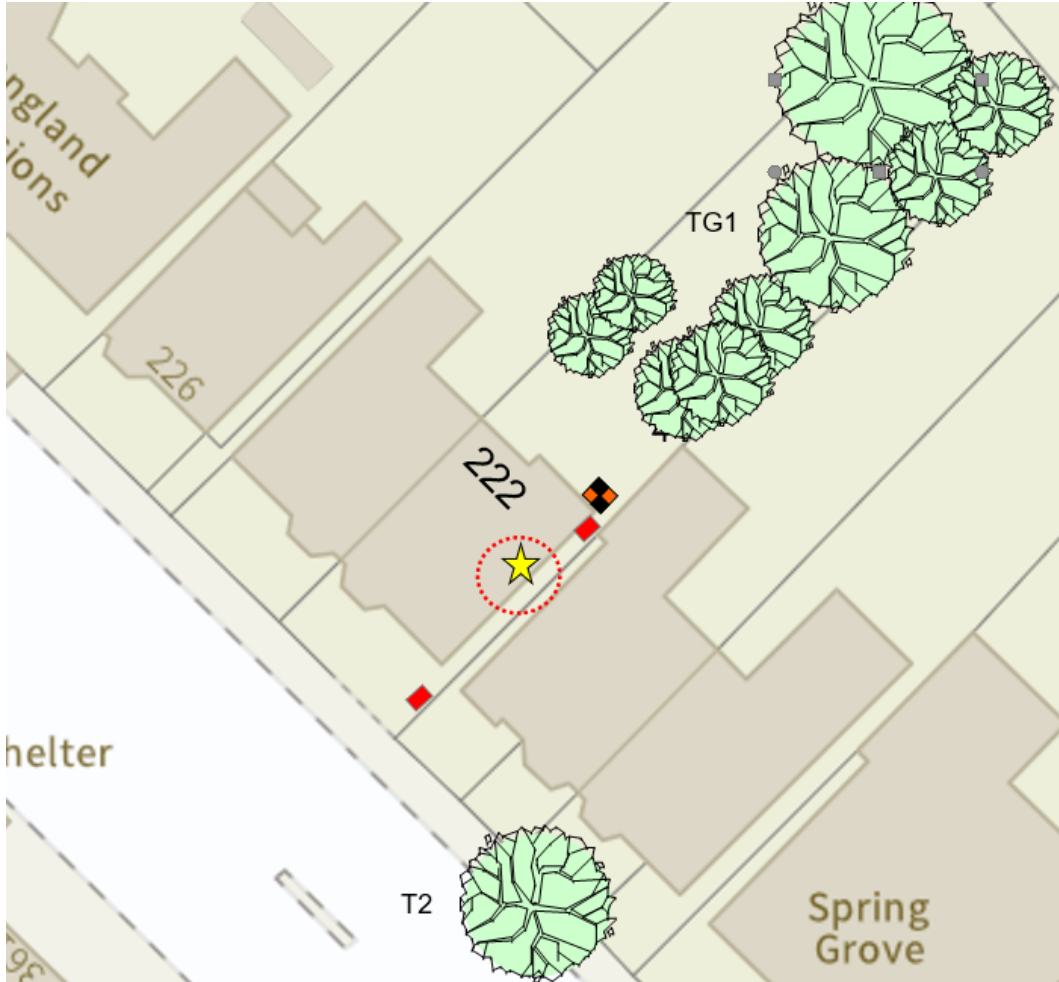
G Site Plan

There are numerous trees growing at the rear of the property within a potentially influencing distance, which could adversely affect the stability of the foundations. Where the sub-soils are cohesive, clay soils, trees will draw moisture from the clay, resulting in shrinkage of the clay and associated subsidence of the site. This can cause foundations to move downwards. This movement induces stress on the building materials and when the stress exceeds the strength of the material, cracks will develop. These are detailed in the site plan that follows.
