PLANNING AND LISTED BUILDING APPLICATION TO LONDON BOROUGH OF CAMDEN

NEWTON HOUSE, 207 HIGH HOLBORN, WC1V 7BW

SCHEDULE OF WORKS

COWIE MONTGOMERY ARCHITECTS

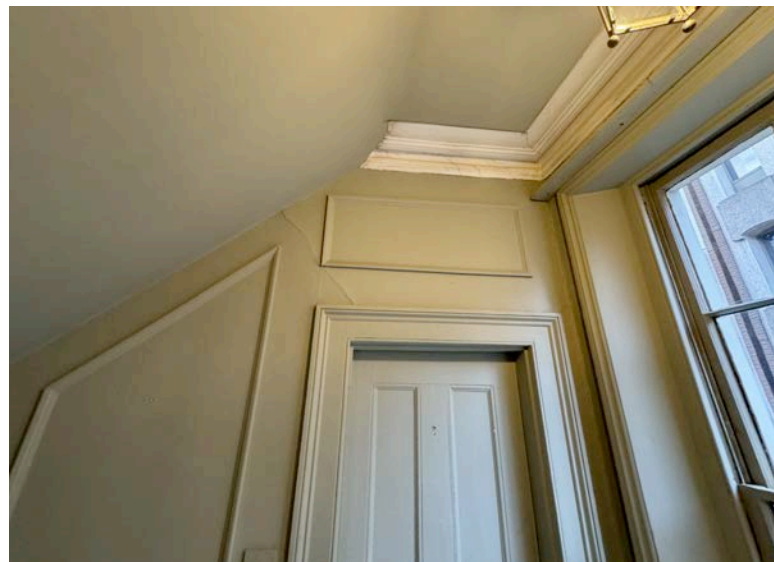
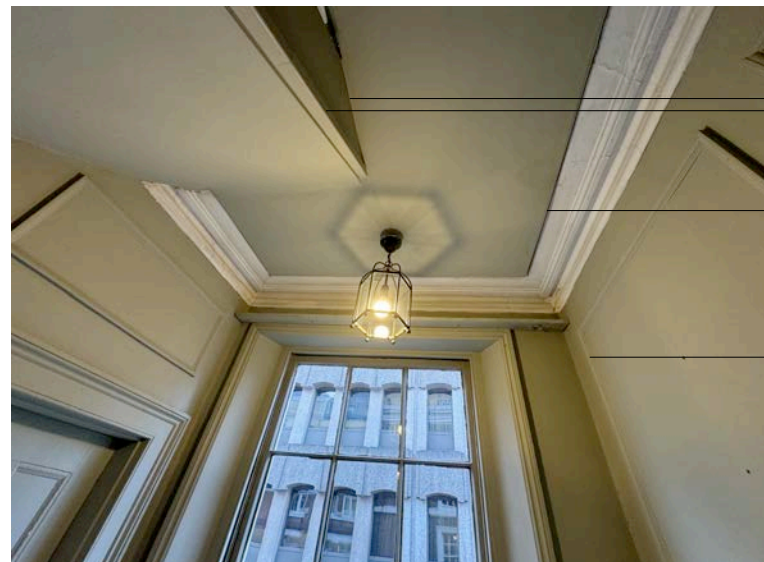
Stair flight from 2nd to 3rd
— was cut through the pre-
— existing floor structure
and linings.

- 2.6 linings added under the original soffit presumably to repair and strengthen.

- 2.5 mouldings planted on walls.

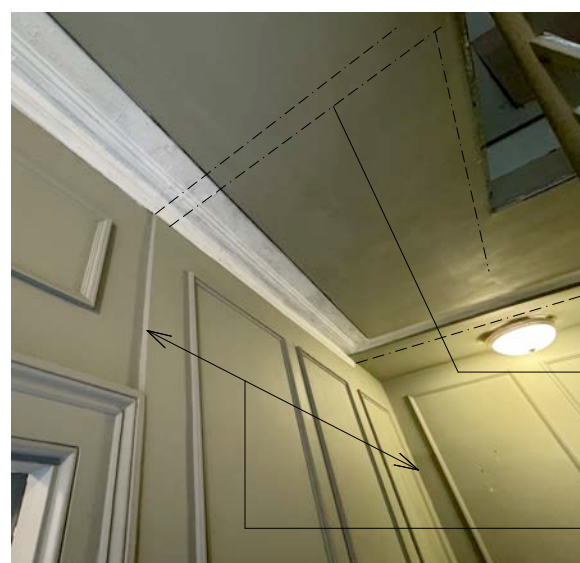
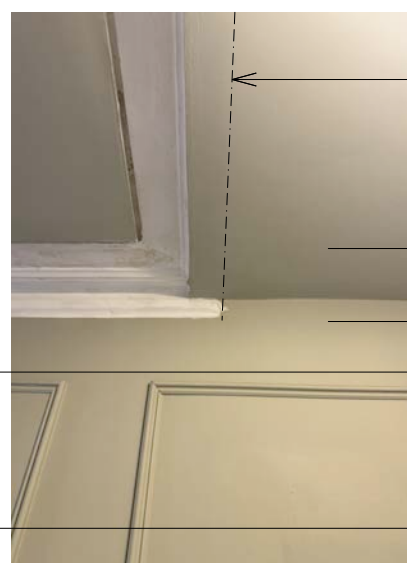
- Line of 1848 cross passage partition indicated by the section of surviving original cornice.

- Plasterboard / fire line board fixed over soffit and walls. Wall board laps over bottom of cornice.

- Line of a modern lobby removed in 1976. The partitions had caused removal of the landing balustrade.

- Wall lined with plasterboard with mouldings planted on.

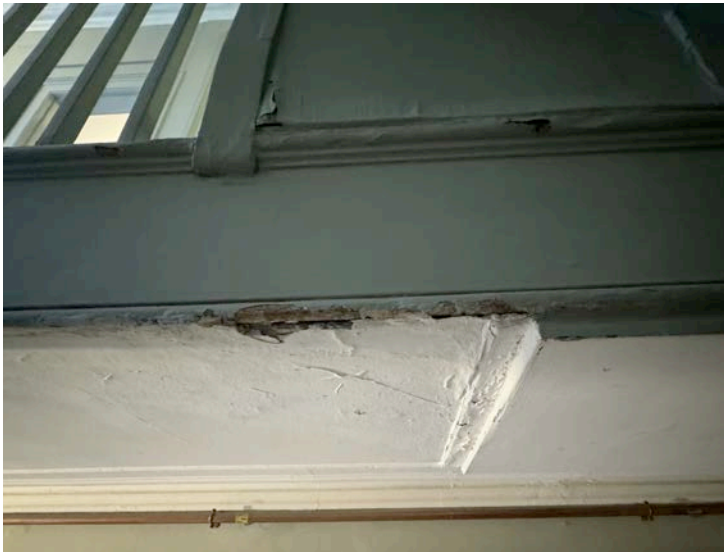
Looking up from below at NEWEL 2B, installed in 1976 which was cut into the side of the second floor fascia through the 1848 edge moulding. The soffit to the right has been underlined with boarding and a crude plaster band added. NEWELS 2A and 2B appear to be reused square posts with chamfers and NEWEL 2B was cut to a taper on the back. There is a hardboard infill between the newels at low level.

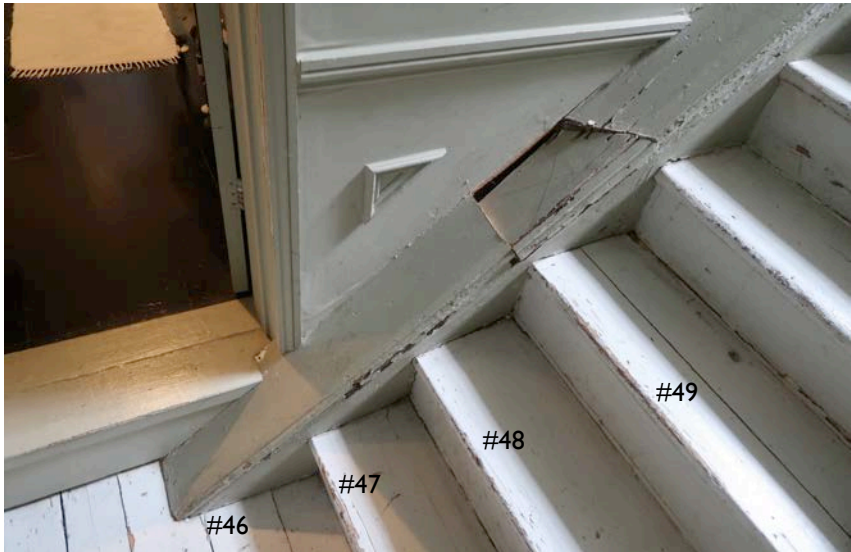
When the third floor infill partition was rebuilt to enclose under the third to fourth floor flight it was positioned out in the stair well. This caused a hazard of head and shoulder collision and so the lower flight was boxed in along the side which reduced the stair clear width. The landing outside the bathroom and the first three treads of the flight up are later alterations to this flight which was first built as a dog-leg.

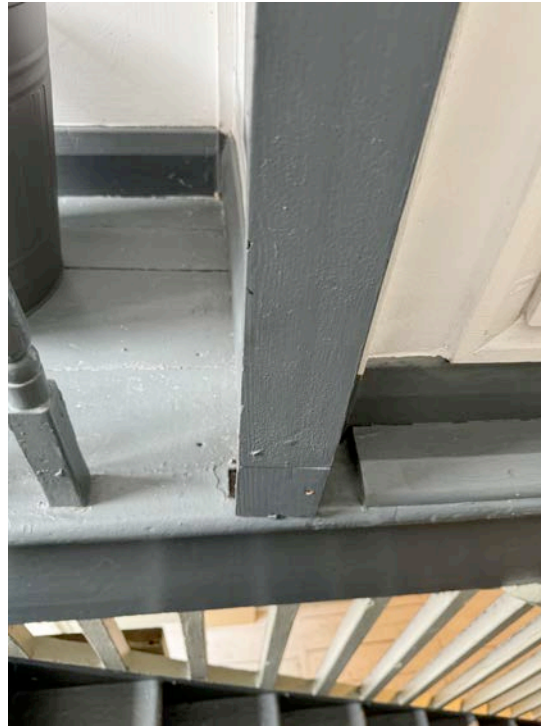
Straight flight down to third is a reconstruction of the early twentieth century installation.

- 4.5 Removal of straight stringered flight from 3rd to 4th first built early twentieth century and subsequently rebuilt. Replacement with straight stringered flight. Newel and balustrading at 4th floor retained and missing reinstated.

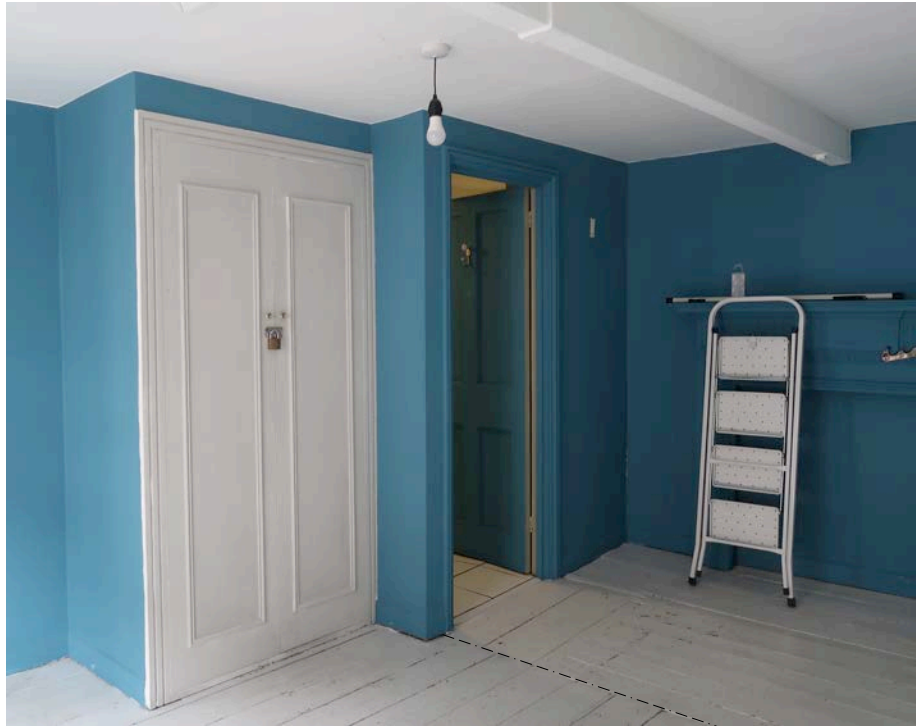
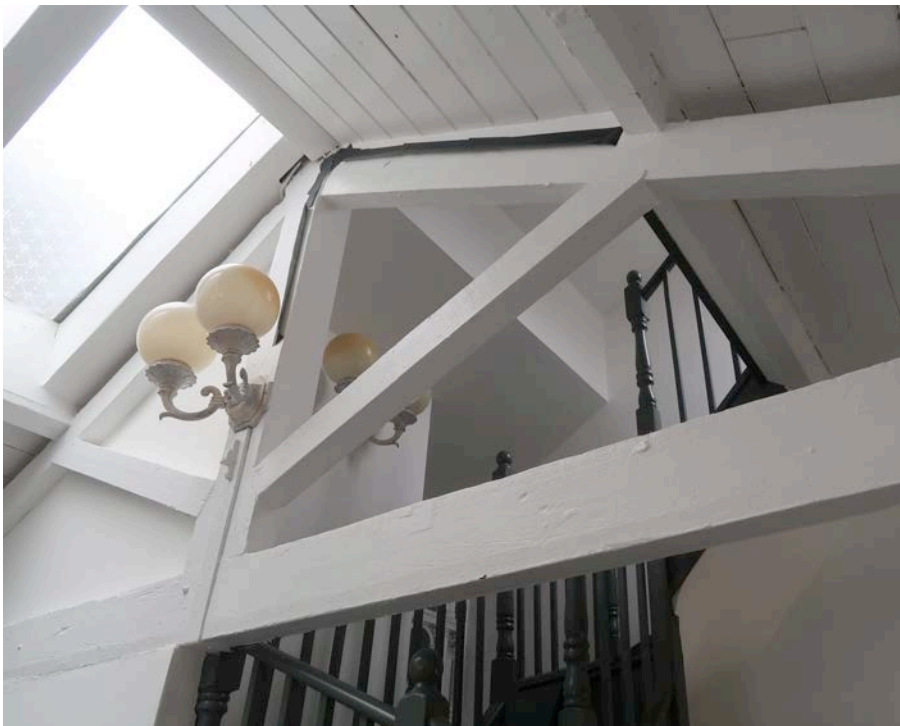
Front space with 2008 roof access stair, plasterboard partitions and back half of modern rooflight. Front half of rooflight filled in and truss partly enclosed by partitions.

- 4.6 Removal of 2008 roof access staircase and construction of new spacesaver type roof access flight in joinery.
- 4.7 Construction of timber framed load-bearing cross walls built on grid lines A and B spanning from fourth floor to underside of roof line in softwood studwork clad as 60 minute fire resisting compartment walls sheathed in ply and fireline board and skim finished both faces in two coat sand-lime plaster for decoration.

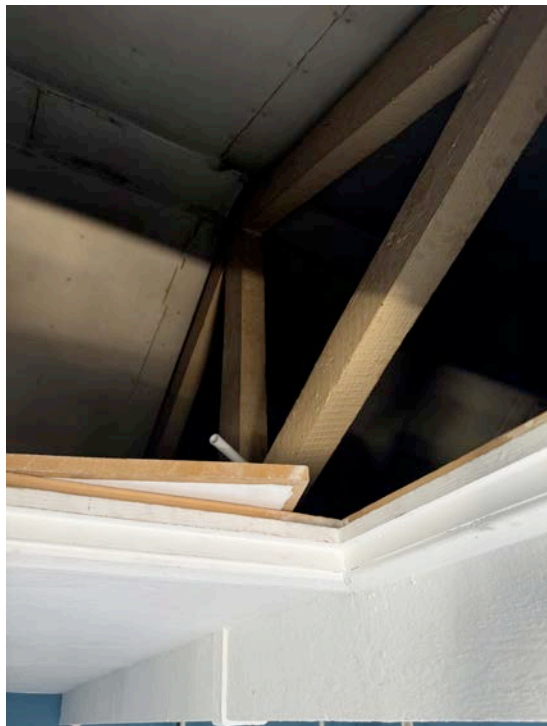
Rear roof space with 1976 rafters and plasterboard ceiling, infilled rooflight originally over back stair. Rainwater pipe from rear gutter formerly in timber boxing to the Newton Street front outlet, now in pvcU pipe. Lining of plasterboard nailed under roof rafters. There is no evidence of any ceiling at the bottom of truss line before 1976.

- 4.3 Removal of plasterboard and rafter suspended ceiling from back room built in 1976.
- 4.4 Removal of fire line boarding nailed to underside of rear room rafter lining in 1976 and replacement with fire line board skim finished in two coat sand-lime plaster for decoration.

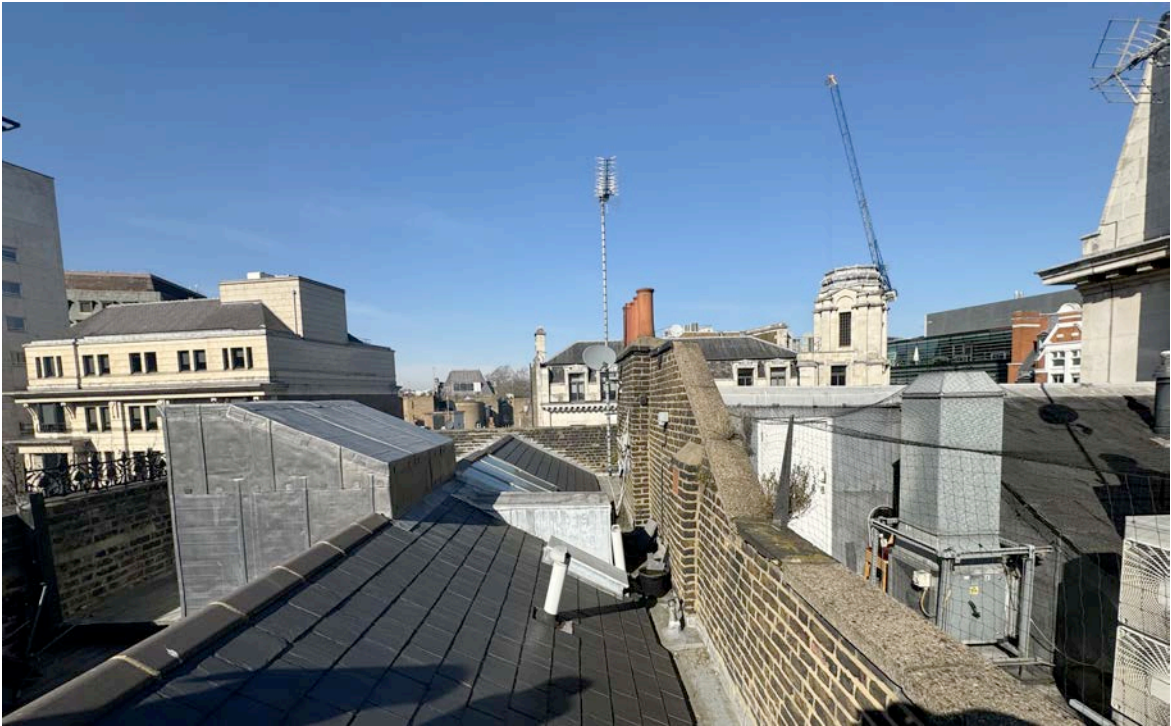
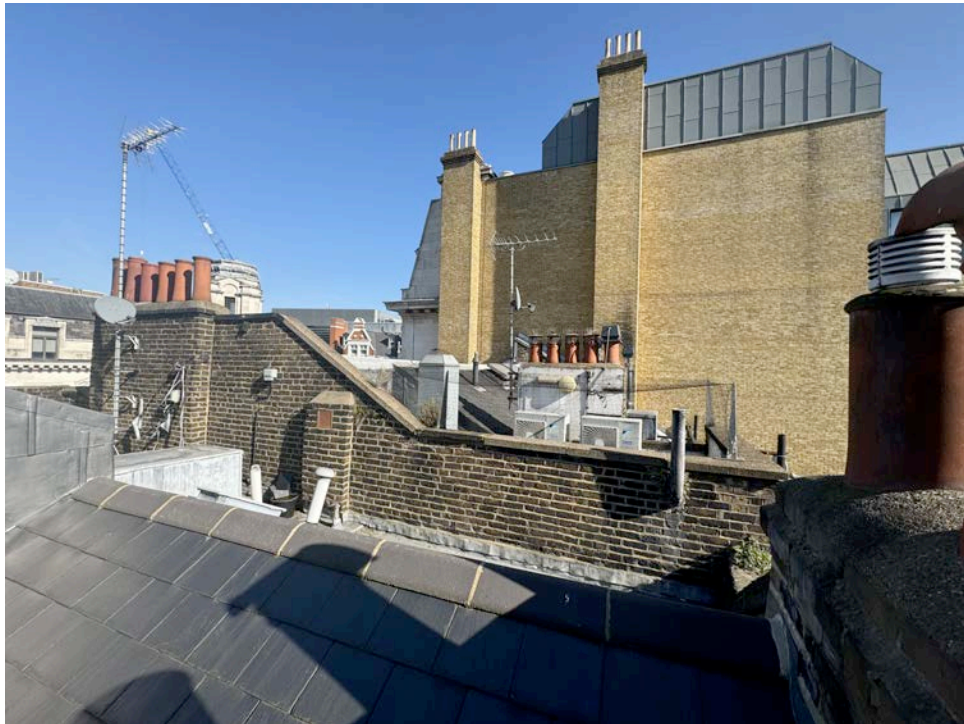
Newton Street front slope with roof access overrun to left and chimney stack to right. Plant compound of Princess Louise and office building at 210 High Holborn beyond boundary wall.

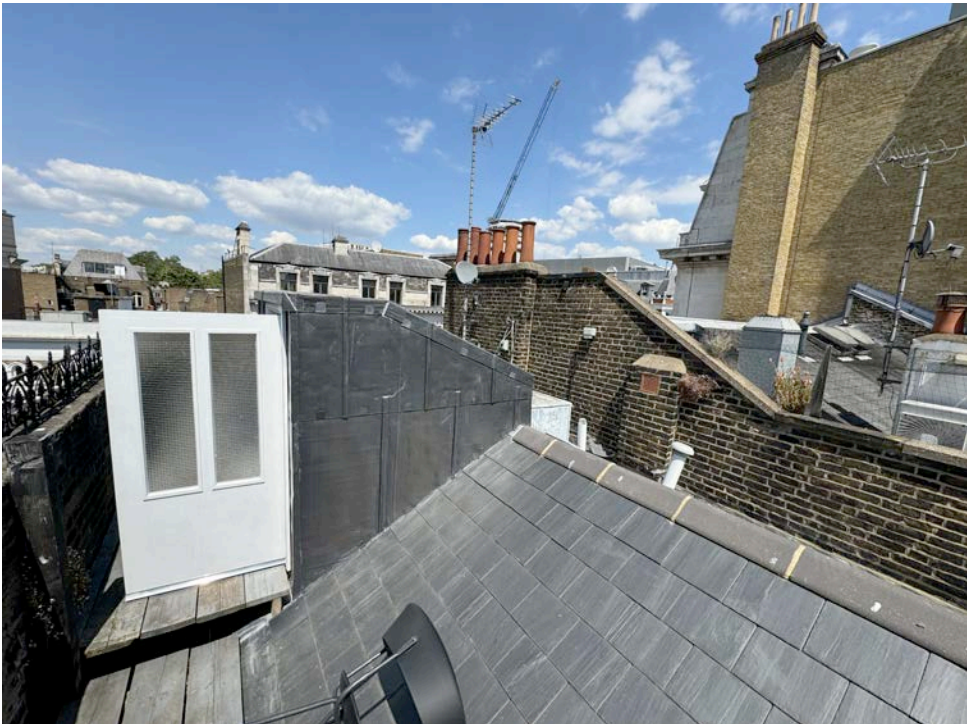
Newton Street front slope with roof access overrun and deck on steel frame to lesser width than permitted in 2008. Victorian style crested parapet is apparently modern.

- 5.1 Removal of roof terrace deck and steel framing over part of front roof pitch built in 2008.
- 5.2 Removal of roof access stair overrun enclosure built in 2008 and altered in 2023 and infilling of roof structure to match existing construction and internal boarded soffit linings.
