Crack and Level Monitoring

Provider Name: My Home Needs

Client: Questgates

Address: 222 Finchley Road, London, NW3 6DH

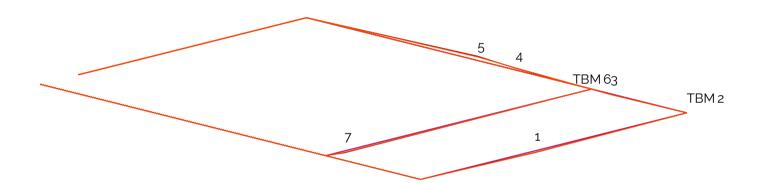
Relative Movement (Relative Survey, for illustration purposes only)

Visit 1	Visit 2	Visit 3	Visit 4	Visit 5	Visit 6	Visit 7	Visit 8
	29/10/24	10/03/25	09/05/25					
TBM 2	0	0	0					
1	0	-1.6	-1.9					
3	0	-0.7	-0.7					
4	0	+1.8	+2.1					
5	0	+4.3	+3.6					
TBM6	0	0	0					
7	0	-1.9	-1.5
