THE ELMS, FITZROY PARK, HIGHGATE, LONDON, N.6.

A SUPPLEMENTARY REPORT ON THE SCOPE TO RECOVER AND REINSTATE DISPLACED WINDOW-JOINERY TO BE READ IN CONJUNCTION WITH THE REPORT OF AUGUST, 2013, PROVIDING ASSESSMENTS OF THE POTENTIAL EFFECTS OF THE WORKS DESCRIBED IN THE ENFORCEMENT NOTICE PROPOSED FOR RETENTION AND THE POTENTIAL EFFECTS OF THE FURTHER PROPOSED WORKS ON THE PARTICULAR ARCHITECTURAL AND HISTORIC INTEREST AND SIGNIFICANCE OF THE PROPERTY, SUBMITTED IN SUPPORT OF APPLICATIONS FOR LISTED BUILDING CONSENT AND PLANNING PERMISSION

FEBRUARY, 2014

PAUL VELLUET – CONSERVATION, DEVELOPMENT AND PLANNING

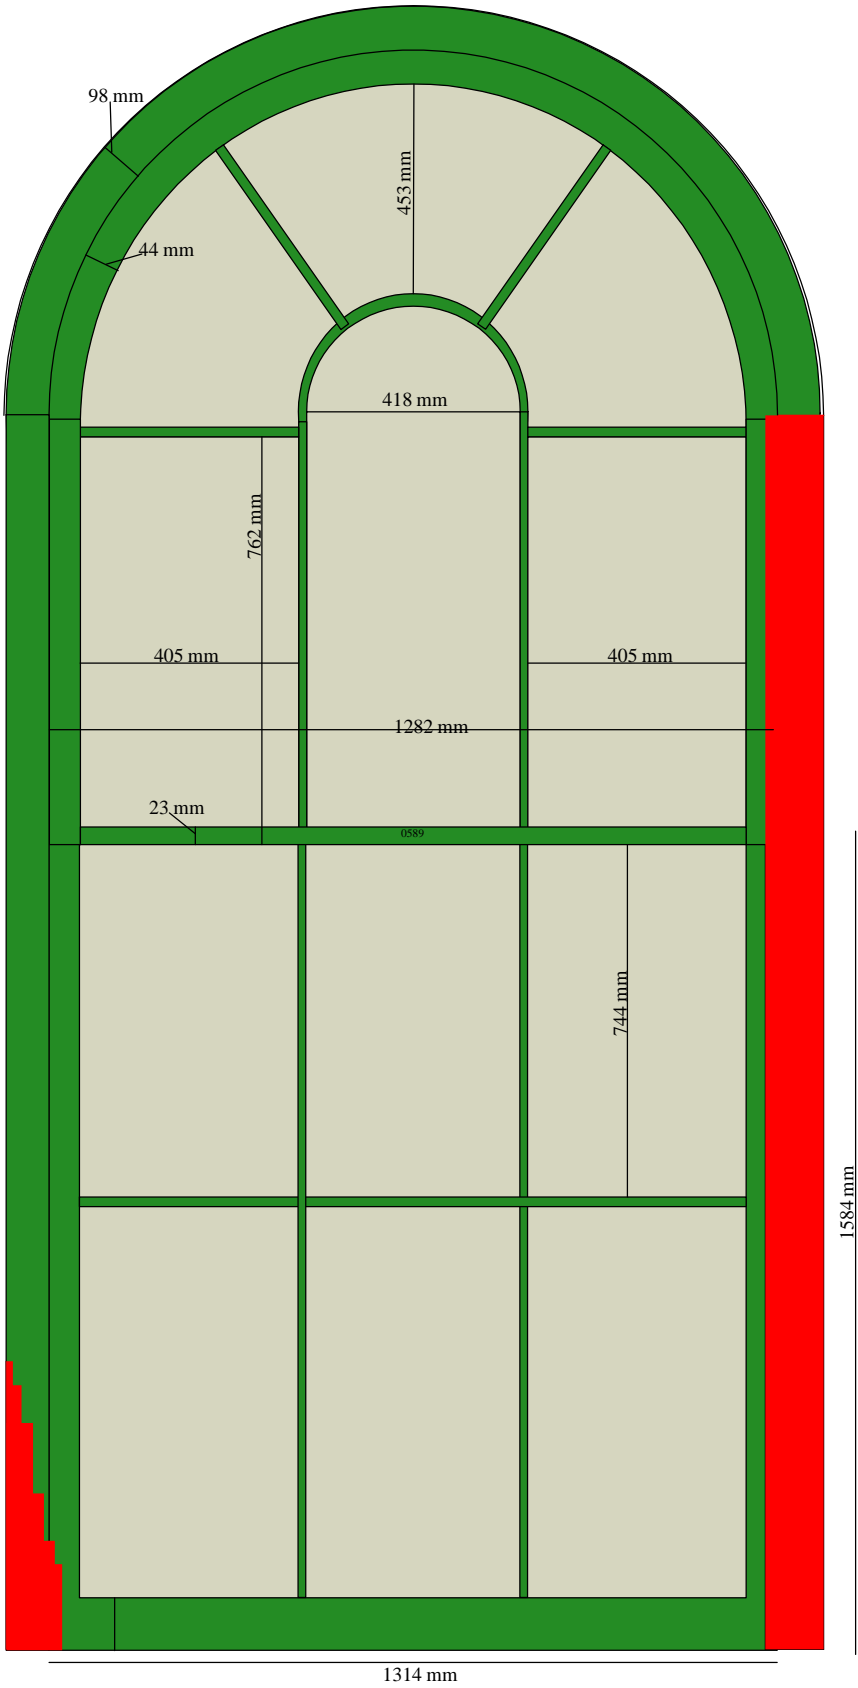
Arched Window

Missing timber

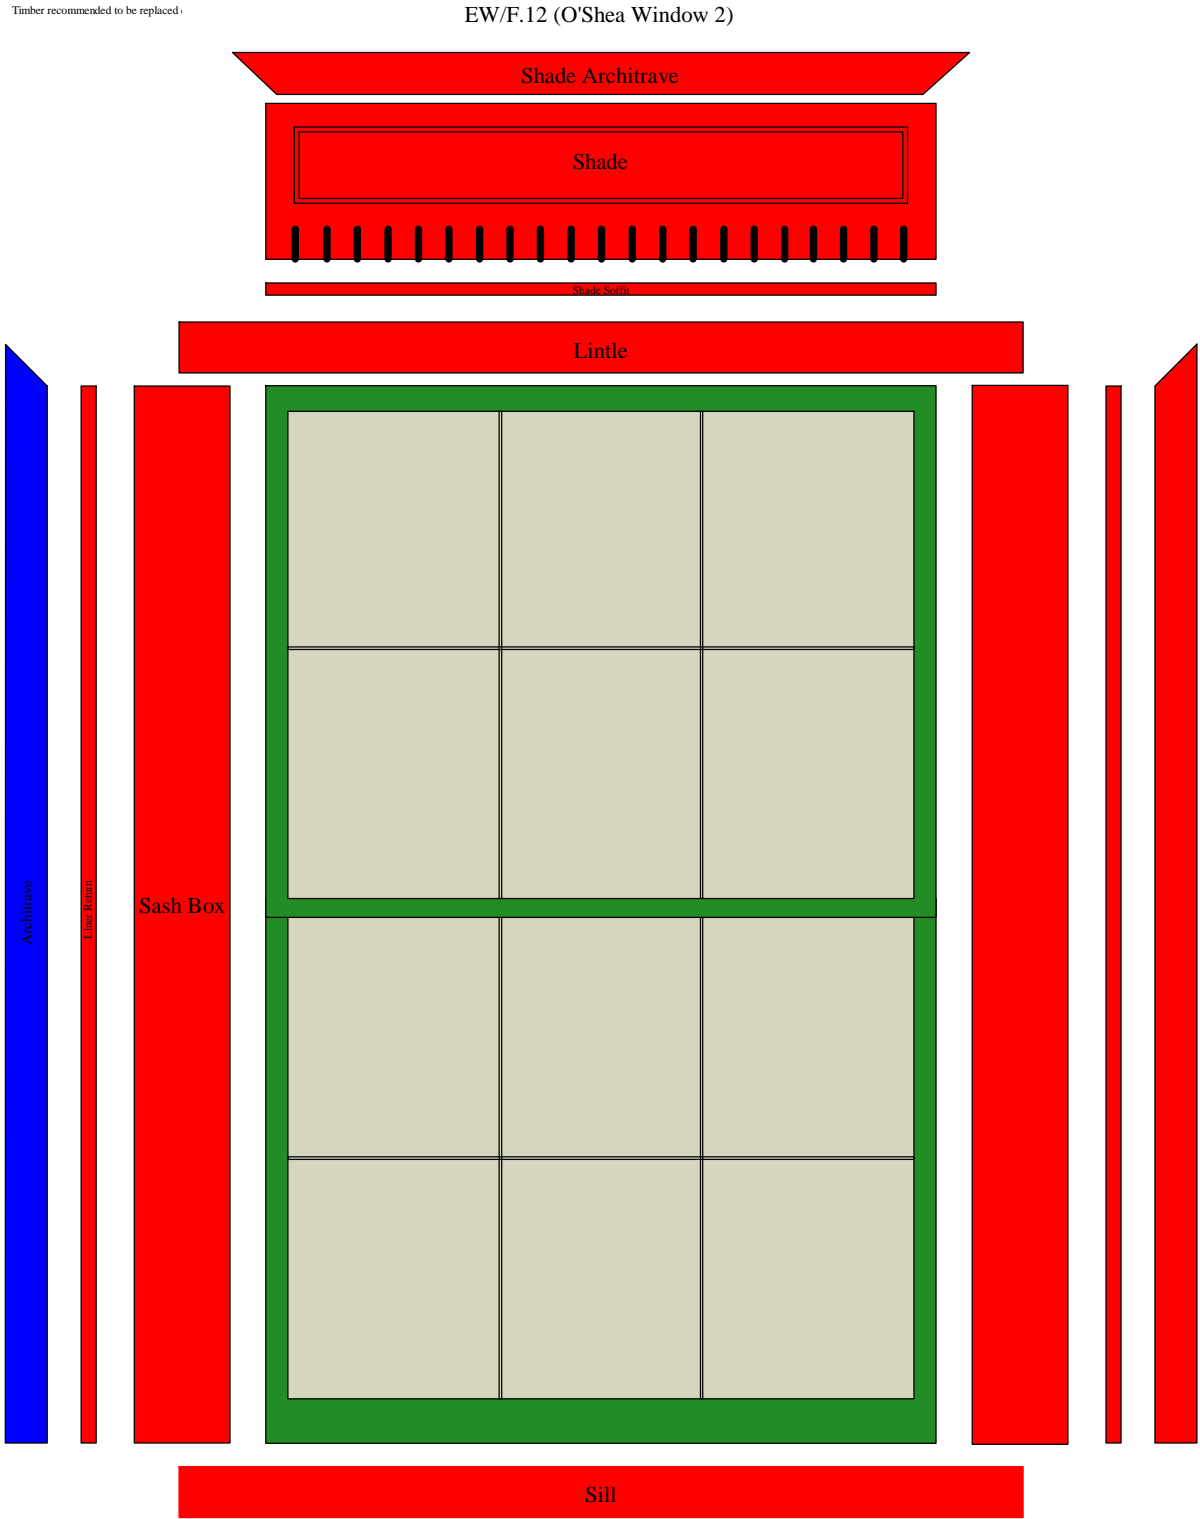
Windows 2, 3, 4, and 5 are all of very similar dimensions, 8 sashes exist with only two identified to a specific window. The top sashes are 1090, 1092, 1088 and 1094 mm wide and 885 mm high. The lower sashes are 1095, 1092, 1090, and 1095 wide and 915 high. Five of the sashes have the same glazing bar profile, the remaining three sashes all have different glazing bar profiles; one of which matches that of the arched window. The variation in profile is indicative of variation in age of the sashes.

Missing timber

It is likely that many of the joints will have to be replaced during the restoration process

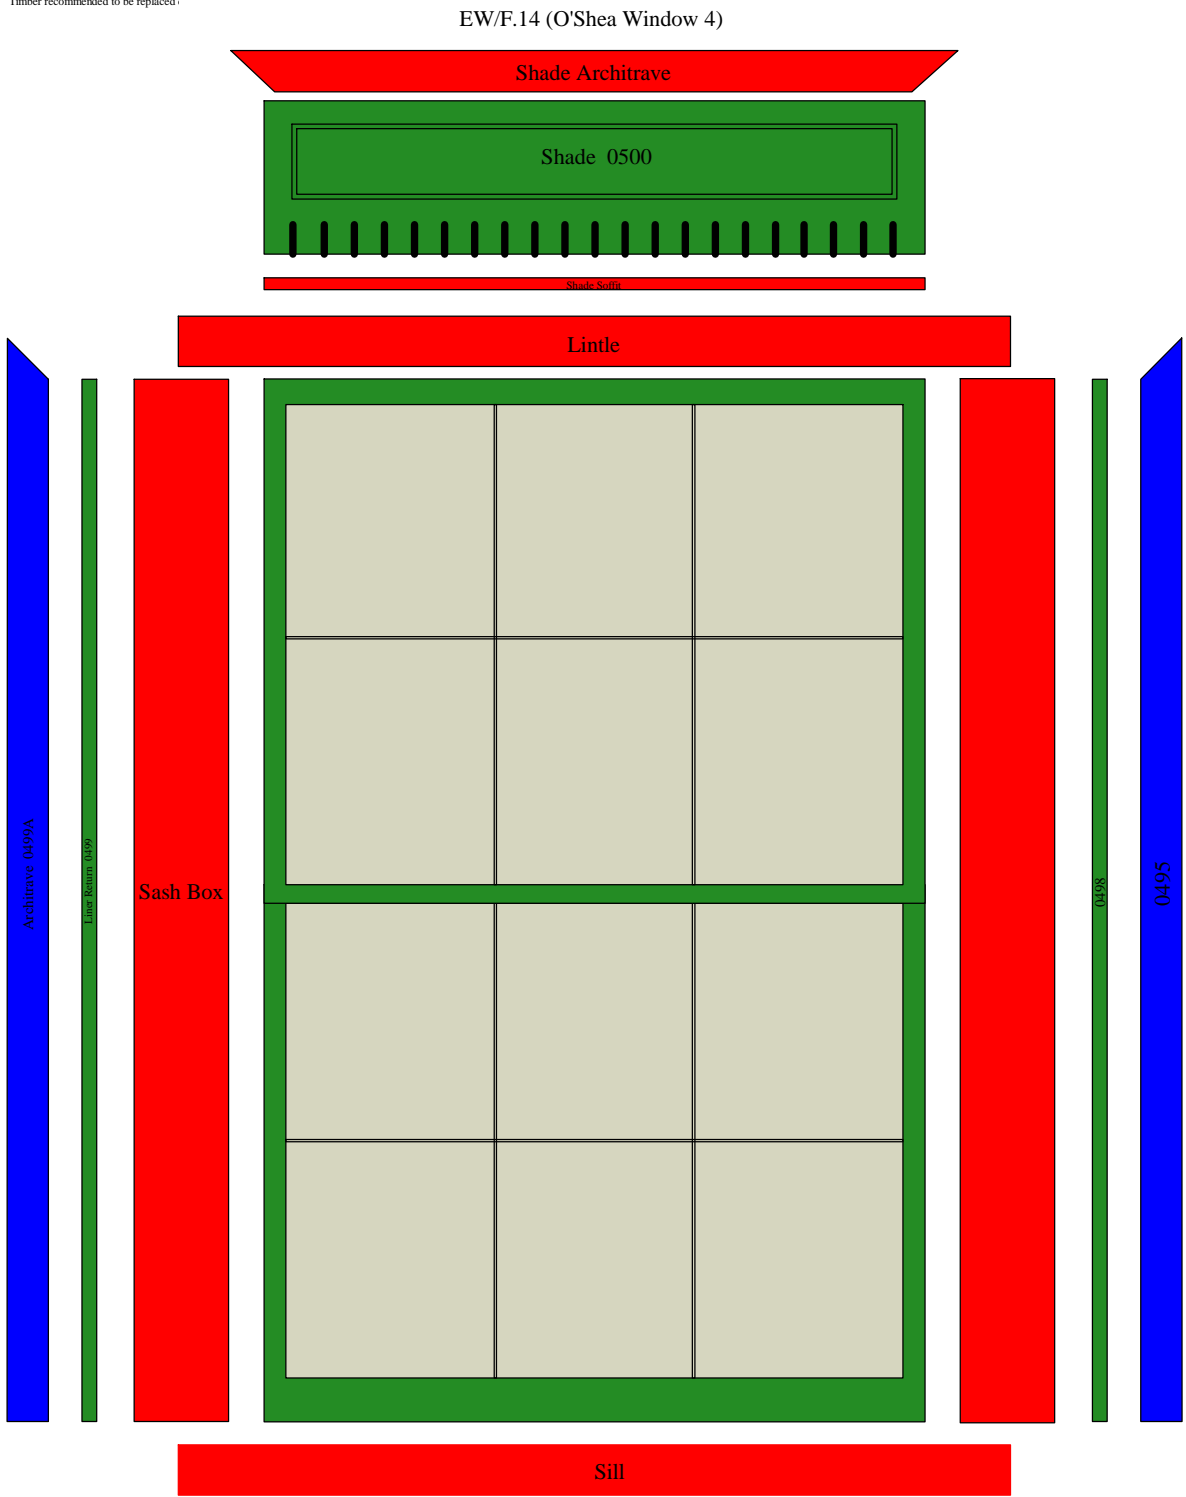
See notes on Window 2

Missing timber

Existing timber requiring refurbishment

It is likely that many of the joints will have to be replaced during the restoration process

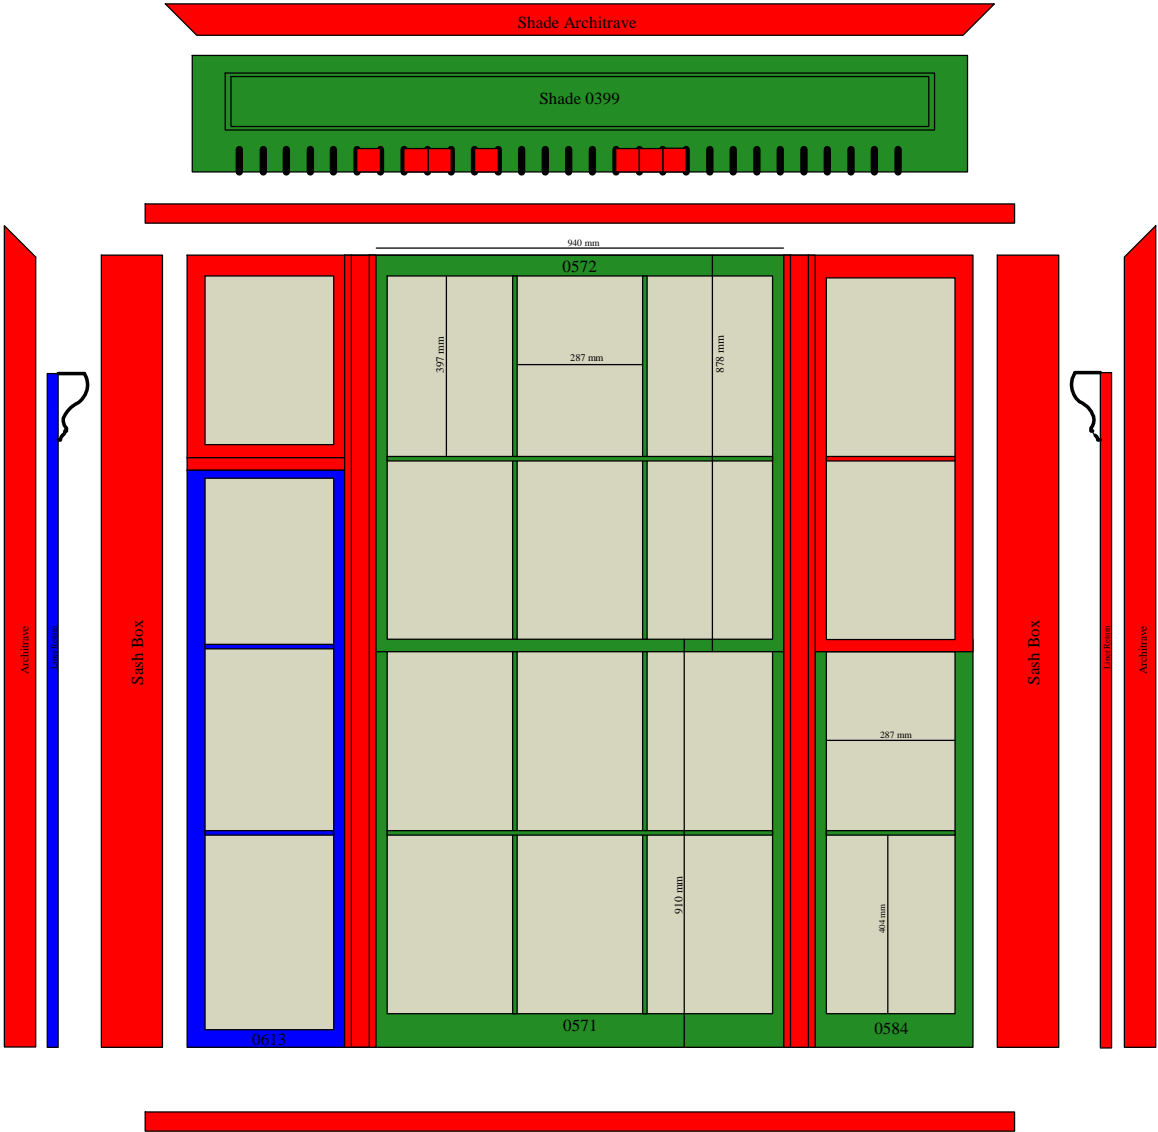
The uppercentral sash 878 mm high
Lower central sash 910 mm high
It is likely that many of the joints will have to be replaced during the restoration process

Missing timber

Existing timber requiring refurbishment
