Landmark Trees

ARBORICULTURAL IMPACT ASSESSMENT REPORT:

Proposed Single Dwelling
10a Oakhill Avenue
London
NW3 7RE

Ref: MEA/10aOA /AIA/02

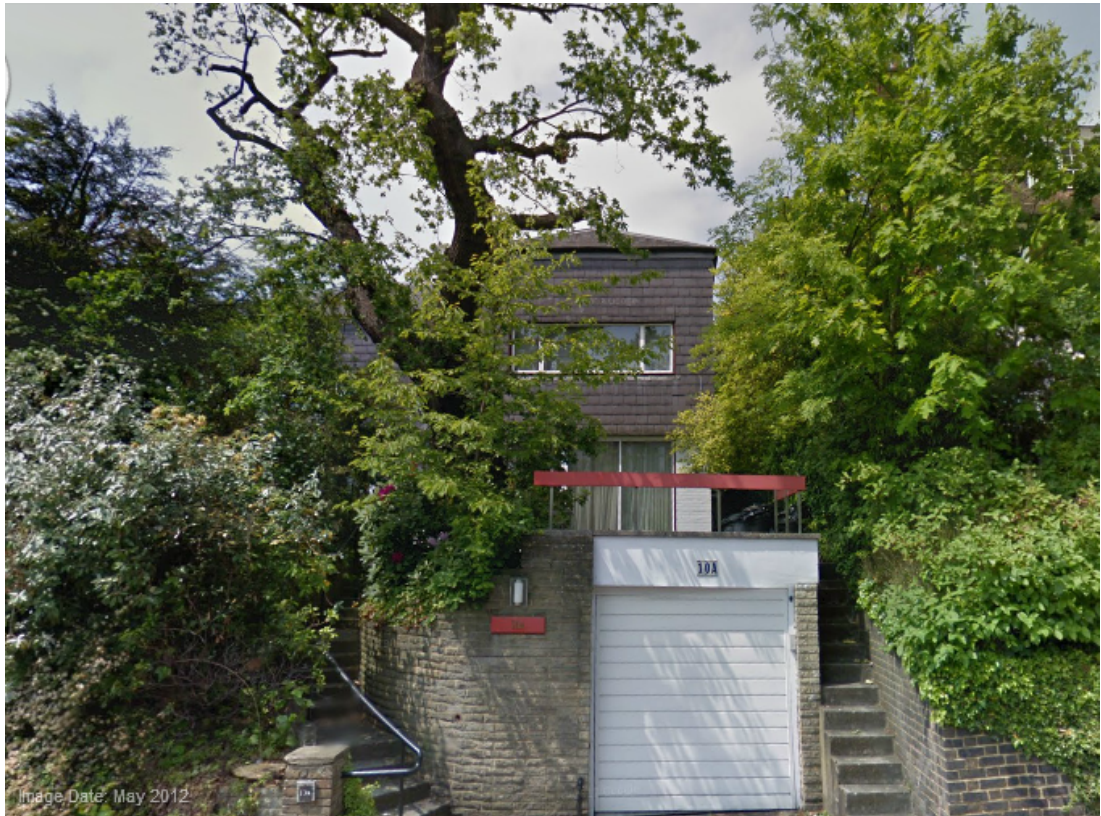
Photograph 1: 10a Oakhill Avenue, London NW3 7RE looking Northwest (Source: Google Maps)

- 3.1.1 The site at 10a Oakhill Avenue comprises an existing detached residential dwelling, situated on the north western side of the Avenue. Due to the local topography, the property has various level differences between the neighbouring properties and within the site itself. There is a split level front garden with two basement garage entrances and areas containing trees/scrub. The rear garden is relatively large with landscaped features including paths and hardstandings.
