Arboricultural Consultancy for Aviva

1. Case Details

| Insured | Mr Martin Jourdan | Address | 55 Shirlock Road, London, NW3 2HR | | |

Scope of Report: To survey the property and determine significant vegetation contributing to subsidence damage, make recommendation for remedial action and assess initial mitigation and recovery prospects. The survey does not make an assessment for decay or hazard evaluation.

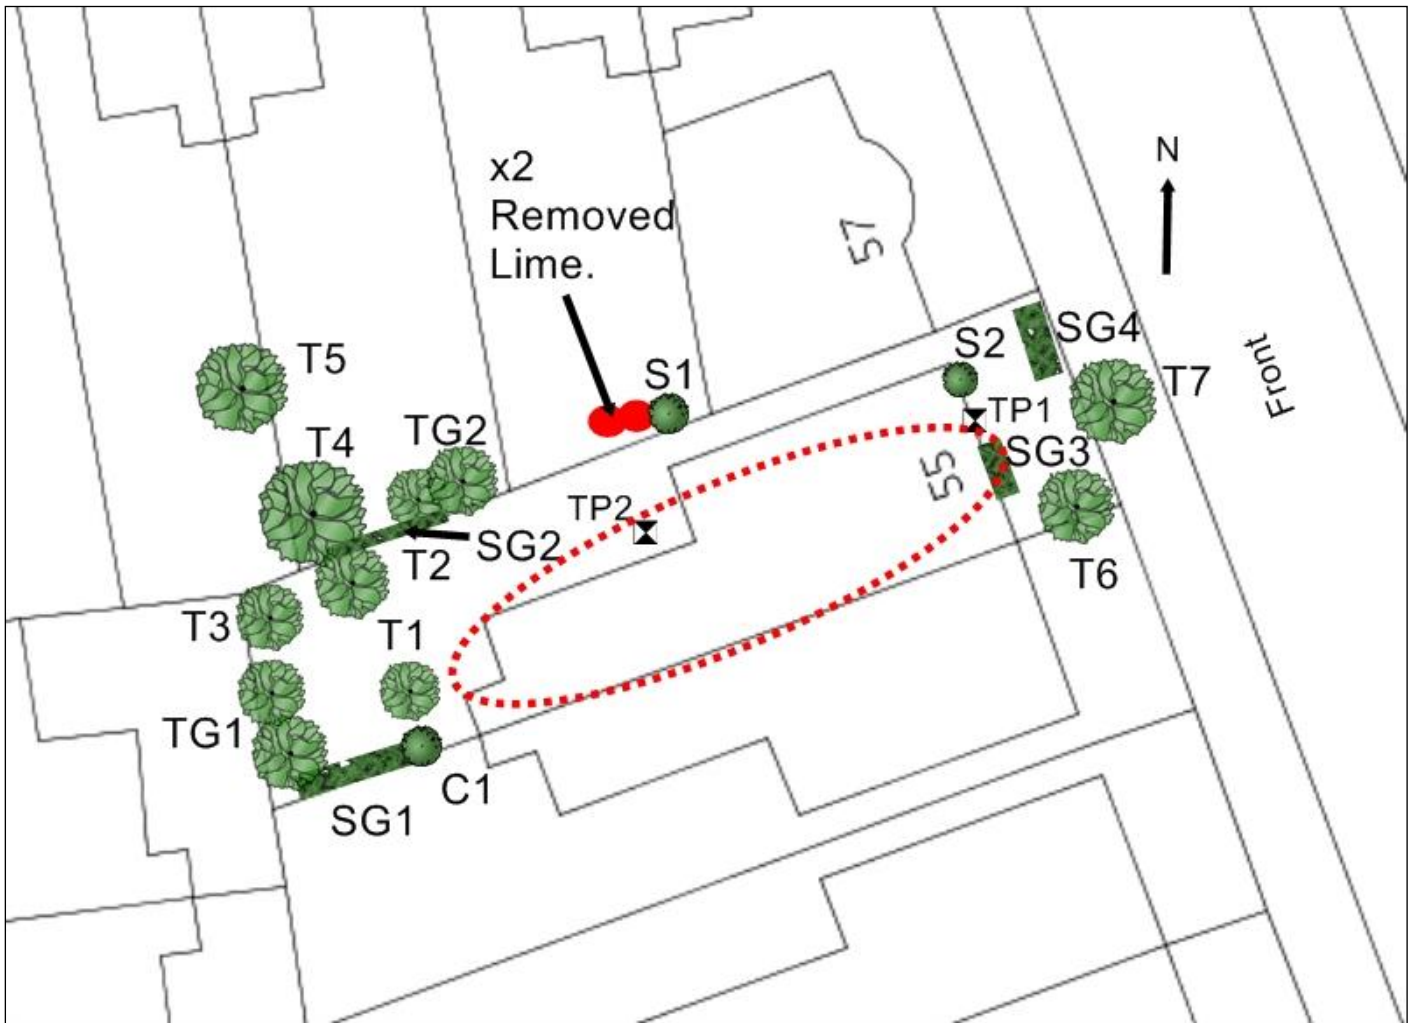
7. Site Plan

In assessing the potential drying influence of the vegetation on site, T4 (Lime) and T7 (Birch (Silver)) are considered the dominant feature and accordingly we have identified them as the principal cause of subsidence. T1 (Magnolia), C1 (Clematis), TG2 (Cypress), S1 (Bamboo), S2 (Rose), SG3 (Mixed species group) and T6 (Magnolia) are also considered to retain a contributory influence.
