APPENDIX 3

PHOTOGRAPHS

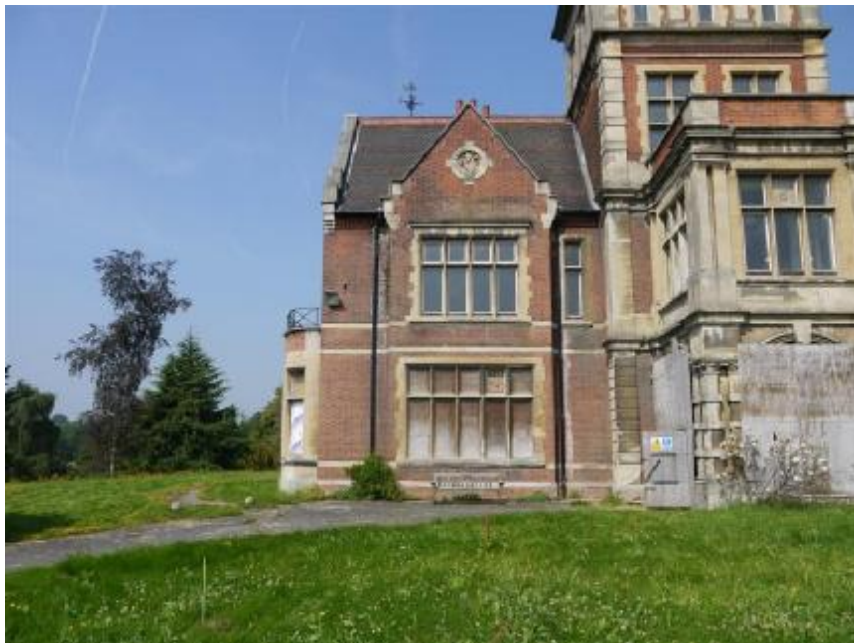
Photograph 1

Photograph Number	Description/Comment
1	Eastern Elevation – General view
2	Eastern Elevation – Southern (left hand) section – General view
3	Eastern Elevation – Showing stained brickwork, vegetation growth, worn masonry detail and defective brickwork joint to the Southern (left hand) section
4	Eastern Elevation – Southern (left hand) section – Showing vegetation behind the Gable wall, defective pointing to ridge tiles and loose/displaced plain tiles
5	Eastern Elevation – Southern (left hand) section – General view of the gable wall showing worn and stained brickwork and masonry surround to the First Floor window
6	Eastern Elevation – Southern (left hand) section – Showing worn and soiled masonry surround to the Ground Floor window
7	Eastern Elevation – Southern (left hand) section – Showing fracture to the masonry between the Ground and First Floor window openings
8	Eastern Elevation – Southern (left hand) section – Showing worn/eroded masonry surround, transoms, mullions and sill section to the Ground Floor window

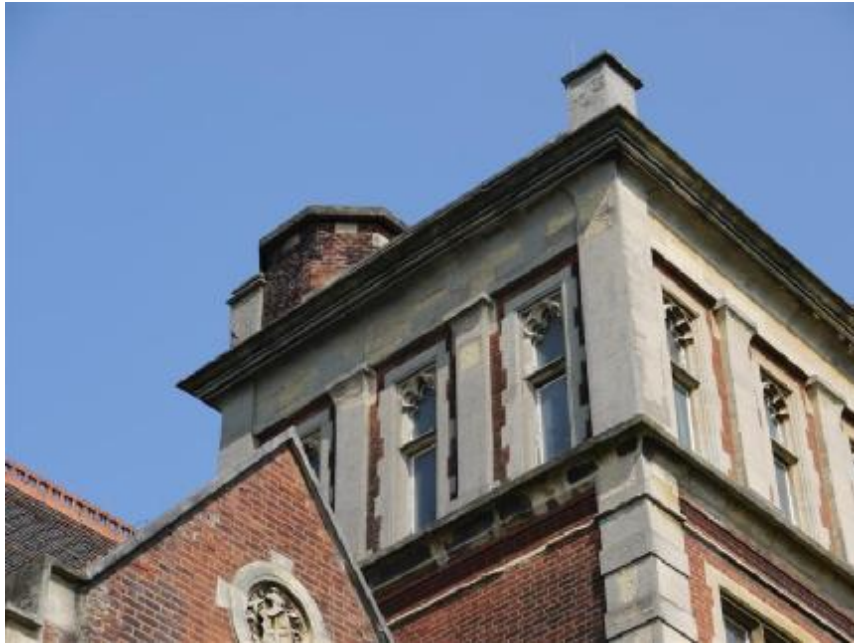
Photograph 10

9	Eastern Elevation – Southern (left hand) section – Showing worn brickwork to the gable, soiled brickwork adjacent to the rainwater pipe and soiled masonry surround to the First Floor window
10	Eastern Elevation – General view of the Main Entrance
11	Eastern Elevation – Showing worn and eroded brickwork to the entrance enclosure to the Flat Roof to the Tower and worn and eroded masonry projections and surrounds
12	Eastern Elevation – Showing worn and eroded masonry to the left hand of the Main Entrance at First Floor level
13	Eastern Elevation – Showing stained and eroded masonry to the left hand of the Main Entrance at Ground Floor level
14	Eastern Elevation – Showing worn and eroded masonry surrounds, soiled masonry detail and soiled brickwork to the upper section to the Tower and above the Main Entrance
15	Eastern Elevation – Showing soiled and worn masonry surround to the Main Entrance at Ground Floor level

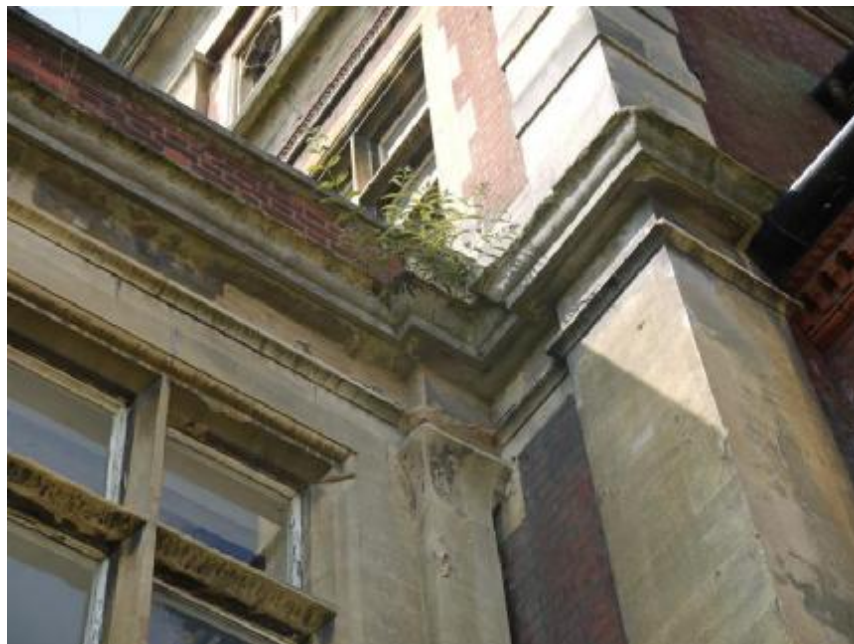
Photograph 17

Photograph Number	Description/Comment
17	Eastern Elevation – Showing soiled and worn masonry to the right hand of the Main Entrance
18	Eastern Elevation – Showing vegetation growth and worn and eroded masonry to the right hand of the Main Entrance at high level
19	Eastern Elevation – Showing vegetation growth and worn and eroded masonry details, sills and projections to the right hand of the Main Entrance at mid-height
20	Eastern Elevation – Showing damaged, worn and eroded masonry to the right hand of the Main Entrance doors
21	Eastern Elevation – Showing worn paving to the Main Entrance
22	Eastern Elevation – Central Area – Showing worn and missing ridge tiles, minor vegetation growth to the gable, uneven/displaced and patch repaired plain tiles and window addition at Second Floor level
23	Eastern Elevation - Northern (right hand) section)– Showing uneven ridge tiles, worn and eroded brickwork and masonry to the chimney stack and worn, soiled and patch repaired brickwork and vegetation adjacent to the rainwater pipe

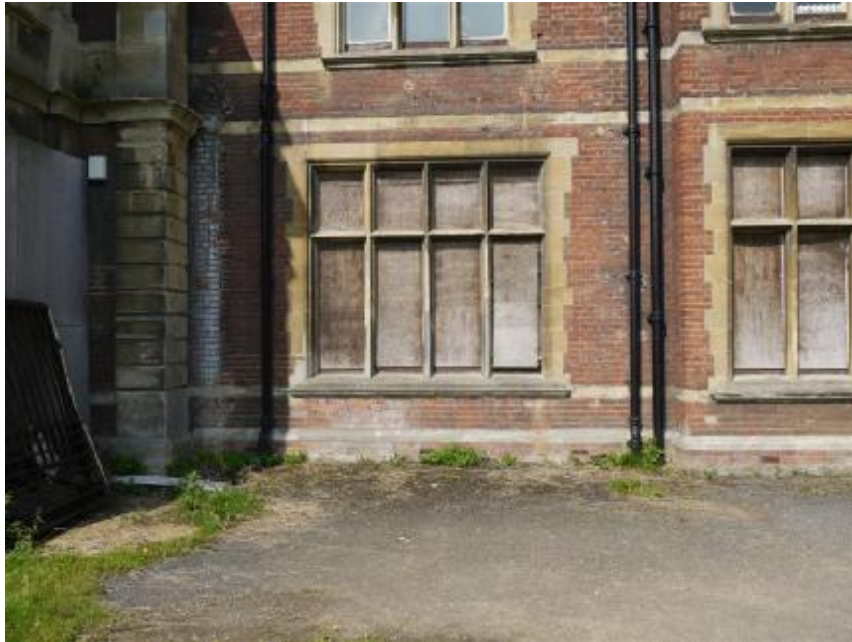
Photograph 24

24	Eastern Elevation – Central section – Showing stained areas of brickwork and worn and eroded masonry surrounds, transoms and mullions to window openings
25	Eastern Elevation – Central section – Showing stained areas of brickwork and worn and eroded masonry surrounds, transoms and mullions to window openings
26	Eastern Elevation – Central section – Showing soiled areas of brickwork and open joint to the Gable and soiled and worn masonry to the First Floor window
27	Eastern Elevation – Central section – Showing worn and eroded masonry sill section, transoms and mullions to the Ground Floor window and worn and eroded masonry projection and brick plinth at low level
28	Eastern Elevation- between Central and Northern (right hand) – Showing high level vegetation and soiled and worn areas of brickwork
29	Eastern Elevation – Northern (right hand) section – Showing fracture to the masonry support beneath the First Floor window projection and worn and eroded masonry sill section

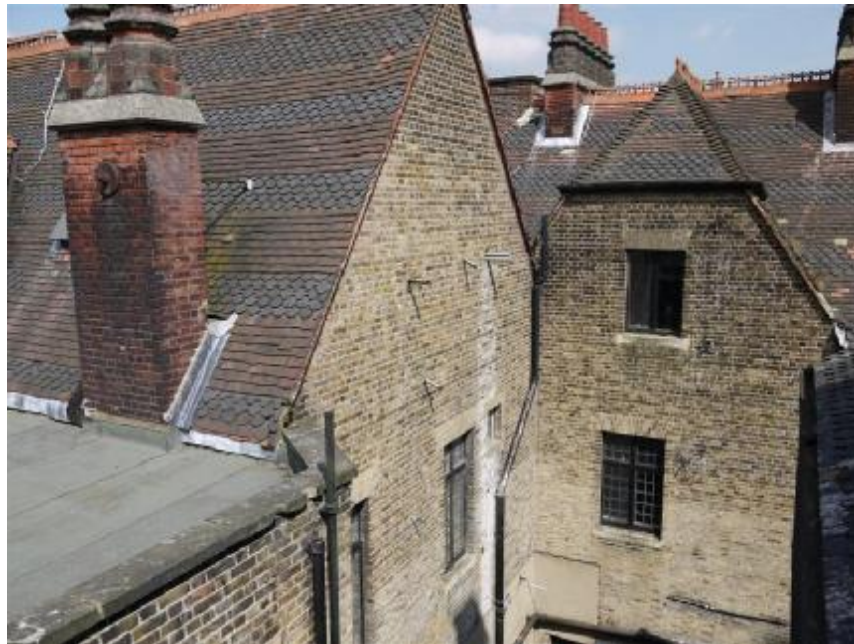
Photograph 114

114	Internal Elevations – Showing the mineral felt and lead covered flat roof areas at Ground Floor level

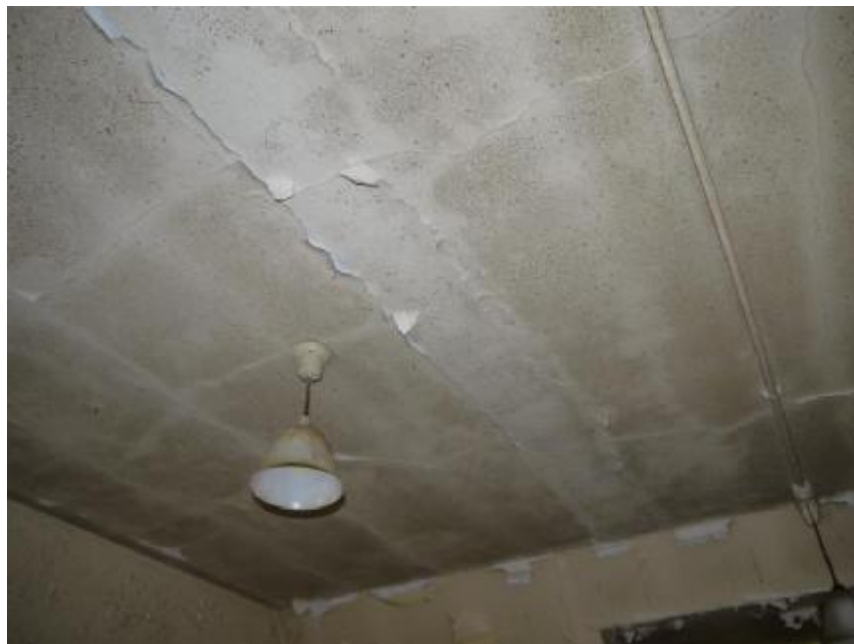
Photograph 161

161	Second Floor (North) – Showing defective plaster and soiled surfaces to the Central Room (East)
162	Second Floor (North) – Showing fractured and soiled surfaces to the ceiling to the Central Room (East)
163	Second Floor (North) – Showing defective/removed plaster to the Central Room (West)
164	Second Floor (North) – Internal corridor showing defective plaster to the walls and ceiling
165	Second Floor (North) – Internal corridor showing timber bracing to the rafters and rot affected timber boarding
166	Second Floor (North) – Internal corridor showing rot affected window frame
167	Second Floor (North) WC – Showing defective plaster and general debris
168	First Floor – Showing extensive fracture to the ceiling of the room at the junction of the North and East areas
169	First Floor – Showing fracture to the ceiling of the room at the junction of the North and East areas
170	First Floor – Showing defective ceiling to the Store to the Eastern area

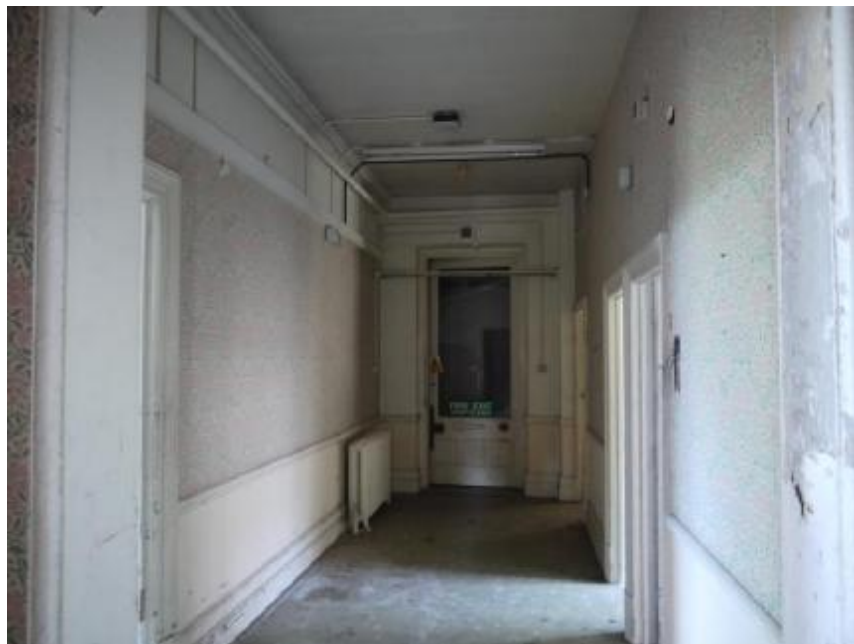
Photograph 199

199	First Floor – Showing rot affected skirting in the Central Room (North) to the Western area
200	First Floor – General view of the Western Circulation area
201	First Floor WC Area (Western) adjacent to the Light Well – General view
202	First Floor Bathroom area (Western) adjacent to the Light Well – Showing extensive pigeon droppings
203	First Floor – General view of the non- original Extension to the North of the Western area
204	First Floor – General view of the non- original Extension to the North of the Western area
205	First Floor – Showing mould growth to the wall to the Northern Stairwell Lobby
206	First Floor – North Circulation Area – General view
207	First Floor – Showing defective plaster and mould growth to the Northern Area (Eastern Room)
208	First Floor – Showing mould growth to the external wall to the Northern Area (Western Room)

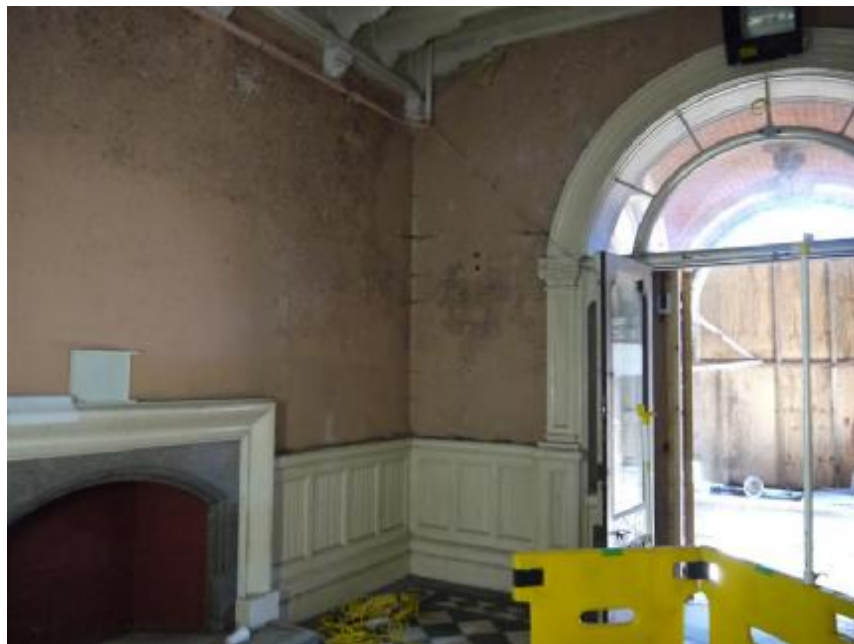
Photograph 209

Photograph Number	Description/Comment
209	First Floor – General view of the former WC facility to the Northern Area
210	Ground Floor – Showing extensive mould growth to the walls within the Main Entrance
211	Ground Floor – Showing defective finish to the timber boarding to the ceiling of the Main Entrance
212	Ground Floor – Showing defective/soiled finishes within the Southern Amenity area
213	Ground Floor – Showing defective/soiled finishes within the Southern WC area
214	Ground Floor – Showing rot affected timber panel to the windows within the Room at the junction of the Eastern/Southern areas
215	Ground Floor – Showing soiled timber panels to the soffit of the Main Staircase
216	Ground Floor – General view of the Main Reception Area
217	Ground Floor – General view of the Main Staircase
218	Ground Floor – Reception Area facing towards the Main Entrance
219	Ground Floor – General view of the Reception Area

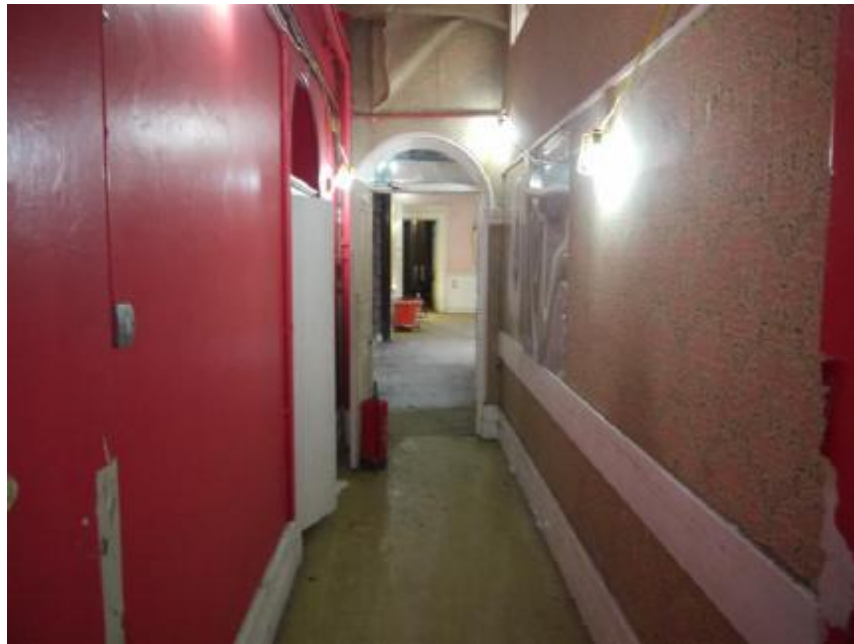
Photograph 250

Photograph Number	Description/Comment
250	Ground Floor – Showing the electrical services to the Northern Circulation area
251	Ground Floor – General view of the Eastern Circulation area
252	Ground Floor – Showing defective finishes to the Room at the junction of the Northern/Eastern areas
253	Ground Floor – Showing defective finishes to the Central Room to the Eastern area
254	Ground Floor – General view of the Central Room to the Eastern area
255	Ground Floor – Showing defective plasterwork to the WC to the Eastern Elevation
256	Ground Floor – Showing previously removed plaster to the WC to the Eastern Elevation
257	Basement – General view of access Staircase showing defective plaster to the wall
258	Basement – Showing extensive damp to the render to the Room adjacent to the access Staircase
259	Basement – Showing rot affected timber to the shelving to the Room adjacent to the access Staircase
260	Basement – Showing water damaged shelving to the central area of the Southern section of the Basement

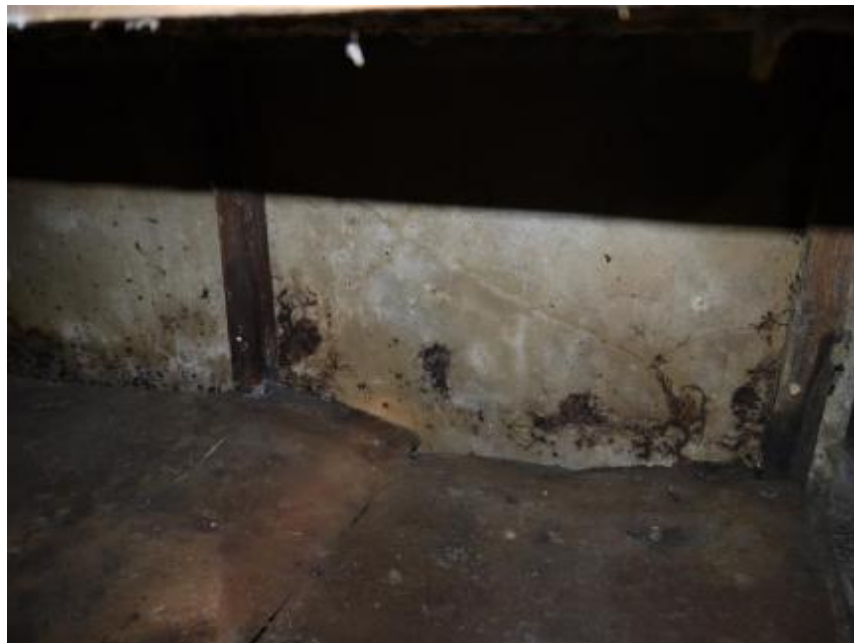
Photograph 261

261	Basement – Showing water damaged shelving to the central area of the Southern section of the Basement
262	Basement – Showing fungal growth to the wall within the Southern section of the Basement
263	Basement – Showing mould growth to the internal door to the Southern section of the Basement
264	Basement – General view of the Circulation area to the Southern section of the Basement
265	Basement – General view of the Circulation area to the Northern section of the Basement
266	Basement – Showing fungal growth to the floor/wall to the Northern section of the Basement
267	Basement – Showing hot water tank
268	Basement – Showing the corroded rainwater pipe to the Northern section

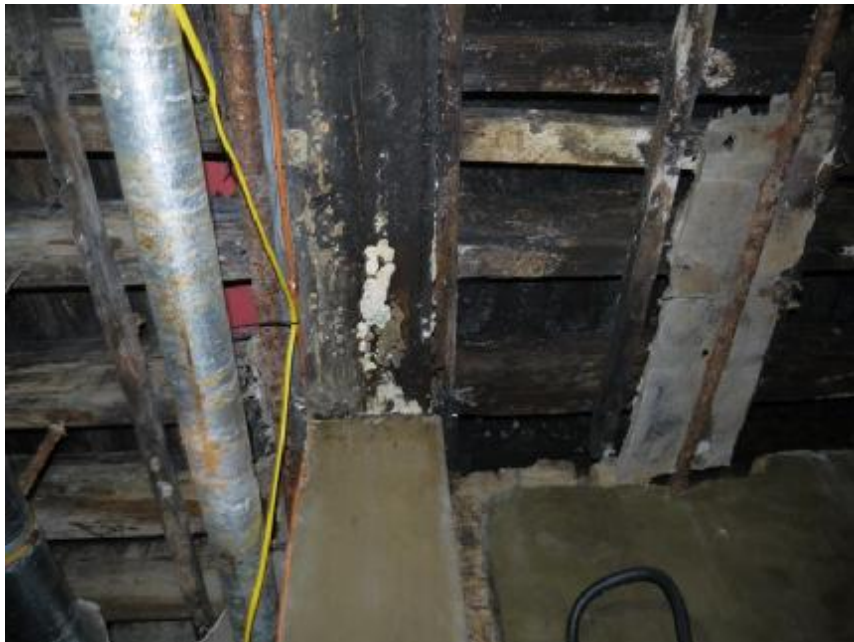
Photograph 269

Photograph Number	Description/Comment
269	Basement – Showing corroded pipework and defective access door to the Light Well
270	Basement – Showing fungal growth to the exposed timber beam to the Northern Section
271	Basement – Showing corroded pipework and displaced inspection chamber cover to the North of the Eastern Circulation area
272	Basement – Showing corroded pipework to the North of the Eastern Circulation area
