ARBORICULTURAL IMPACT ASSESSMENT REPORT:

99a Frognal, Hampstead London NW3 6XR

Ref: HVC/FRG/AIA/03

Date: 20th September 2013

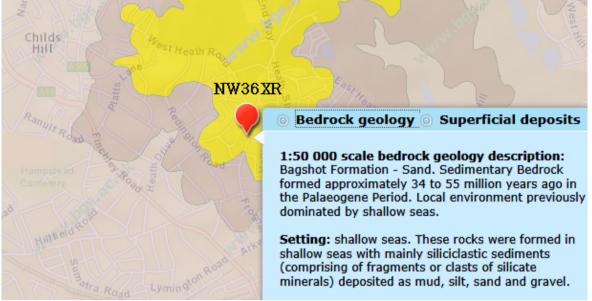
Figure 1: Extract from the BGS Geology of Britain Viewer

- 3.1.2 In terms of the British Geological Survey, the site overlies the Bagshot Formation (see indicated location on Fig.1 plan extract below). The associated soils are generally fine, white, buff and sometimes crimson sands, grey when unweathered, with sporadic seams of pale pipe-clay and local beds of flint-pebble gravel. The actual distribution of the soil series are not as clearly defined on the ground as on plan and there may be anomalies in the actual composition of sand, clay and gravel content. Further advice from the relevant experts on the specific soil properties can be sought as necessary.
