## 4 Assessment

### 4.1 Archway 1

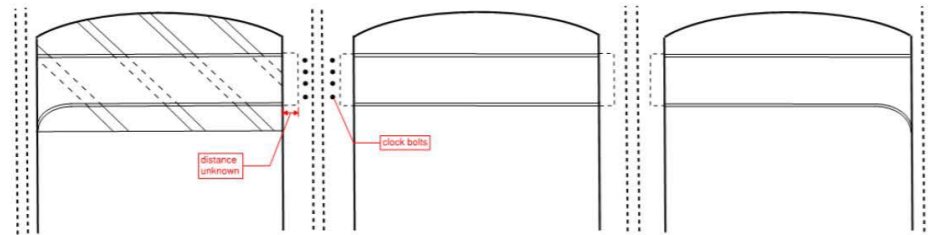
Figure 10: Schematic view of rear elevation of façade.

- Brickwork appears to have been removed at both ends, that would have been partially supporting the concrete arch above (Figure 11). At present, archway is only supported by brick packing onto plate girder beam.
- Beam is not continuous through masonry piers (as not encountered during drilling for clock), and beam bearing left onto brickwork unknown (Figure 10). However once area has been infilled (as recommended in section 5), beam will be carrying no significant load.
- Brick pier is not fully supported at ground level (Figure 7). Pier below plate girder beam is of more recent construction.
