DESIGN AND ACCESS HERITAGE STATEMENT in support of applications for Listed Building Consent

81B ALBERT STREET, LONDON NW1 7LX

September 2013

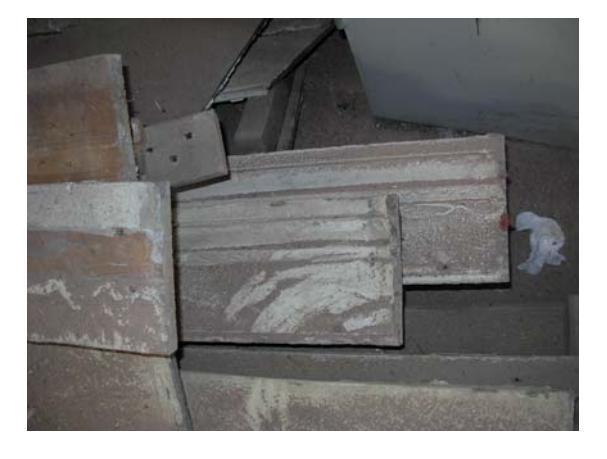
Figure 4 – Skirtings and architraves

- Removal of the kitchen units and wall tiling.
- All doors and architraves removed but set aside for future reuse. (Figure 6)
- Most of the skirtings removed but set aside for future reuse. (Figure 4)
- Removal of lime and lath finishes to the existing stud walls including staircase stud. (Figure 5)
- Removal of lime and lath ceiling finishes but retention of the original cornices in both front and back rooms and stair landing. (Figure 7)

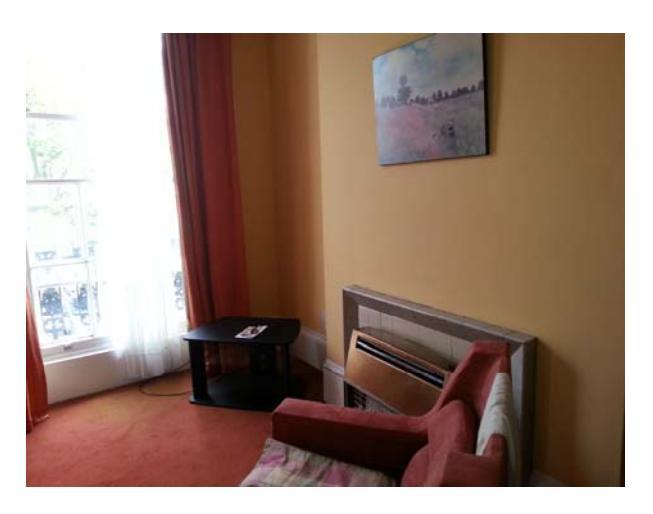
Figure 9 – 1^{st} floor living room fire place

- The floor boarding is unchanged. Softwood floorboards, 175mm x 22mm locally damaged. (Figure 8)
- The chimney places are blocked at this level; the date of this alteration is not apparent but was not executed under the recent works. (Figure 9)
- Perimeter walls with original lame plaster finish in sound condition with some hair line cracks.
- Original window sashes and architraves in fair condition requiring local repairs. (F 10)
- Window architraves at the rear elevation where the kitchen use to be are cut through.

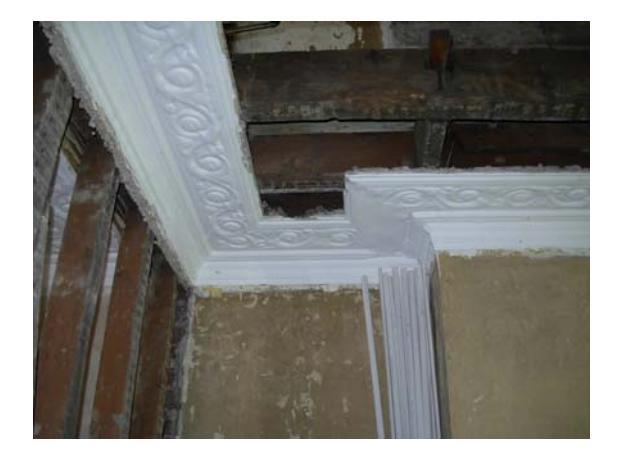
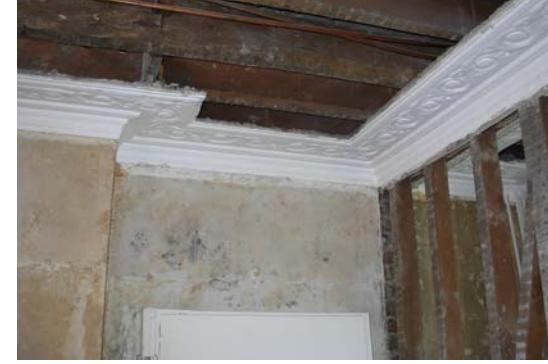
Figure 22 – Retained original plasterwork

Fractured decorative plasterwork

The damaged sections of ornamental work will be recorded and mouldings taken, using a 12mm clay squeeze, from adjacent work that replicates the missing sections. The existing enrichment is to be cleaned and lightly oiled before the mould is taken to ensure the detail is sharp. The damaged area is then to be carefully worked to provide a clean square edged mortice into which the new section is to be placed. Removal is to be carefully controlled to ensure minimal loss of the original fabric.

The repair casts are to be cut and profiled to fit into the mortice in the existing work and to pick up the pattern of the surrounding ornament. The repairs are to be applied into the original runs using casting plaster as an adhesive. When the plaster has started to set the contractor is to carefully work plaster filler into the repair joints and profile so as the new work blends with the existing. (Figure 22)
