4216 - The Elms Veranda - Condition Report

<u>Description :</u>	Grade II listed detached house. 1838 - 40 by George Basevi. With later alterations. A tented veranda with thin 'cast' iron columns
<u>Address :</u>	N6 6HS
<u>Generated on :</u>	10/06/2013
<u>Building stages :</u>	- Condition Report
<u>Building trades :</u>	- Masonry - Metalworks
<u>Stakeholder :</u>	
<u>Drawings :</u>	- Columns - 001 (Condition Report) - Columns - 002 (Condition Report) - Columns - 003 (Condition Report) - Columns - 004 (Condition Report) - Gutter detail (Condition Report) - Reusable strip (Condition Report) - Roof members - 001 (Condition Report) - Roof members - 002 (Condition Report) - Roof members - 003 (Condition Report) - Roof members - 004 (Condition Report) - Tie bars (Condition Report) - Zinc roofing (Condition Report)

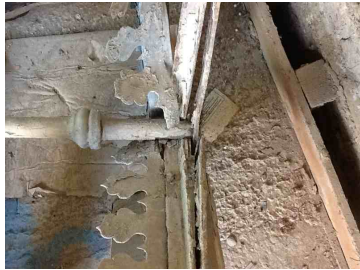
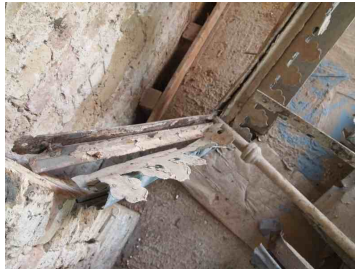
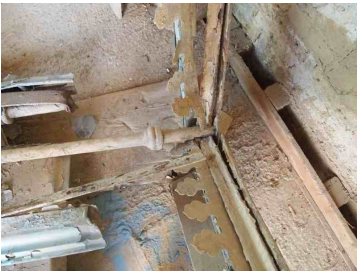
Observation #2

Column 005 remains attached to guttering, steel plate structure and decorative zinc work. Evidences construction methods.

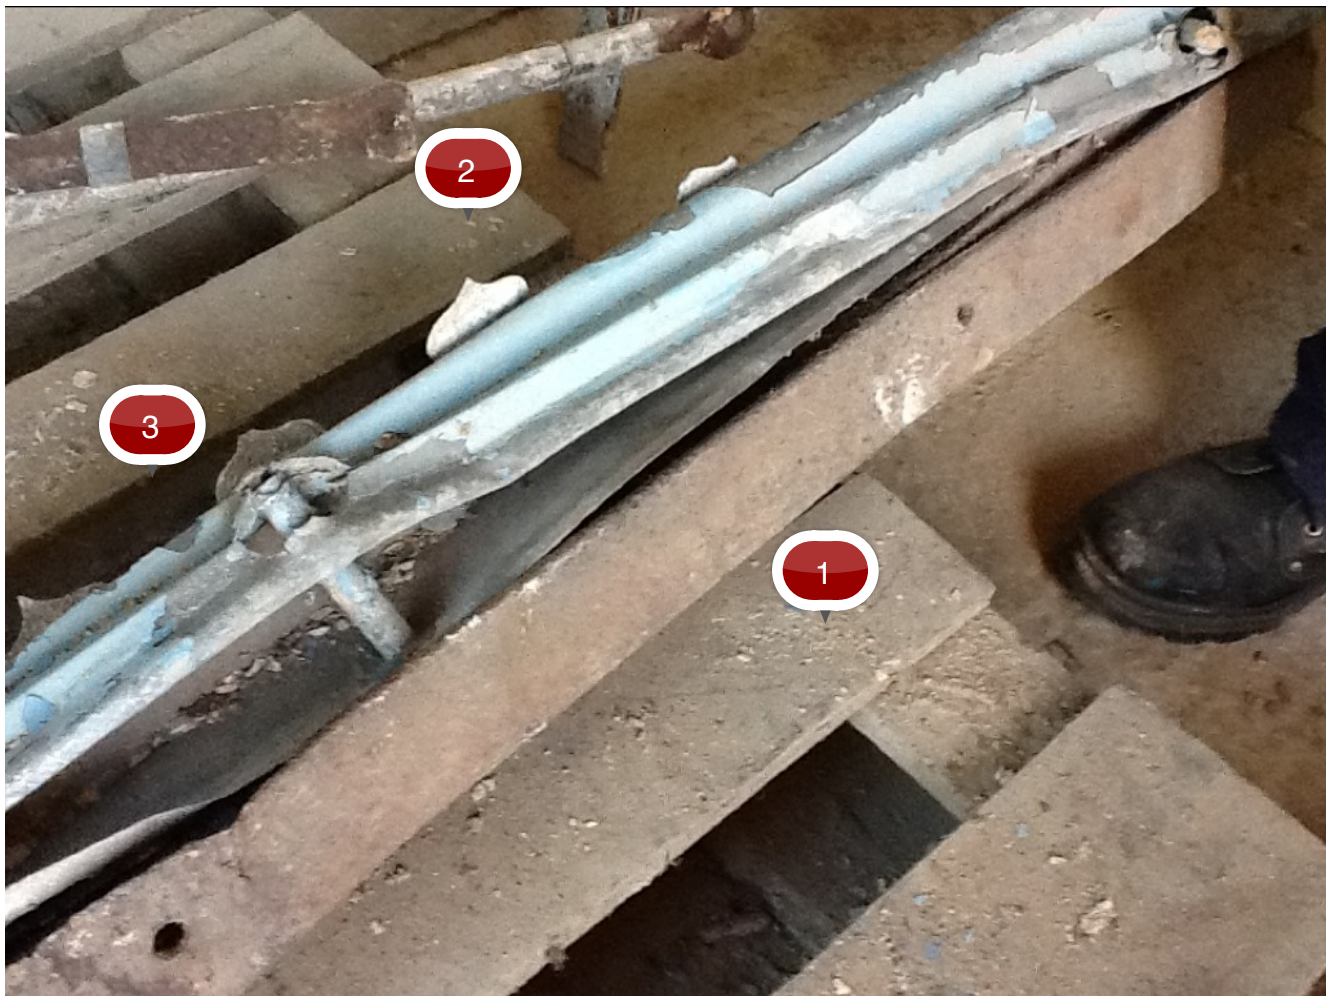
Observation #1

Top plate 60mm wide x 6mm thick

Observation #2

Decorative Zinc:

'Leaf' detail repeated at 4 inch centres

140mm full height overlapped by angle bar, to which the top plate is fixed.

80mm decorative 'leaf' height

73mm width of decorative 'leaf'.

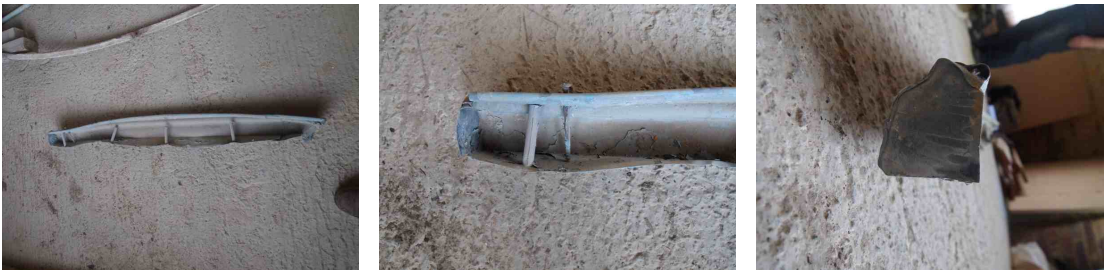
Observation #3

Section detail. Most guttering severely damaged or distorted.

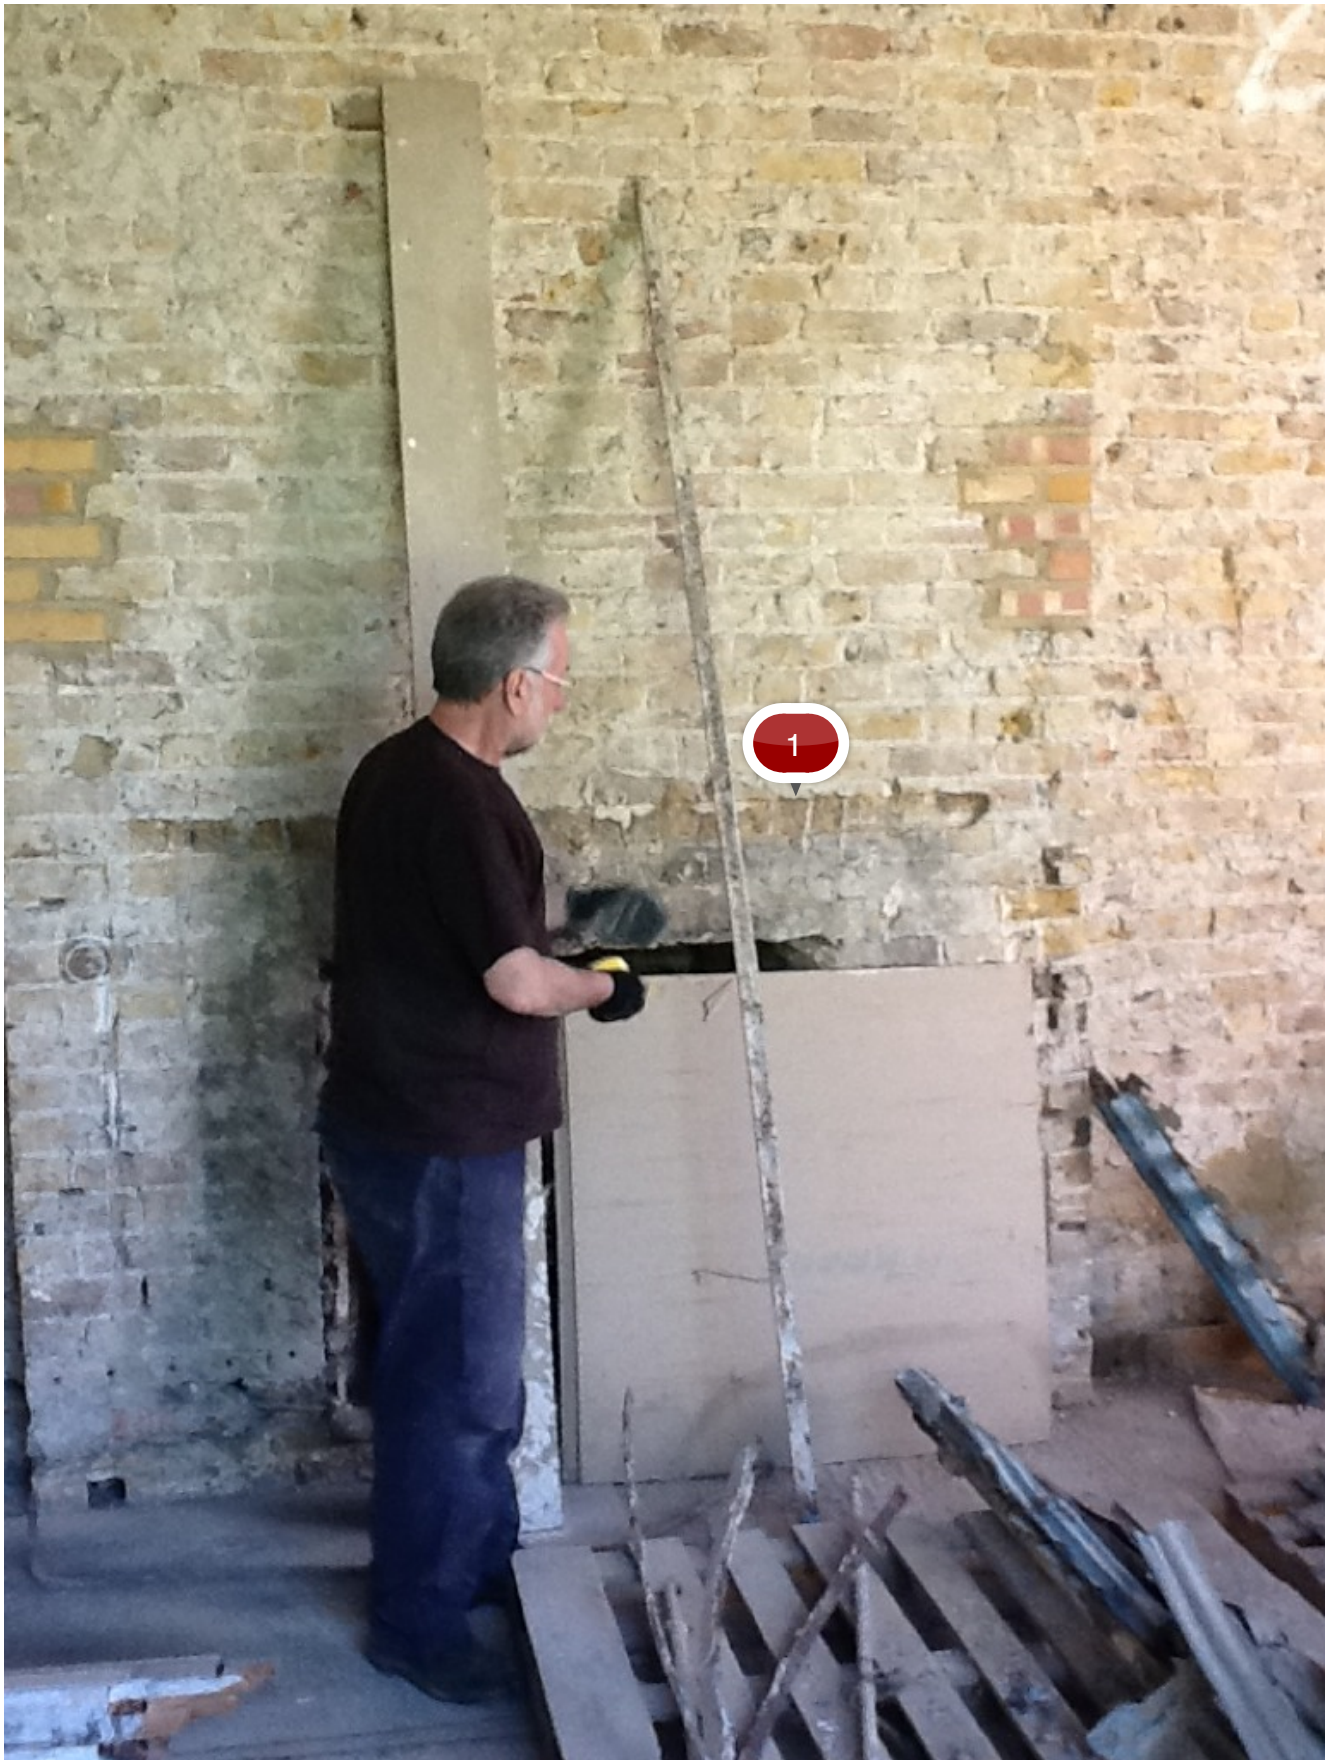
Observation #1

Reusable steel strip - likely to be angle section for attaching to guttering.

2660mm total length.

Quarter inch depth with 45mm centres between holes approx.

Angle dimensions 40mm by 40mm approx.

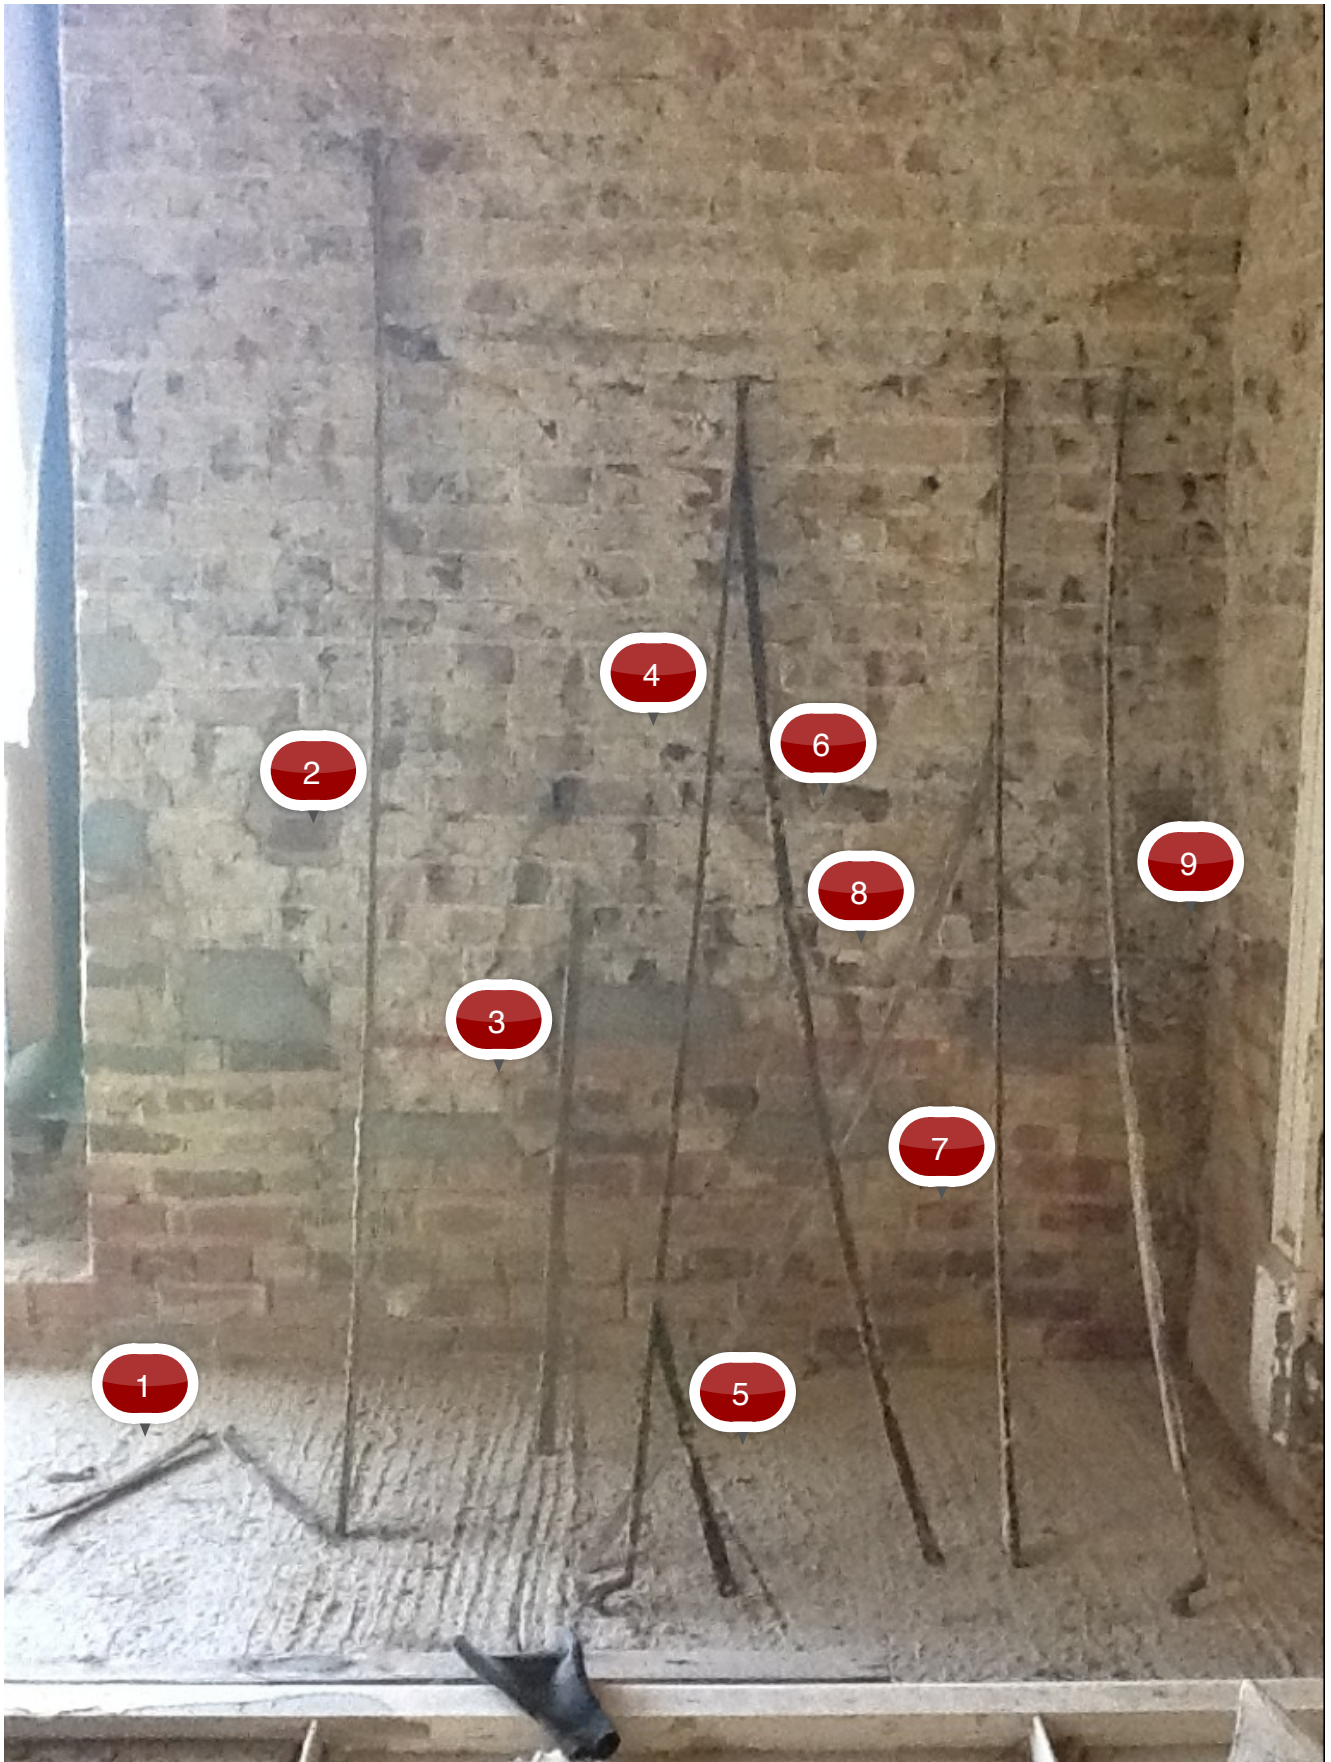
Observation #1

470mm curve
25mm x 10mm D section.

NB. D section sizes assumed the same for all.

Observation #2

2400 curve length
2370 straight length
30mm depth
10mm width

Observation #3

1050 mm curve
1015 mm straight
Same d section

Observation #4

2160mm curve
2100mm straight

Observation #5

480mm curve

Observation #6

2000mm curve
1930mm straight

Observation #7

2130mm curve
2080mm straight

Observation #8

1700mm curve
1660mm straight

D section

Observation #9

Same as observation no. 7

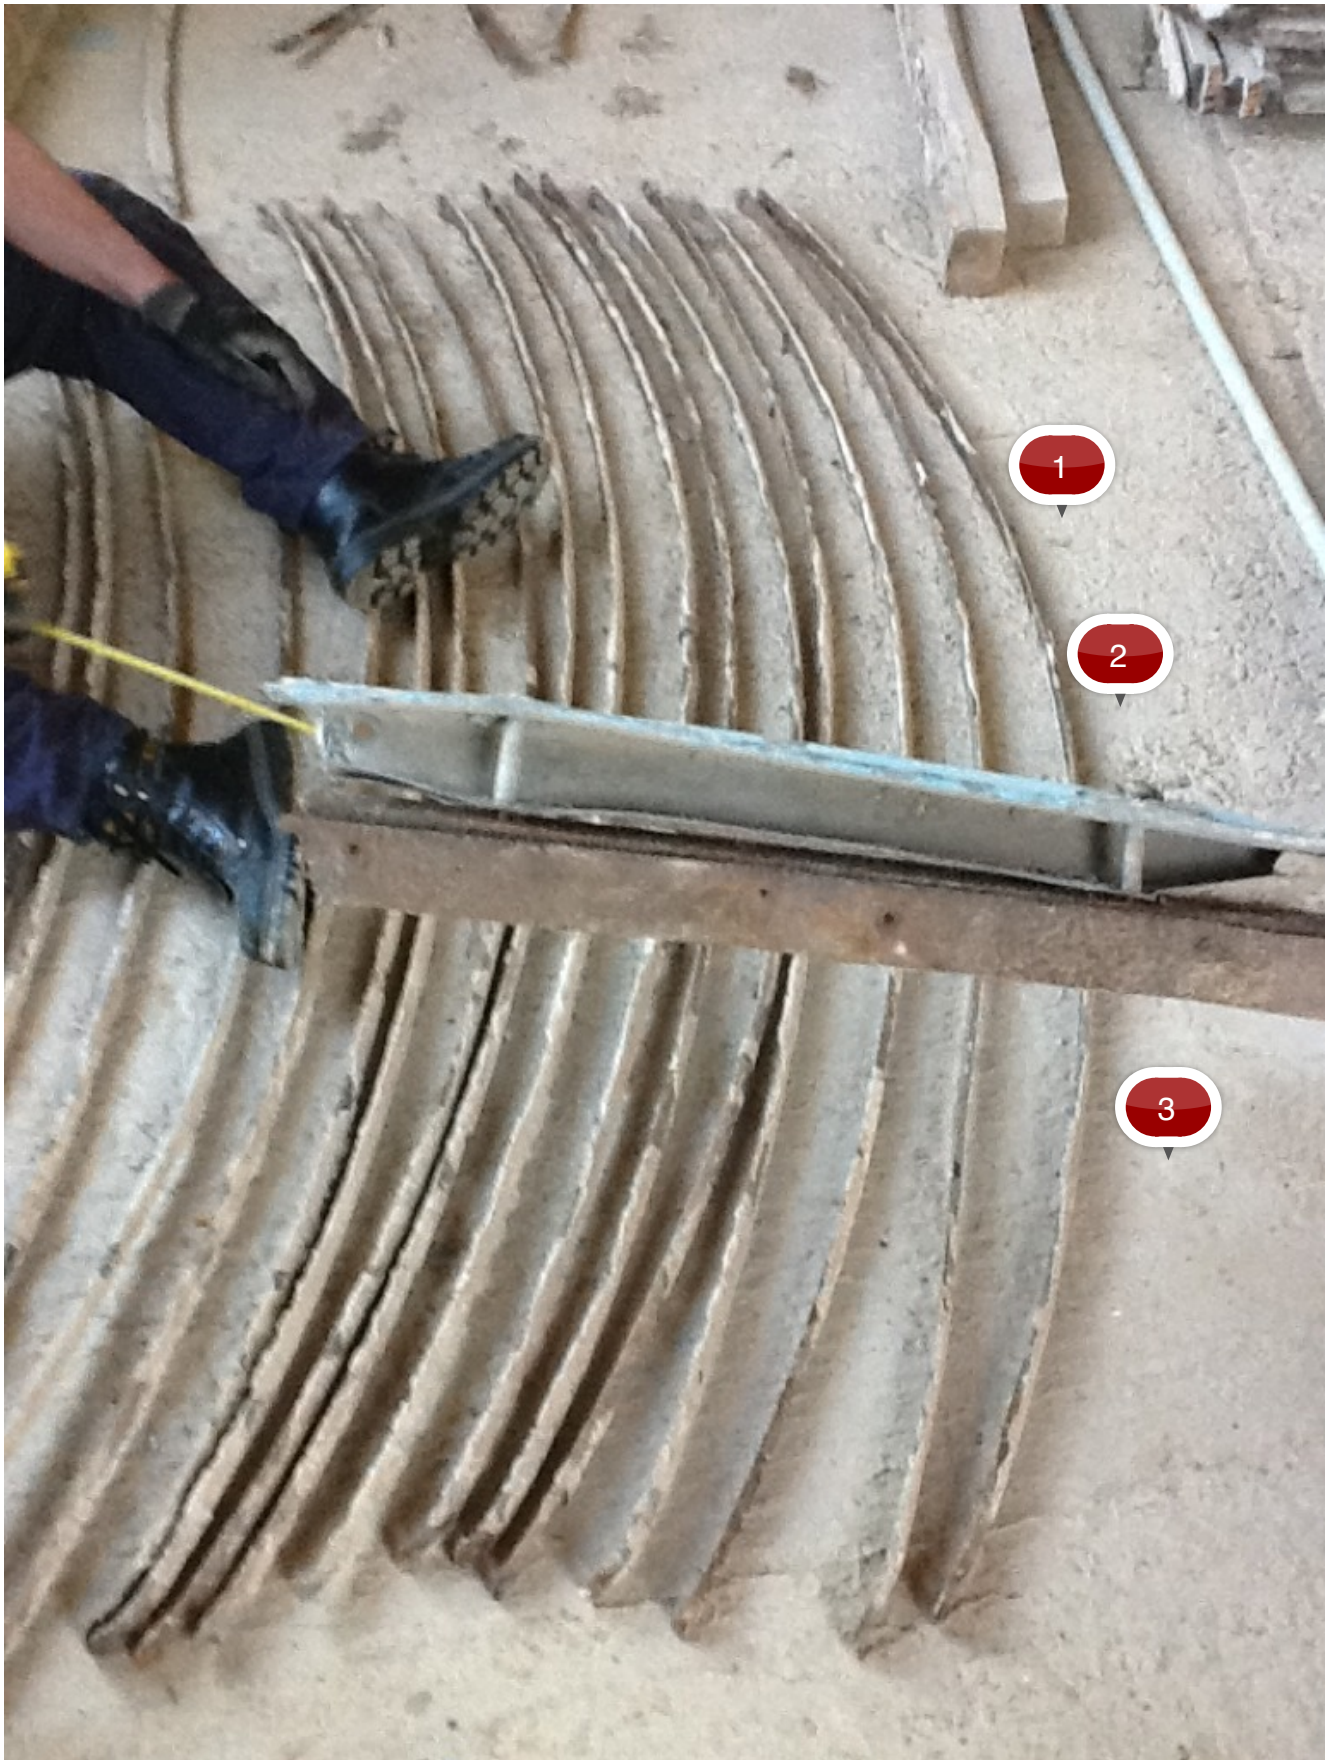
Observation #1

2080mm - 225mm arc Sagitta - 25mm wide by 10mm thick semi circular

Observation #2

17 no. In total with evidence of 'plaster coating' along parts.

1 missing an end.

Observation #3

Zinc straps every 45 mm approx

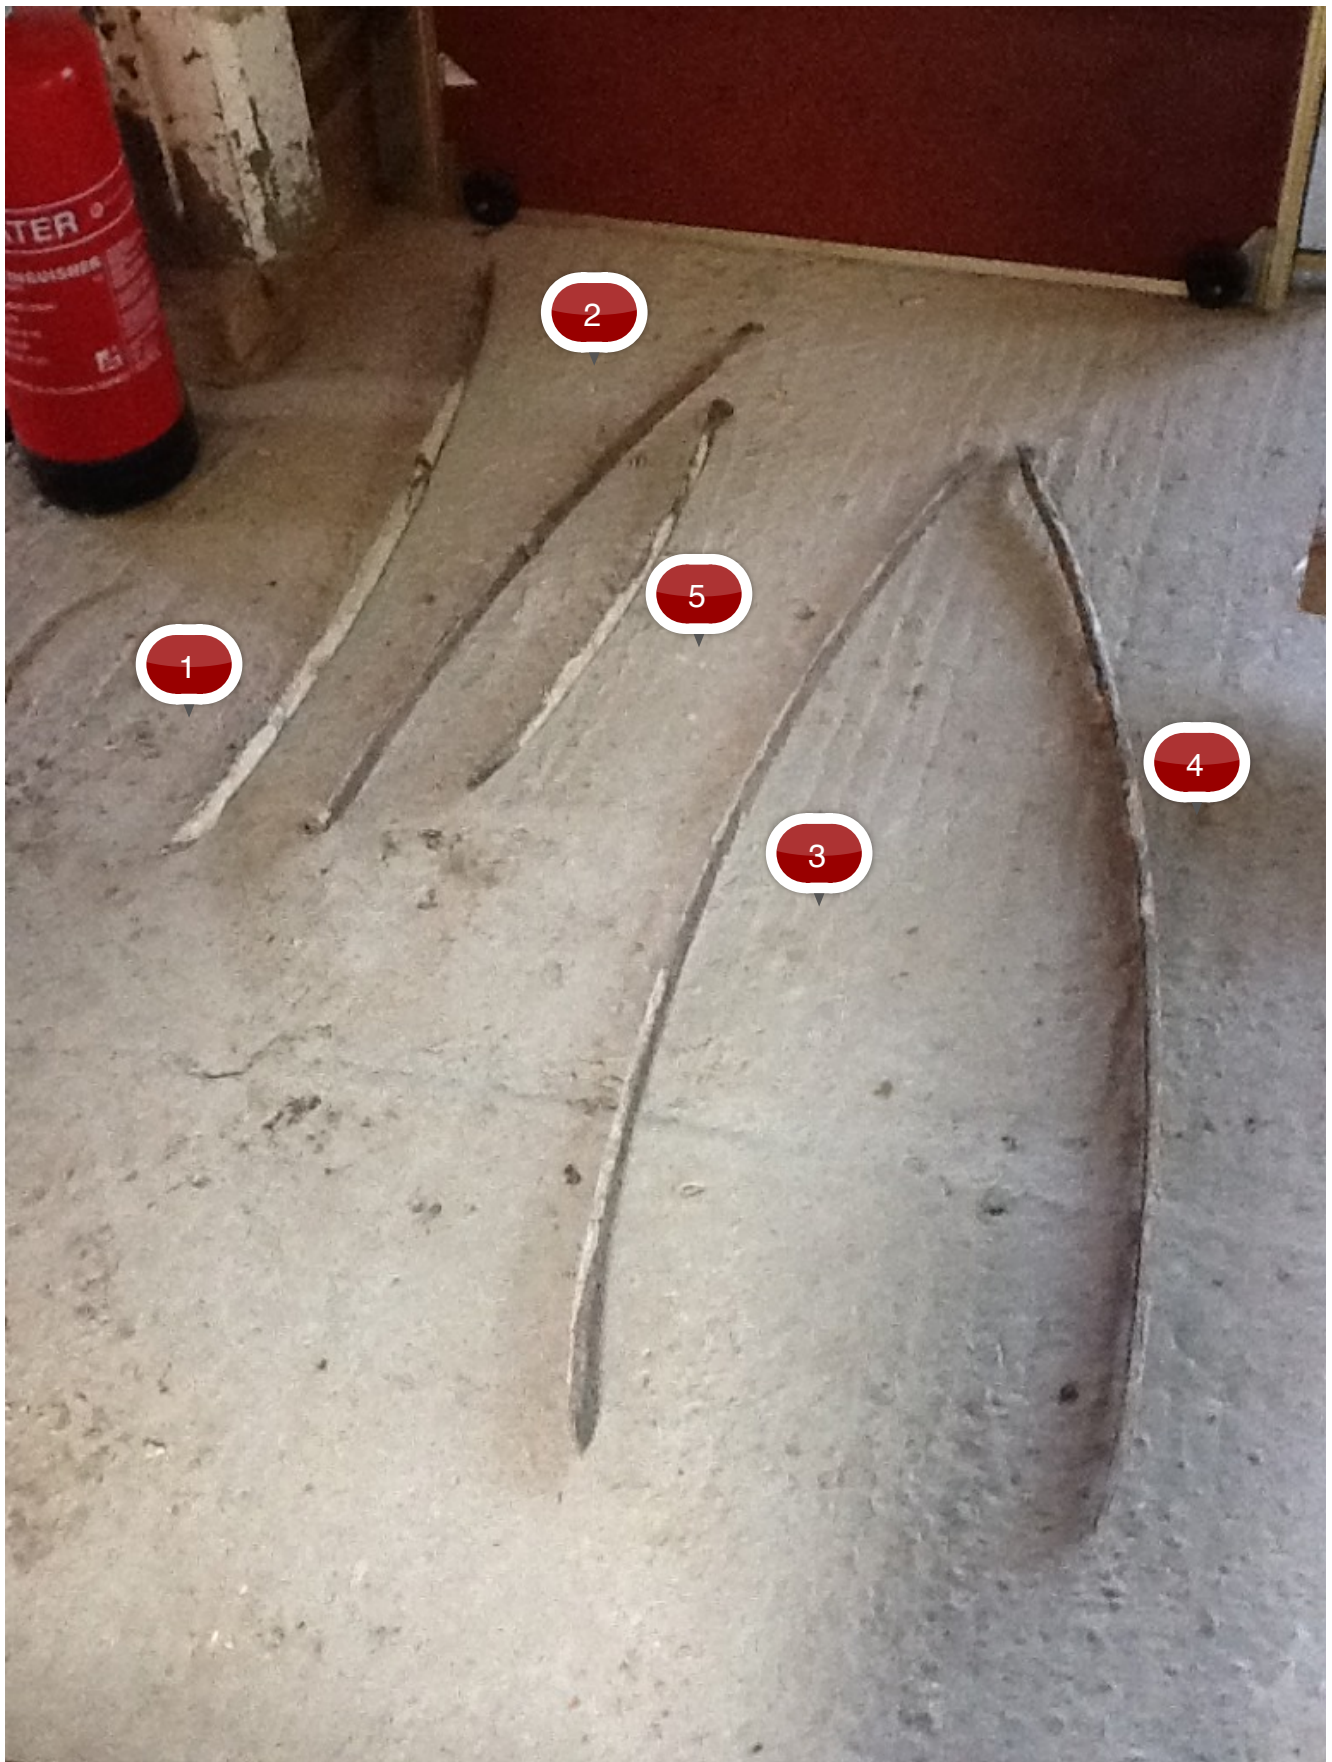
Observation #1

990mm curve
970mm straight

Observation #2

920mm straight
930mm curve

Observation #3

1220mm curve
1200mm straight

Observation #4

1210mm straight
1240mm curve

Observation #5

470mm curve
450mm straight

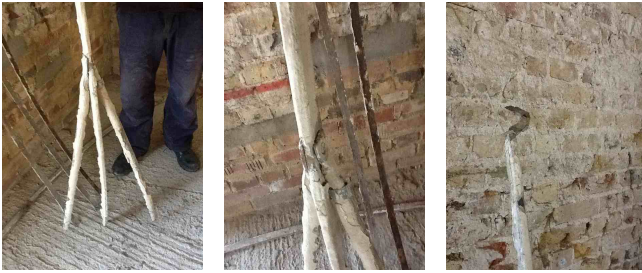
Most intact roof member, with sections still attached. Evidence of 'plaster' coating as per others.
