Arboricultural Appraisal Report

Subsidence Damage Investigation at:

32 Heath Hurst Road
London
NW3 2RX

CLIENT:	Crawford & Company
CLIENT REF:	SU1204069
POLICYHOLDER:	Mr Andre & Mrs Myra Polya
MWA REF:	NW070113.01DW-REV1
MWA CONSULTANT:	David Williams (N.D.Arb MArborA)
REPORT DATE:	02 September 2013

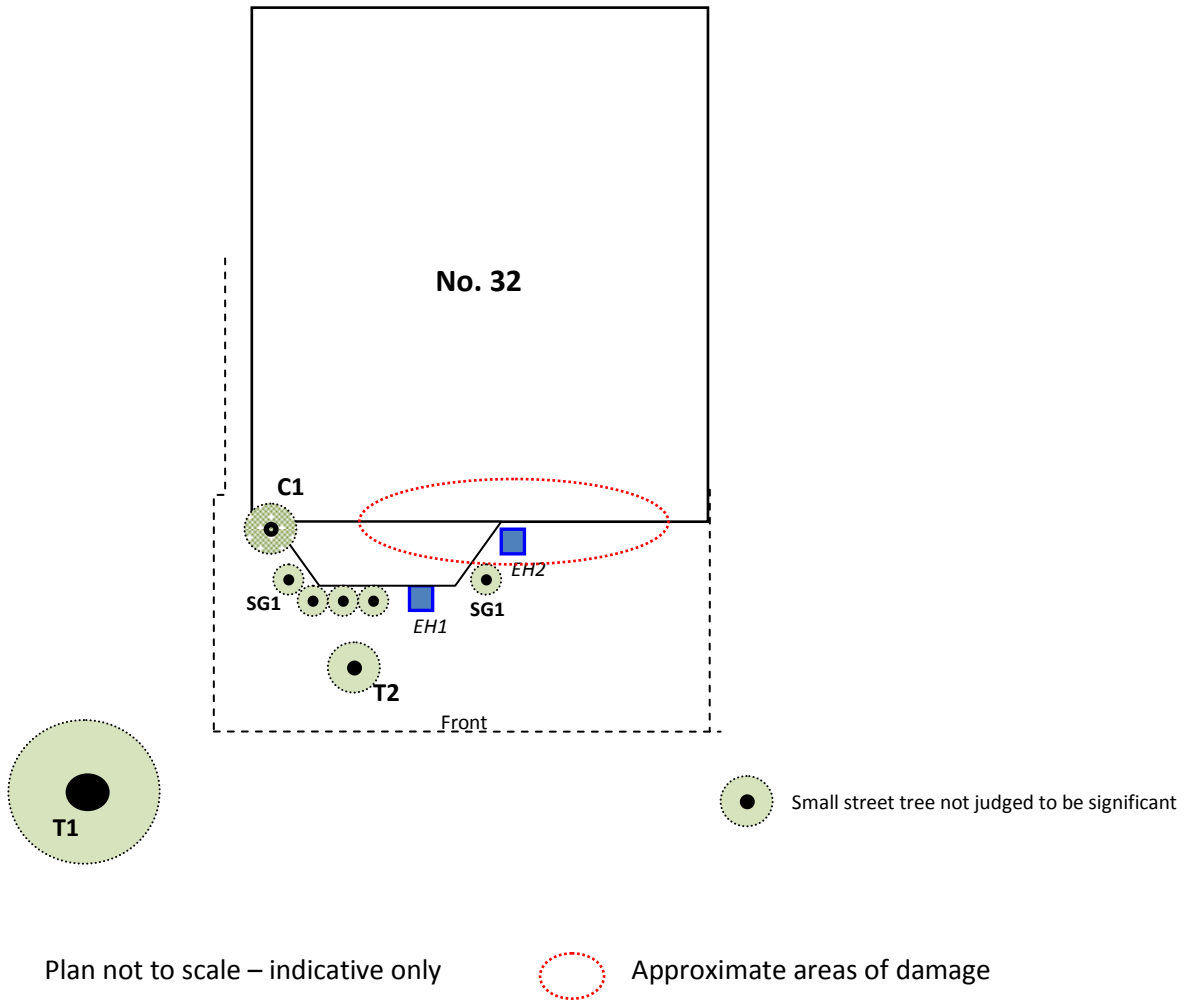
SITE PLAN

The current damage is focused around the front bay and porch and we have recorded vegetation with the ability to influence soil volumes beneath this area of the insured property.

Roots were observed to 1500mm in EH1 and confirm the trespass of roots originating from T1. Other roots recovered were from shrubs forming SG1.
