# Arboricultural Consultancy for Lloyds TSB Insurance

<b>Insured</b>	Peters	<b>Address</b>	15 Pandora Road, London, NW6 1TS		
<b>Client</b>	Halifax General Insurance	<b>Contact</b>	Godfrey Sims	<b>Claim No.</b>	100996767
<b>MT Ref</b>	NL/1201121237/AC-REV1	<b>Consultant</b>	Thomas Peppiatt	<b>Contact No.</b>	08702 416 180
<b>Report Date</b>	02/05/2012

**This is a revision of our original report dated 09/02/2012, due to the addition of further site investigations.**

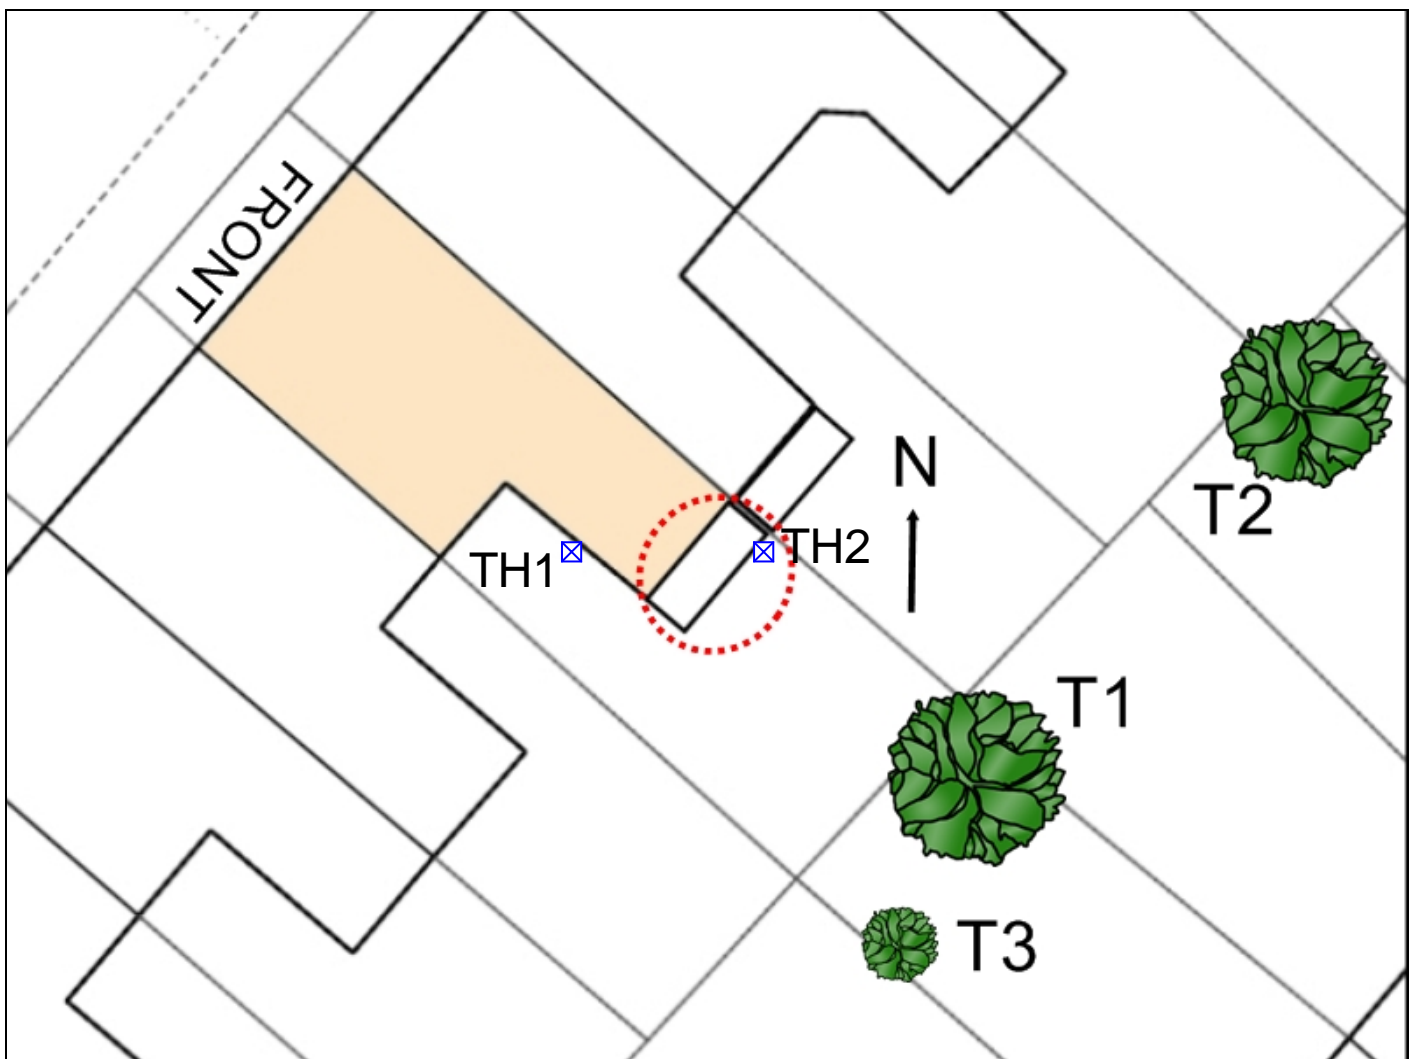
## 7. Site Plan

Based on our observations on site and with reference to supporting technical information, it is our opinion that T1 (Plane (London)) will be exerting the principal vegetative influence in respect of the current damage.

Such circumstances confirm the potential for T1 (Plane (London)) and T2 (False Acacia) to influence soil volumes below confirmed foundation depths and thereby contribute to the damage observed.

Known practice and established research (Hortlink 212) suggests that pruning is an ineffective means of controlling water uptake. For these reasons removal is recommended.
