## **PICUS SONIC TOMOGRAMS**

### **For two London Plane trees in Bedford Square Gardens, London WC1B**

**Prepared for:** Dr Martin Dobson of Martin Dobson Associates Ltd acting for Bedford Estates

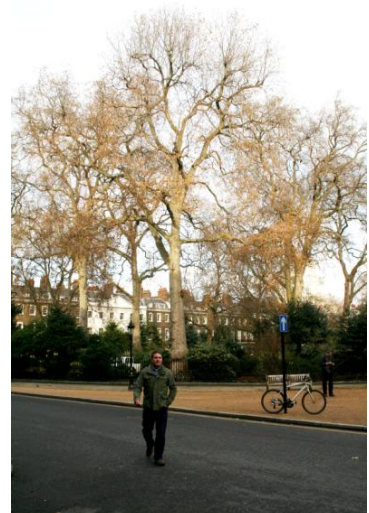
**Tree 3:** The tree was a mature London Plane (*Platanus x acerifolia*) with a height of 28m, and a trunk diameter at 1.5m of 1430mm.

**Rooting zone:** The tree stood less than 1m from the railings, in a shrub bed at the south-west end of the gardens. Outside the railings was a well-used pedestrian area with seats and old-style lamp posts. Beyond that was the road and across the road a Georgian terrace of buildings. The gardens inside the railings are private but even on the cold day I was there, several people were present. There were thus plenty of targets should the tree fail.

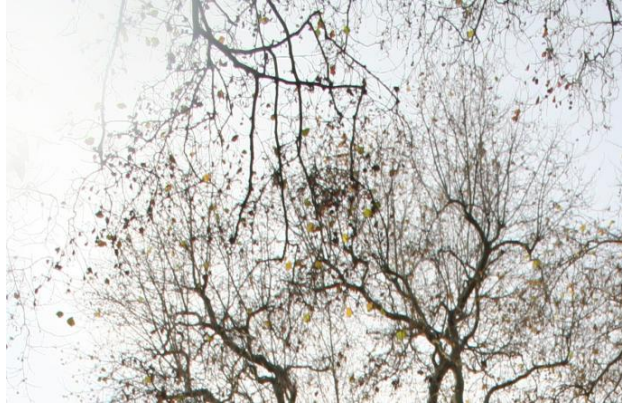
Above 7m the stem divided progressively to create a spreading crown. The crown spread was 11m to the north, 11m to the west, 12m to the south and 10m to the east. The weight distribution was predominantly to the south-west, away from the garden and towards the street.

Vigour appeared normal and re-growth at the top suggested that the tree had been reduced a few years previously.

- **Reduce the height by approximately 3m back to previous pruning points and by a further 2m or so if considered practicable. (See indication in picture below) The spread would also be reduced slightly to maintain a good form.**
- **Re-examine for spread of decay in three years' time**

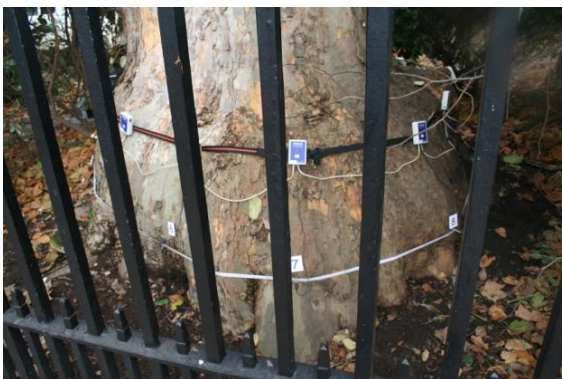
Sensors 5 - 8

The green patch between sensors 1 & 2 is related to a depression between these two sensors and does not indicate decay. The green near sensor 8 is less clear, but undulations in the trunk profile at this point are the most probable explanation of this green patch, rather than decay.

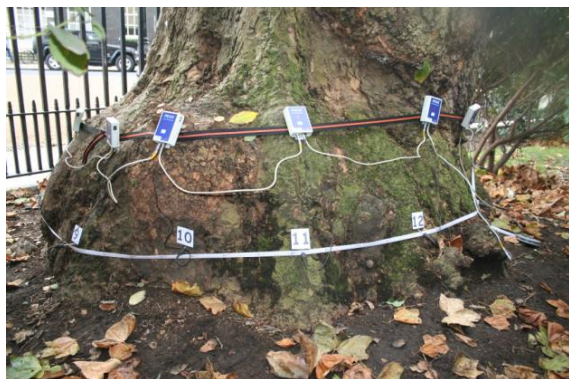
Sensors 9 - 12

*Ganoderma applanatum* degrades lignin rather than cellulose so that the tree is stimulated to lay down extra wood in response to greater flexure of the stem. This would cause swelling at the base of the trunk. Typically the area of decay would taper upwards from the roots into the trunk. The tomogram was taken low down so that decay further up the stem is likely to be less extensive. Decay penetrating into the roots is probable, but serious root death would show as die-back in the crown. The dead epicormic growth and associated dead bark near ground level below sensor 12 may indicate a minor amount of root death.

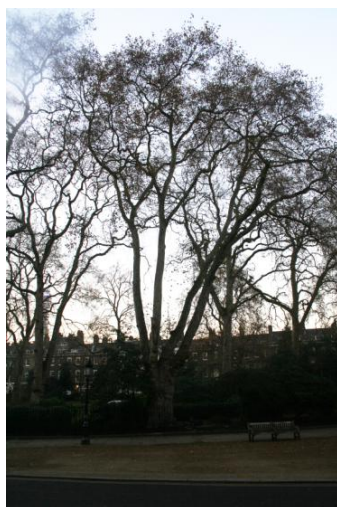
From outside the garden

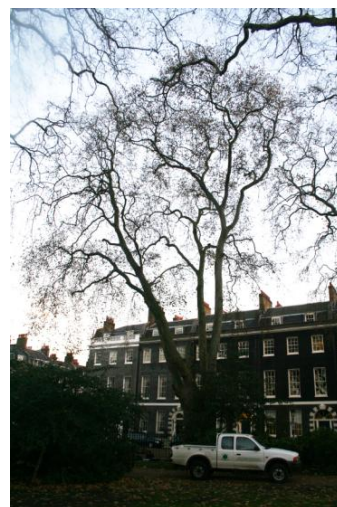
From inside

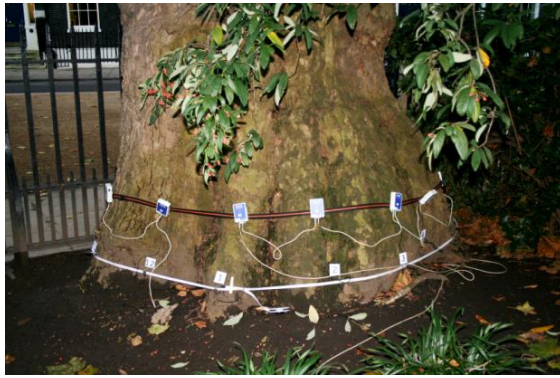
Sensors 11 - 4

The buttressing at 4 and 11 looks thick and strong, but decay was detected at 4 and the north-west side of the tree is not so strong. In my opinion, the position of this tree overhanging the street, and the weakened condition of the trunk lead me to conclude that this tree poses an unacceptable risk, and is likely to become more dangerous as time passes.
