# Arboricultural Consultancy for Ecclesiastical Insurance Group

<b>Insured</b>	27 Arkwright Road RTM Co Ltd	<b>Address</b>	27 Arkwright Road, London, NW3 6BJ		
<b>Client</b>	Infront Innovation	<b>Contact</b>	Oliver Deakin	<b>Claim No.</b>	IFS-EIG-SUB-12-0039018
<b>MT Ref</b>	NL/1401131331/TP	<b>Consultant</b>	Thomas Peppiatt	<b>Contact No.</b>	08702 416 180
<b>Report Date</b>	24/01/2013

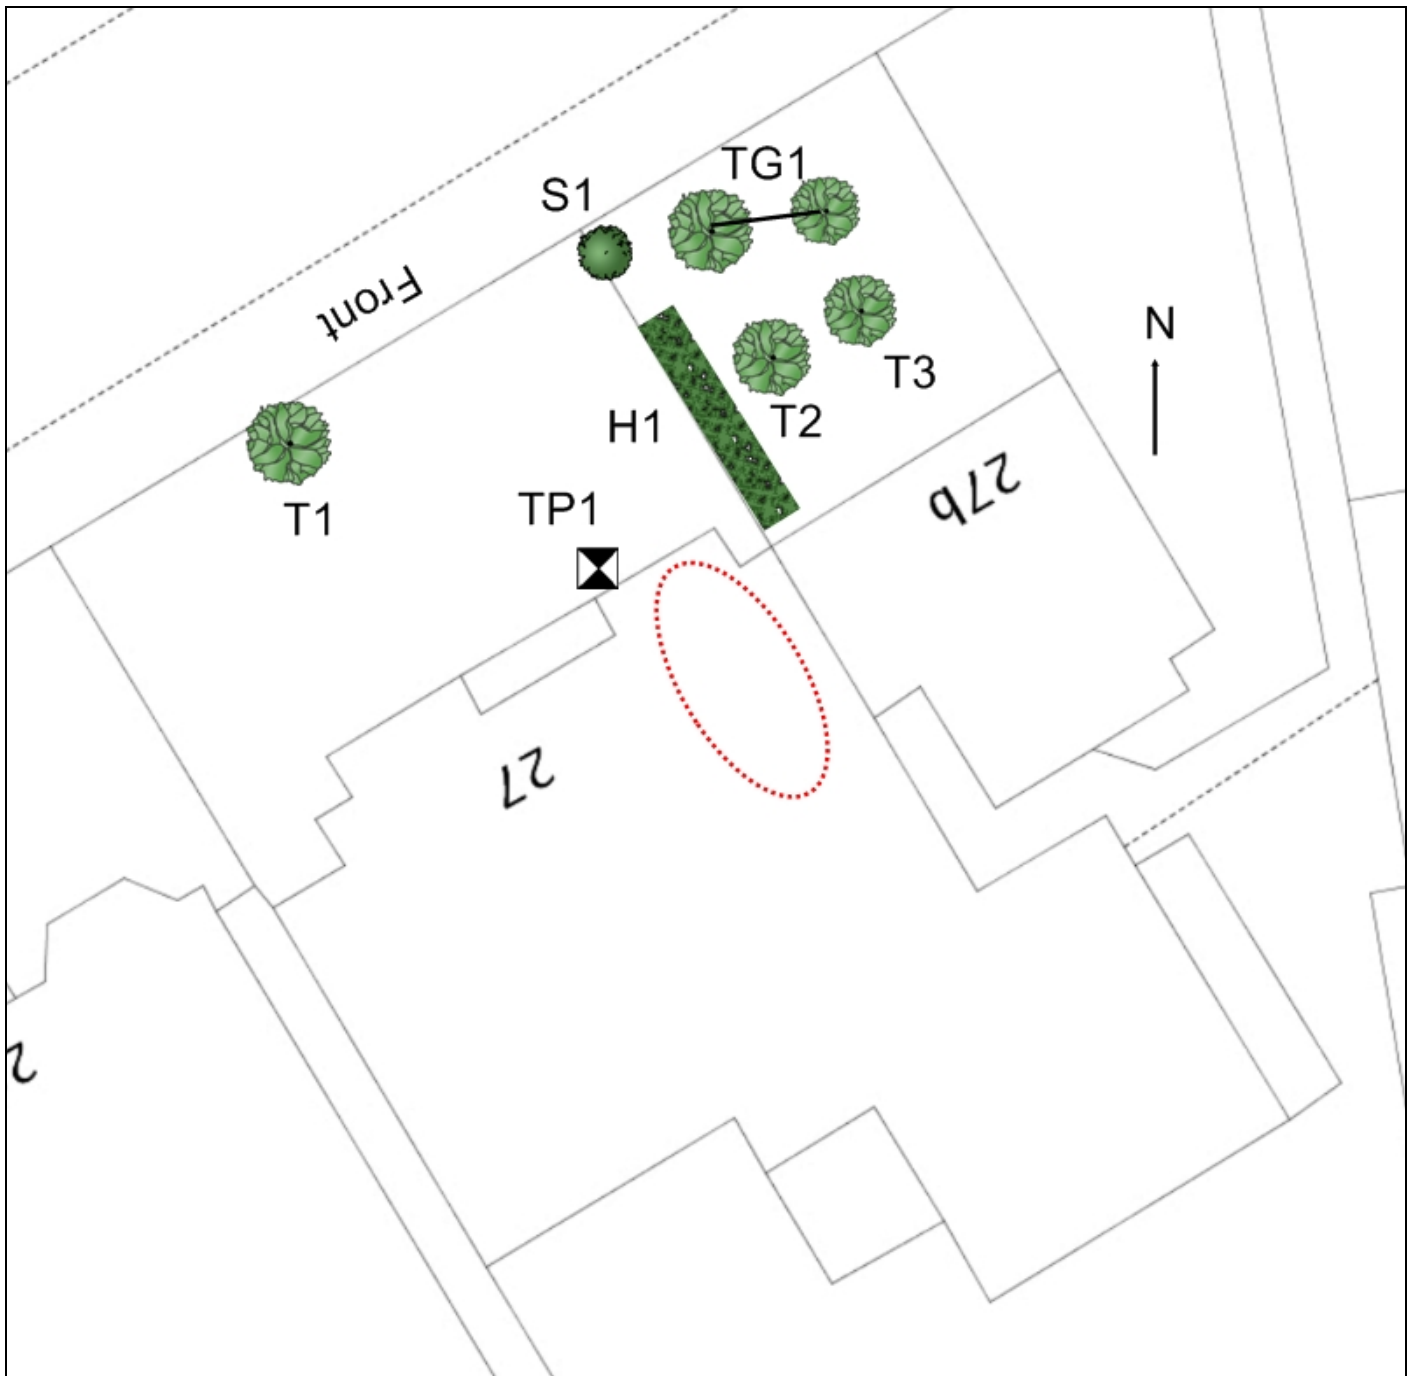
## 7. Site Plan

*Leguminosae* spp roots have been identified within TP/BH1 that confirm the influence of T2 (False Acacia) below foundation level.

T3 (Prunus) and H1 (Euonymus) are also considered to be significant factors in the damage based on size and proximity.

In assessing the potential drying influence of the vegetation on site, the above vegetation is judged to be the dominant feature and accordingly we have identified them as the principal cause of the subsidence.

In order to mitigate the current damage and allow for soils beneath the property to recover to a position where effective repairs can be implemented we recommend the removal of vegetation as detailed within this report.
