Engineer's Report

Our Reference	IFS-EIG-SUB-12-0039018
Claim Reference	000266699
Prepared for	Ecclesiastical

Report Date	21 September 2012
Policyholder	27 Arkwright Road RTM Co Ltd
Address	27 Arkwright Road, London, NW3 6BJ

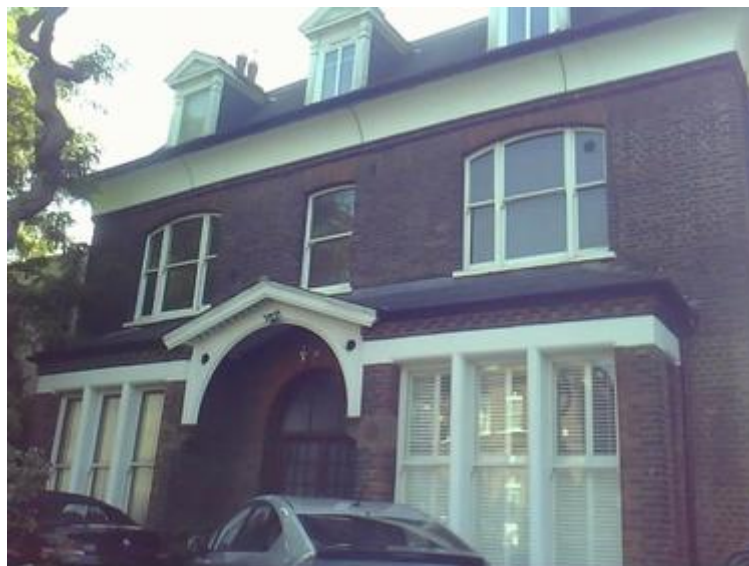
FIGURE 2 Front Elevation

Crack damage to the left side of the front elevation comprises cracked bricks in locations under the ground floor bay window as well as above the window, where the lintel bears onto the left side brick pier. There is also some distortion to the entrance arch.
