# Engineer's Report

| Our Reference | <b>IFS-RSA-SUB-12-0034571</b> |

| Address | <b>113 Chetwynd Road, London, NW5 1DA</b> |

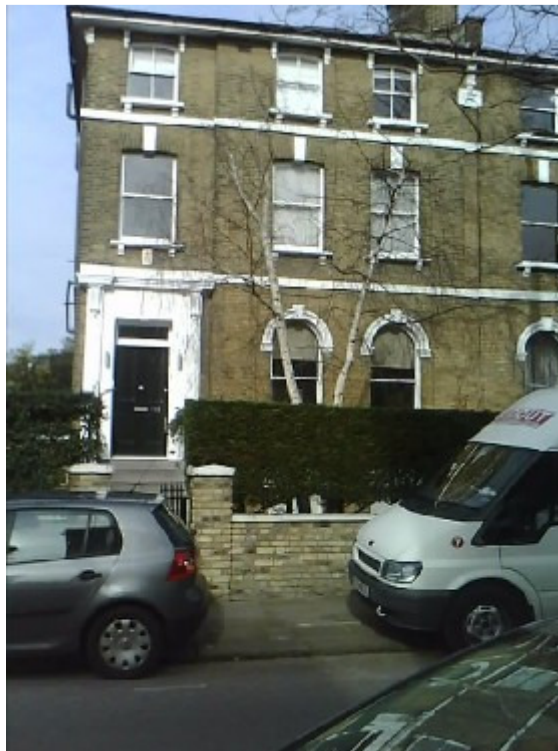
FIGURE 2 Front Elevation

The property is a four storey semi-detached house of traditional construction with solid brickwork walls surmounted by a hipped slate covered roof.
