STRUCTURAL ENGINEERS APPRAISAL

Job Number 121212
22 January 2013

CROFT
STRUCTURAL
ENGINEERS

30 St Marks Crescent

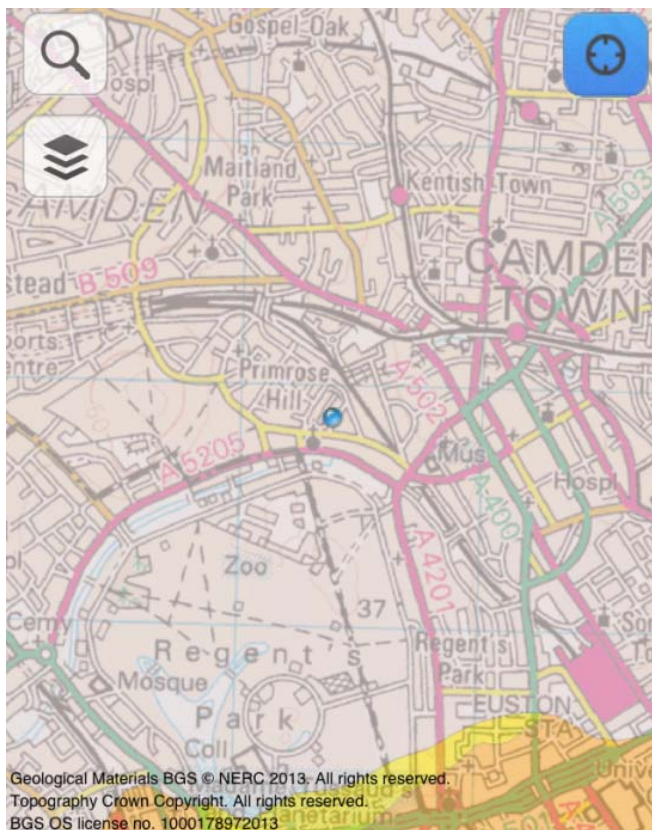
From the North London Geological Drift Sheet (extract opposite) it can be seen that the site is underlain by London clay. In this area we often find part of the Claygate Bed Members are also present. This type of soil is susceptible to subsidence and volume change due to water ingress and egress. Items that will cause problems with subsidence are trees locally and drainage.
