# BACTON LOW RISE REDEVELOPMENT

TREE SURVEY, IMPLICATIONS ASSESSMENT AND CONSTRAINTS

NOVEMBER 2012

### Bacton Low Rise, Tree Survey, Implications Assessment & Constraints Report

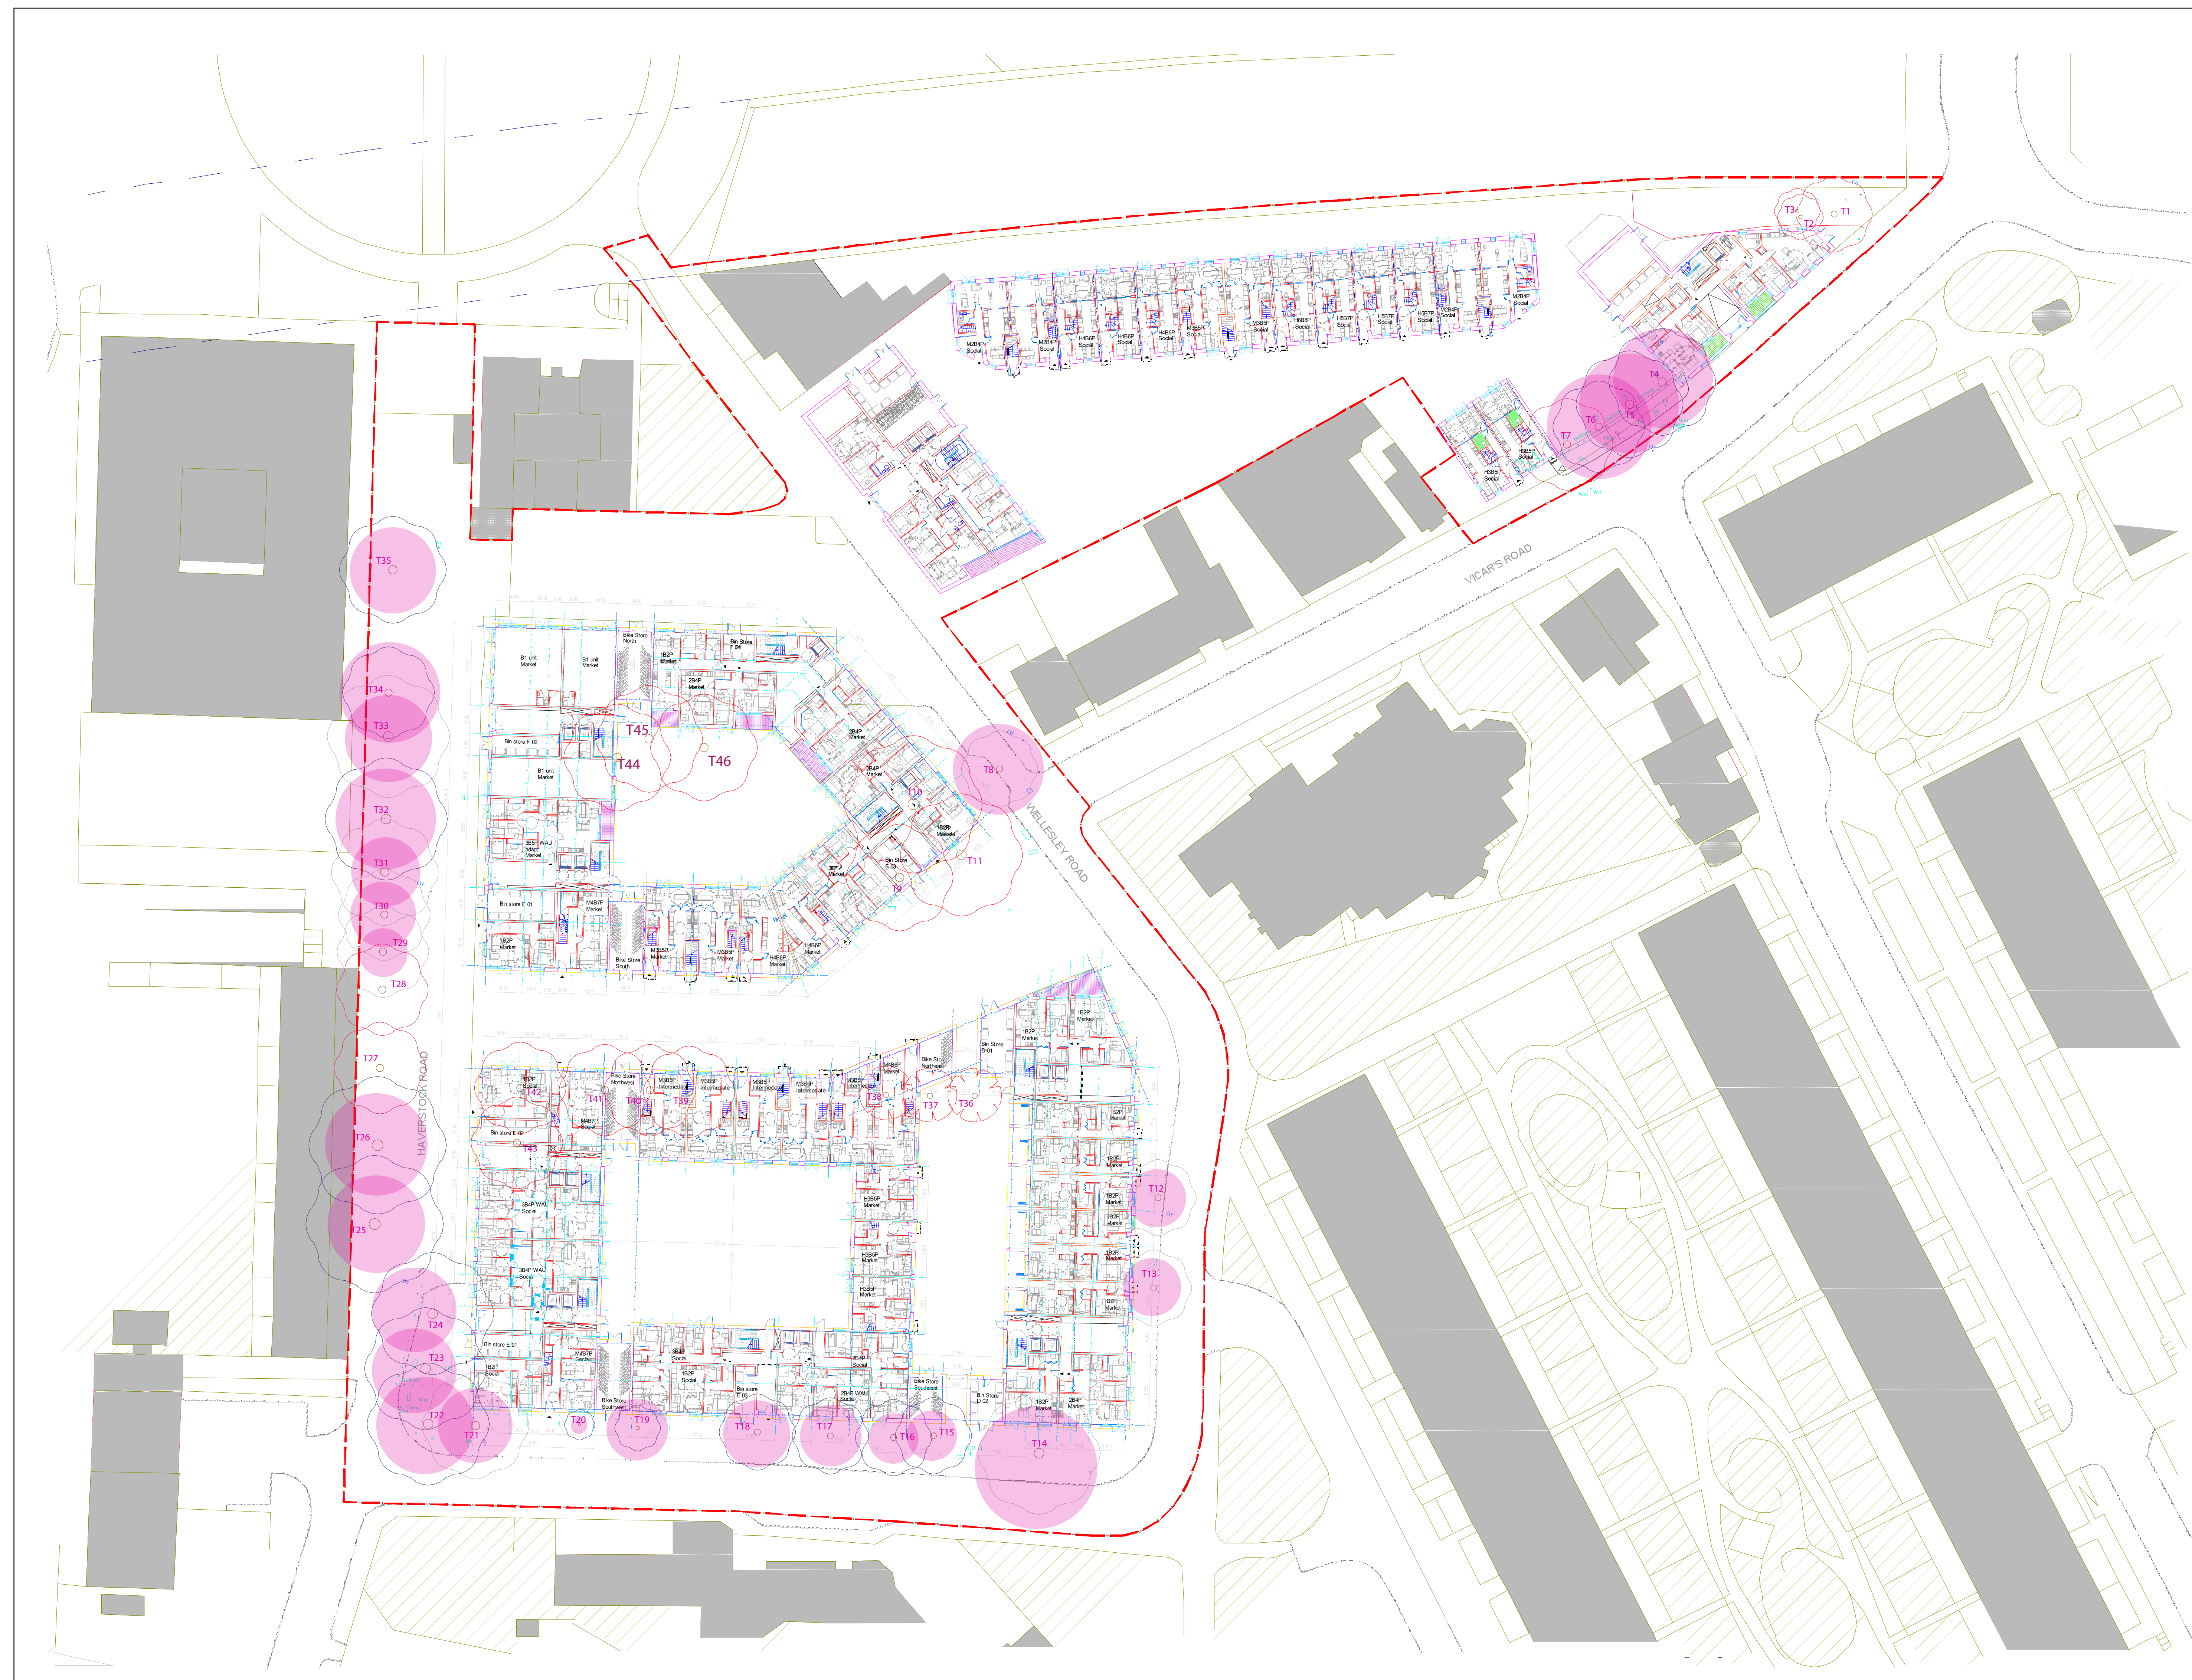
**Arboricultural Method Statement - Bacton Low Rise**

Significant incursion into the RPA of T4 would occur with the proposals as shown. It is the intention to carry out air spade investigative works under arboricultural supervision to determine the extent of the root crown of T4. These investigations are to inform the proposals for incorporating T4 into the build and are likely to include crown reduction and special surfaces to APN12.

Trees marked with a red outline should be felled prior to construction work commencing by fully insured and qualified arborists working to BS3998:2010

Tree protection fencing shall be erected following the remedial tree works and retained for the duration of the project. The fencing shall be erected as per Detail 1 with signage erected as per Detail 2 every 10 meters along the linear length of the fence. Site hoarding, where it forms a physical barrier between the street trees and the site, shall be sufficient as tree protection fencing. Individual trees shall be protected as per Detail 1 and shown on the plan in orange. No works shall take place within the tree protection fencing without arboricultural supervision on site.
