## LABORATORY REPORT

**Address:** 105 Bartholomew Road,  
London,  
NW5 2AR

# Arboricultural Consultancy for Aviva

## LEVEL MONITORING - RELATIVE SURVEY READINGS

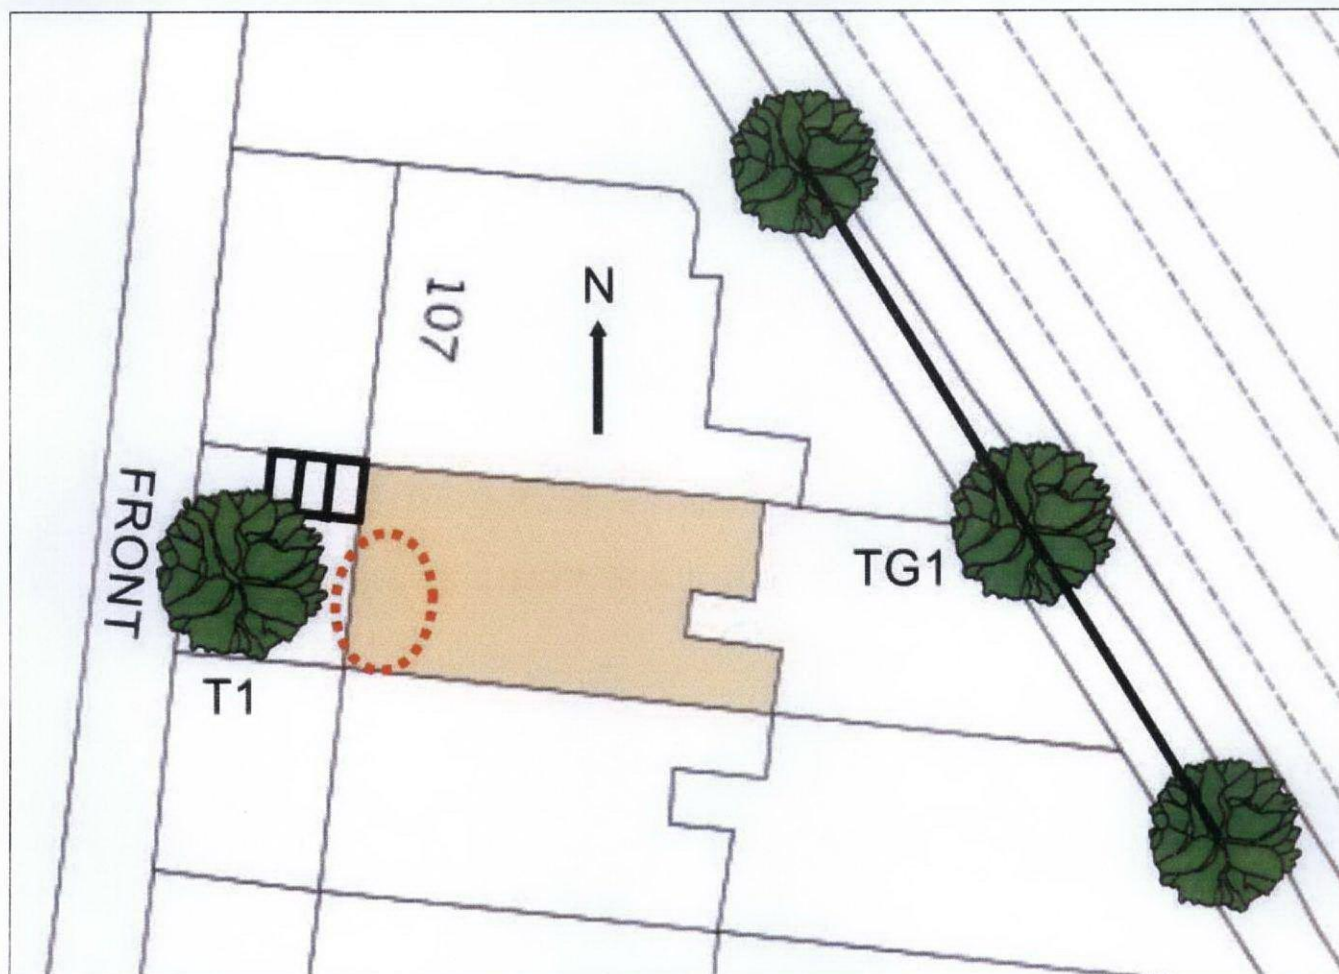
## 7. Site Plan

Based on our site investigations, and taking account of vegetation location, relative to the focal area of movement / damage, it is our opinion that T1 (Plane (London)) will be exerting a significant vegetative influence.

Although T1 (Plane (London)) has been reduced, known practice and established research (Hortlink 212) suggest that pruning is a largely ineffective means of controlling water uptake; for this reason removal is recommended.
