Arboricultural Consultancy for Lloyds TSB Insurance

Insured	Shane	Address	2 Netherhall Gardens, London, NW3 5RR		
Client	Halifax General Insurance	Contact	Godfrey Sims	Claim No.	100941801
MT Ref	NL/3001121501/TP	Consultant	Thomas Peppiatt	Contact No.	08702 416 180
Report Date	24/02/2012

Scope of Report: To survey the property and determine significant vegetation contributing to subsidence damage, make recommendation for remedial action, initiate mitigation action and assess recovery prospects. The survey does not make an assessment for decay or hazard evaluation.

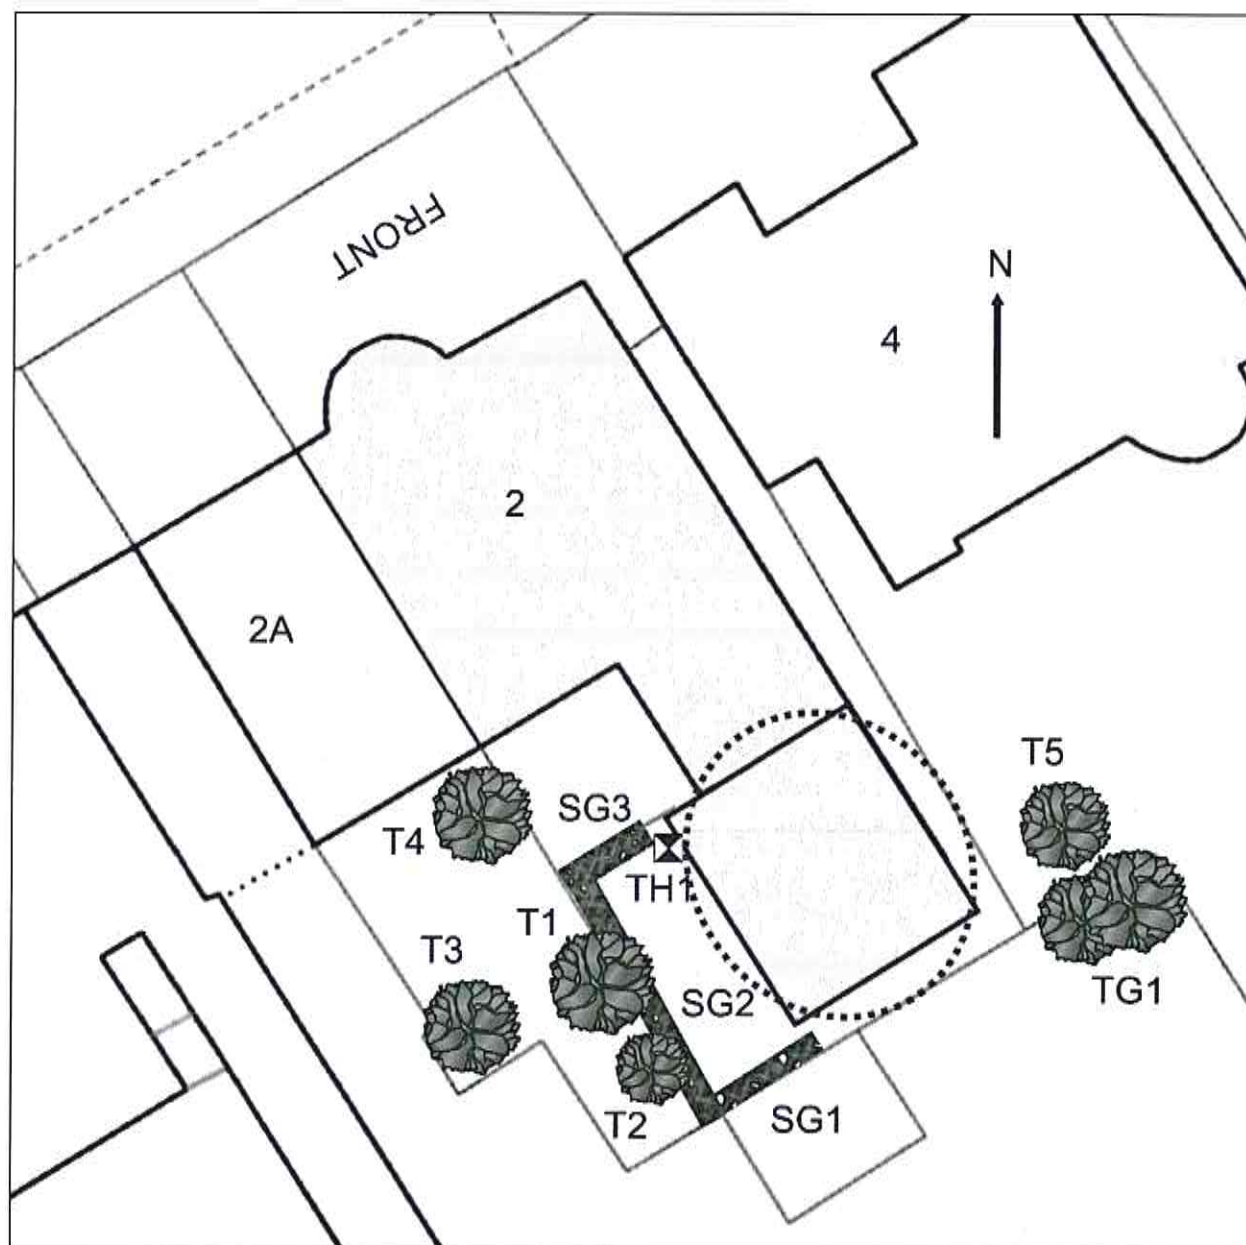
7. Site Plan

Roots recovered from TH1 have been formally identified as *Prunus* spp and *Pomoideae* gp. The most likely origin of the roots is T1 (*Prunus*) and T2 (*Apple*) respectively. Such circumstances confirms the potential for T1 (*Prunus*) and T2 (*Apple*) to influence soil volumes and to contribute to the damage observed.

We have given consideration to pruning as a means of mitigating the vegetative influence, however this has been discounted. Known practice and established research (Hortlink 212) suggests that pruning is an ineffective means of controlling long term water uptake. For these reasons removal is recommended.
