**PRE-ACQUISITION STRUCTURAL SURVEY REPORT**

**7 UPPER ST MARTIN'S LANE  
LONDON WC2H 9DL**

**ANGLE PROPERTY (ST MARTINS) LTD &  
TELENOMICS LTD**

**Project No. P1986**

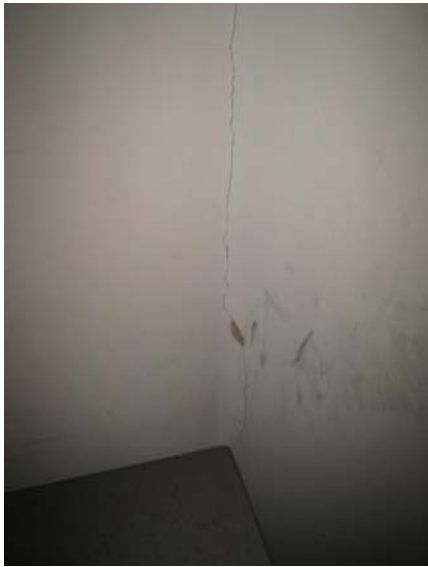
**Photograph 4.02.6a**

- 4.02.5 The lift motor room was not accessed during our visit.
- 4.02.6 There is an office to the rear of the basement, and here minor cracking was observed in two locations. Readings from damp meter gave normal readings, so it seems likely that this cracking is superficial rather than caused by any water ingress or other significant structural cause.

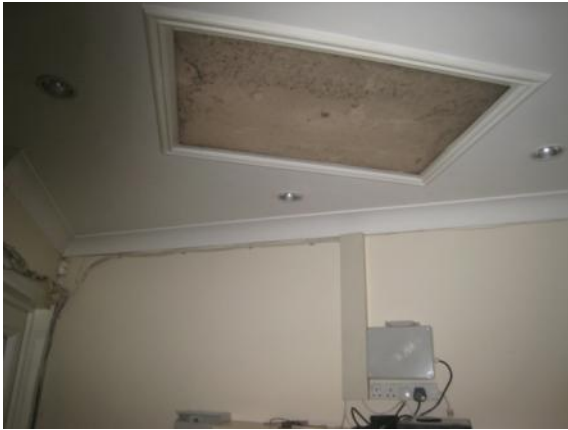
**Photograph 4.03.5**

- 4.03.5 Behind the main staircase there is a BT & security Room, which has rooflights and assumed flat roof construction, similar to the rear room.
- 4.03.6 There is a corridor running to the front elevation alongside the main office area as a secondary escape route. There is a substantial length of boxing out within the corridor, but it is not clear what is concealed behind. There is some cracking in this corridor on the interface between stud walls and masonry walls, which is of decorative concern only.

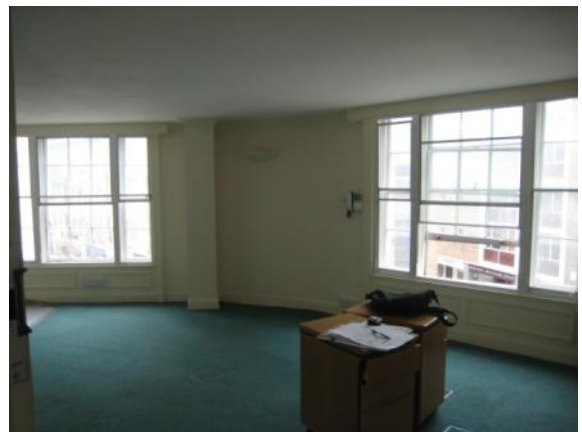
**Photograph 4.05.1**

- 4.05.1 The second floor comprises two office areas either side of the internal party wall, with an opening between. To the rear of the left hand office there is a corridor and kitchen which are sub-divided by non load-bearing partitions.
- 4.05.2 The windows to the front elevation have rotten frames, particularly those to the left hand side. The worst are in need of urgent repairs and generally replacement will be required in due course. There is also cracking to some of the stone cills beneath the windows, which will in due course need cosmetic repairs.

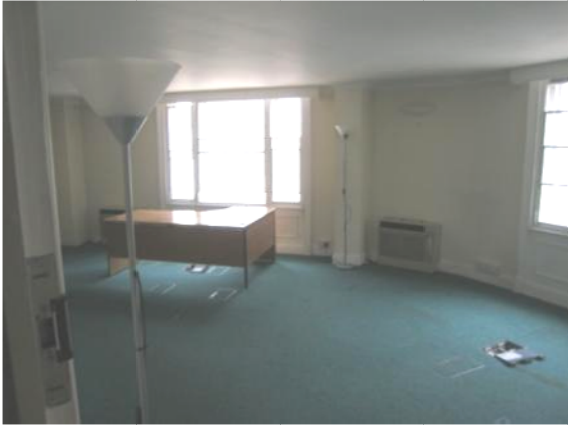
**Photograph 4.06.1**

- 4.06.1 The third floor is laid out similarly to the second and first floors, but with no internal partitions.
- 4.06.2 The windows to the front elevation again have rotten frames, with attention required in the short term. There is also cracking to the reveals around the windows, which look to have been repaired previously – this is likely to be caused by the deterioration of the sash windows.

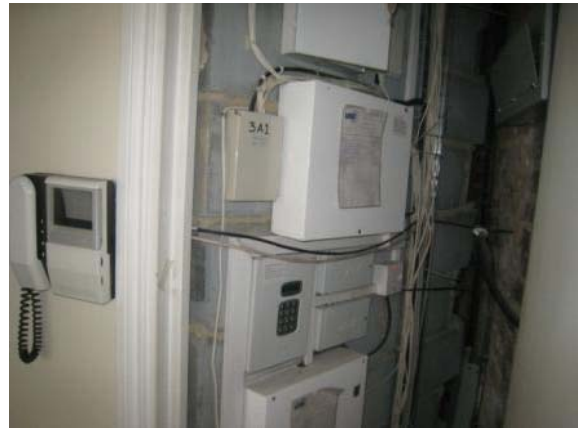
**Photograph 4.06.3a**

- 4.06.3 At third floor it was possible to access the service riser from the office footprint – refer photos in Appendix A. It was observed that the wall between the riser and the staircase is a newer blockwork rather than an original brickwork wall.

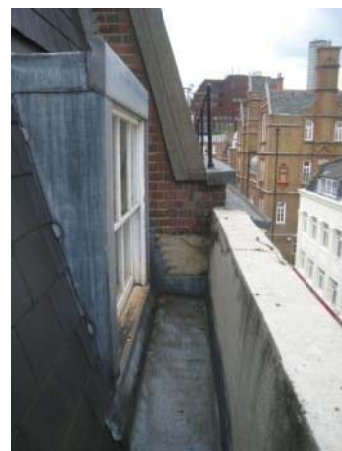
**Photograph 4.07.2a**

- 4.07.1 The fourth floor is the lower of two floors behind a sloping mansard elevation, which looks to have been constructed in traditional materials. The floor is generally open plan, but with one section partitioned off. The party wall does not continue through this level. The mansard facades steps back from the main line of the elevation, which continues above fourth floor to form an approximately 1m high parapet.
- 4.07.2 The section of the parapet to the right of the building (when viewed from the street) has cracking both in elevation and on its top face. The parapet leans out by approximately 40mm at its worst point. This will need further investigation as to its cause but repairs will be required to prevent any potential worsening of the lean or cracking.

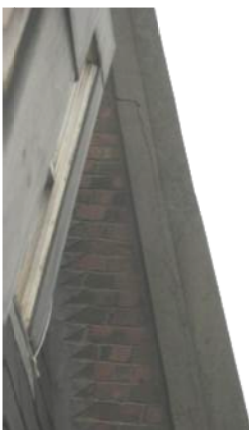
**Photograph 4.07.2f**

Adjacent to the mansard elevation there is cracking to the party wall to St Martin's Theatre – refer photo 4.07.2f. This may be just expansion/contraction of the finishes relative to the masonry substrate behind but it should be monitored going forward to check whether the condition is deteriorating.

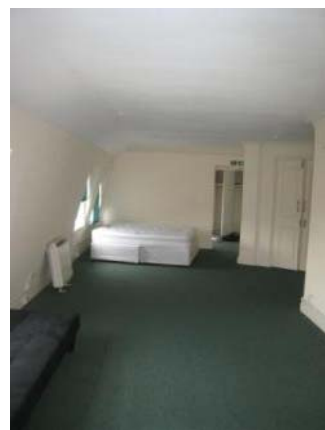
**Photograph 4.08.1a**

- 4.08.1 The fifth floor has a sloping mansard elevation and is sub-divided by partition walls to create a storage area, a kitchen, bathroom and office/bedroom area. It is connected to the main staircase by a small flat-roofed lobby.
- 4.08.2 The small lobby was extensively damp with discolouration to walls, ceiling and floor. Humidity levels of 50% to walls and 100% to floor were recorded using a damp meter.

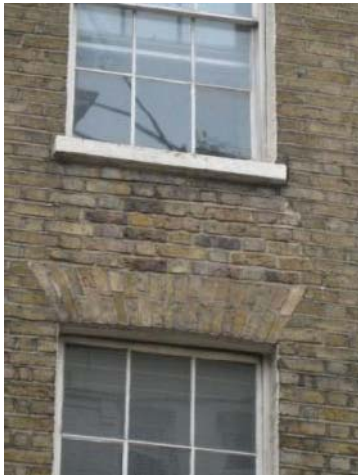
**Photograph 4.12.6a**

- 4.12.6 At 2<sup>nd</sup> and 3<sup>rd</sup> floors within Elevation 2 there has been previous rebuilding of the spandrel panels between windows. However there is diagonal cracking to the right hand side of these rebuilt sections. It seems likely this is due to movement of the lintels below, so helical stainless steel bar repairs will again be advisable in due course.

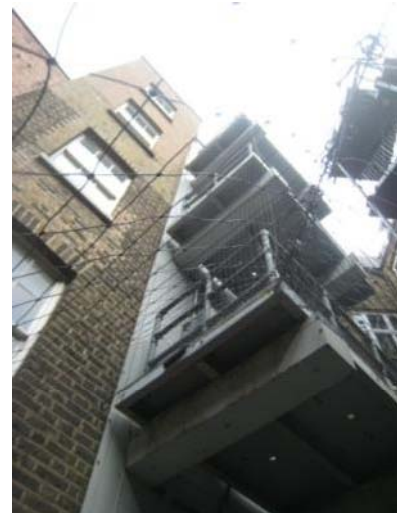
**Photograph 4.13.1a**

- 4.13.1 The rear elevation has three principal sections; the rear wall to the secondary staircase (left hand side of Elevation 3 on the survey elevations), the toilet block extension (central section of Elevation 3) and the side wall to the main staircase (right hand section of Elevation 3)
- 4.13.2 For the right hand section of Elevation 3, sections of brickwork have been rebuilt between the windows.
- 4.13.3 More general brickwork repairs have been made to the left hand side of Elevation 3, to spandrel panels and around the windows.
- 4.13.4 The toilet extension has an external finish of metal panels, which appear to be in reasonable condition.

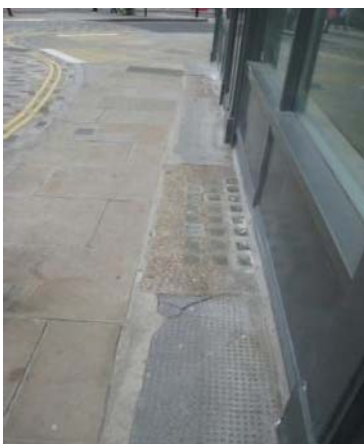
**Photograph 4.14.1**

- 4.14.1 At ground floor level there are 'Luxcrete' type pavement lights in two locations. These have not recently been replaced look in fair condition. There is no pavement light in the location where it is suspected that a former pavement light has been infilled (refer 4.02.3)

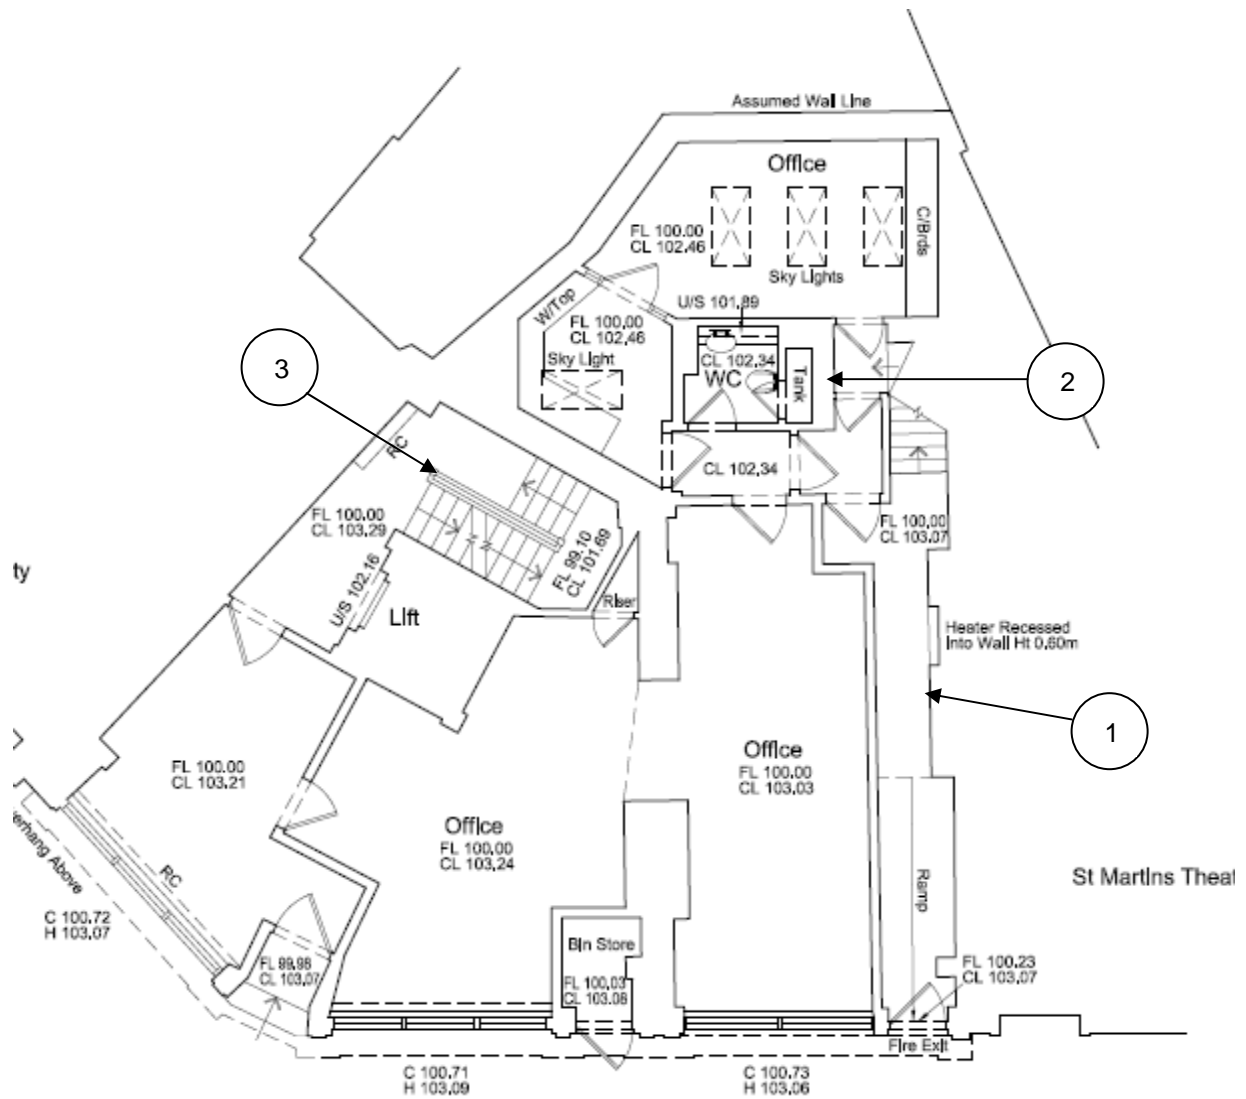
**BASEMENT LEVEL KEY PLAN**

1	Lightwell shown on earlier drawings but not evident on site	5	Damp section
2	Damp corner	6	Service intake under reconstructed half landing
3	Kitchenette surrounded by masonry walls	7	Steel beam over
4	Cracks in wall	8	Lift motor room not accessed
