STRUCTURAL APPRAISAL REPORT ON THE EXISTING BUILDING OF 6 WEDDERBURN ROAD, LONDON NW3 5QE

RE: Geo-hydrology Screening Assessment, 6 Wedderburn Rd, Belsize Park, North London, NW3

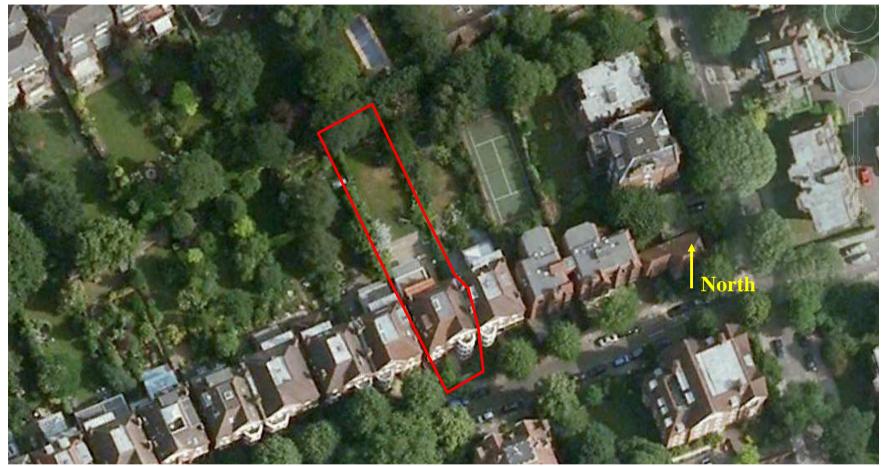
Figure 1: 6 Wedderburn Road Red Line Boundary

The red line boundary of the property is presented on Figure 1 (Enclosure 1). The site consists of a single residential c. 1900 mansion building (containing two units) in a residential area.
